**M. Cepak, M. Keenhihan, M. Nelson, “*DENR Underground Inspection, May 28 and 29, 2003*”**

## **HOMESTAKE UNDERGROUND INSPECTION**

**May 28 and 29, 2003**

## Inspection Report

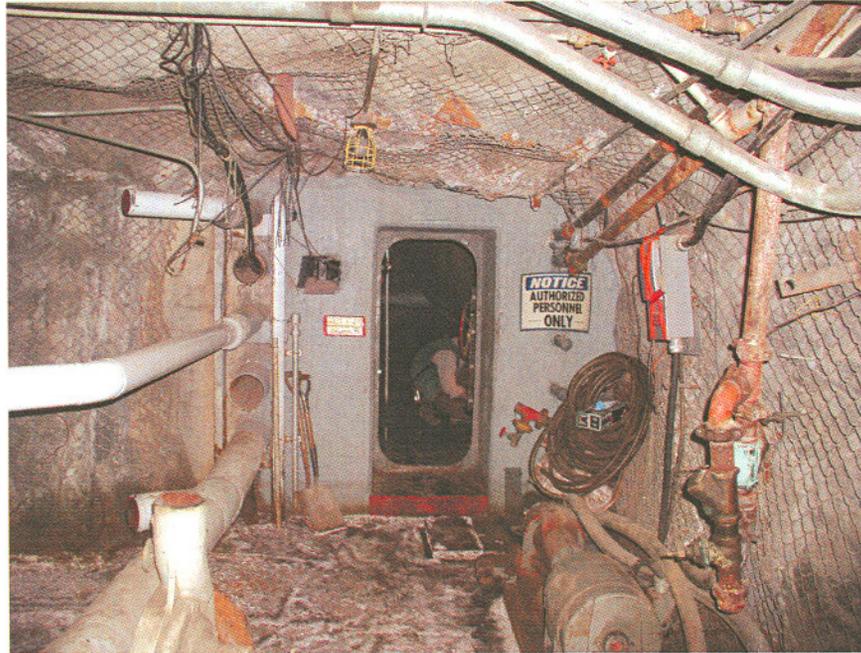
The neutrino lab is just off the Yates Shaft lift area on the 4850 Level. Some equipment remains in the drift between the Yates shaft and the lab including rail, steel, and various cables and hoses. Within the lab, nearly all electrical and testing equipment had been removed. The 100,000-gallon capacity perchloroethylene tank, a few other small tanks that contained potassium hydroxide or mineral oil during the lab operations, some small pumps, piping, and structural steel infrastructure remain in the lab area. These tanks have been drained, and mercury and lead used as shielding for the experiments have been removed from the mine. Within the tank room white precipitates were observed on the floor. In addition, orange-colored water was observed in the tank room and within a floor sump at the base of the access drift. The pH of this water was measured at 6.3. The composition of the white precipitates and orange water is unknown, but are likely the result of calcium and sulfate mineral precipitates and iron from the rusting of infrastructure components. The neutrino lab area was decommissioned by Tier De, an environmental consulting firm, as part of the mine closure activities. The tanks and piping were cut open to facilitate and verify the removal of the contents. Wipe tests were reportedly conducted in the area where mercury flasks were stored. Homestake personnel reported they are currently reviewing a draft version of the Tier De closure report for the underground neutrino lab.

Photo 1. Pump room at 4850 Neutrino Chamber (bottom of ramp).

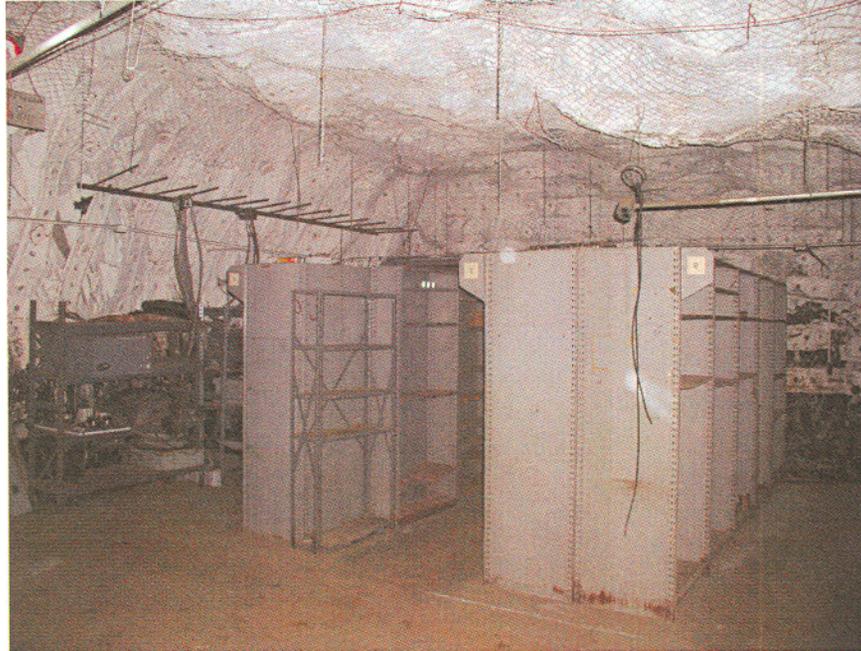
Electricians were still working on the 12 KV line, so at 9:30 a.m. we proceeded to the 4850 Electrical Shop near the shaft station. A sign going into the shop read "4850 Electrical Shop Unmaintained Area Clean for Closure 4-29-03 TR". Air handling equipment, electric motors, piping, storage cabinets, workbenches; along with electrical conduit, wiring, and junction boxes remain in this area. The overall condition of this area was clean. The floor had been swept and lighting fixtures were removed. No oil or chemicals were found.

A broken fluorescent light bulb was noted in a trash can. Homestake personnel verified their closure procedures for bulbs included the removal of hazardous waste fluorescent and sodium lamps and lamp ballasts, but that some non-hazardous waste fluorescent lamps and incandescent bulbs may remain. The bulb type was not verified. This was the only spent fluorescent lamp noted in underground mine areas during the inspection. During the subsequent records review on May 29<sup>th</sup>, Homestake personnel stated they were removing this bulb from the mine.

Photo 2. 4850 Electrical Shop. All remaining equipment and materials to be abandoned in place.

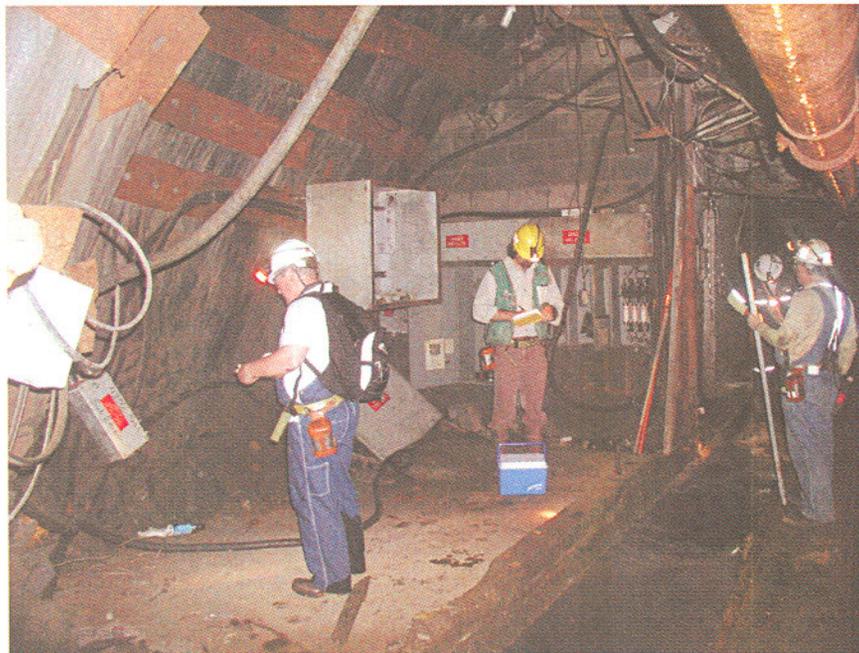
4850 45-Crosscut 17L Electrical Substation. Homestake personnel removed an oil-filled transformer from this site during closure operations. Equipment remaining in this area after sampling and remediation operations consisted of gutted electrical switching boxes and the cleared concrete pad. Drill holes in the pad from the PCB sampling were still visible. Sampling results for this pad indicated less than 1 ppm PCB. Therefore, the concrete pad was left in place consistent with the Homestake remediation plan.

At this location the inspectors noted a slight sheen on water in an adjacent drainage ditch. Homestake personnel said they mucked approximately 300 feet of drainage ditch in the area of the LHD shop, and then applied Spill Shark absorbent. The Spill Shark could be seen floating on the water surface. Homestake personnel said the Spill Shark would still work in wet conditions. The inspectors collected a sample of the water in the ditch to test for hydrocarbons. The pH of the water was 7.8 with an electrical conductivity of over 2000 uS/cm.

Photo 3. 4850 Level, 45 crosscut electrical substation. All remaining equipment abandoned in place.

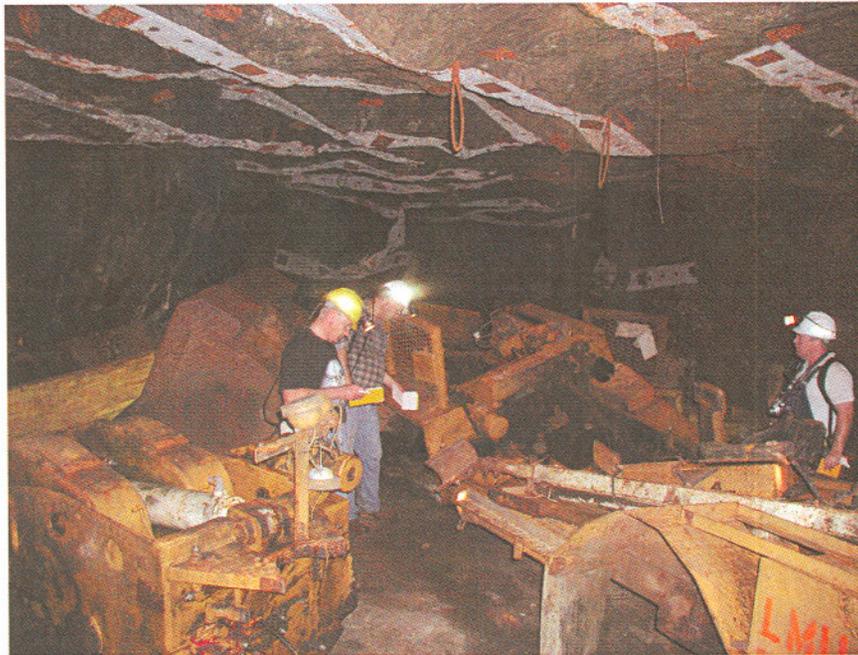
4850 100-foot Subsill Bone Yard and Backfilled Mine Stope Areas. We walked up a ramp to a subsill 100 feet above the 4850 Level. Painted on the wall of this subsill was “42A”. Homestake used this subsill as a small equipment abandonment area. We observed an old steam-cleaning unit that Homestake personnel said they decommissioned and abandoned due to poor condition. Homestake reportedly evaluated other steam-cleaning units on a case-by-case basis. There were

a few old Load-Haul-Dump (LHD) chassis and a truck abandoned in this area. Observations indicated Homestake removed engines, transmissions, pumps, hoses, radiators, and other parts that typically contained vehicle fluids. Batteries and tires were also removed from the equipment and taken out of the mine during closure activities. Hydraulic fluid reservoirs and hydraulic cylinders were left in place. Homestake personnel stated that these components were drained. It is probable that there are grease and lubricant residues on some of the remaining chassis components in areas that were not visible, but overall these abandoned chassis did not contain significant quantities of residues. The inspectors also observed the sand backfill walls for some of the old backfilled mine stopes in this general area. The backfill walls were dry and did not afford the opportunity for collecting a water sample.

Photo 4. 4850 100-foot subsill equipment bone yard. Abandoned in place.

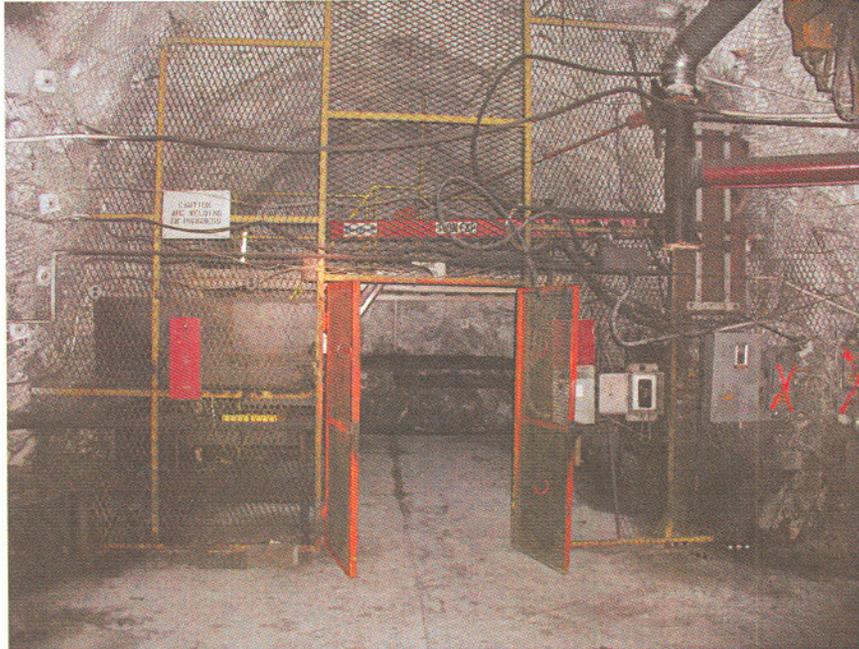
7400 Level, 21 Ledge LHD Shop. A sign at the entrance of this shop read "7400 LHD Shop Unmaintained Area Clean for Closure 3-18-03 TR; QA 4-3-03 TR & MZ OK". The shop storage room had the metal shelving abandoned in place, but the parts had been removed and the shelving was clean. The shop area had metal gas cylinder cages, an overhead crane, exhaust ventilation system ducting, electrical conduit, and other infrastructure components abandoned in place. A metal structure used to drain used oil filters and collect the used oil had been cleaned for closure and abandoned in place. DENR personnel noted the cleaning job was fairly thorough, and an attached note indicated the structure was treated with Spill Shark absorbent. The inspectors noted some parts of this cabinet still had residual oil detectable by feel. Gutted electrical junction boxes were abandoned in place just outside the shop area.

Photo 5. 7400 LHD shop. All remaining equipment and materials to be abandoned in place.

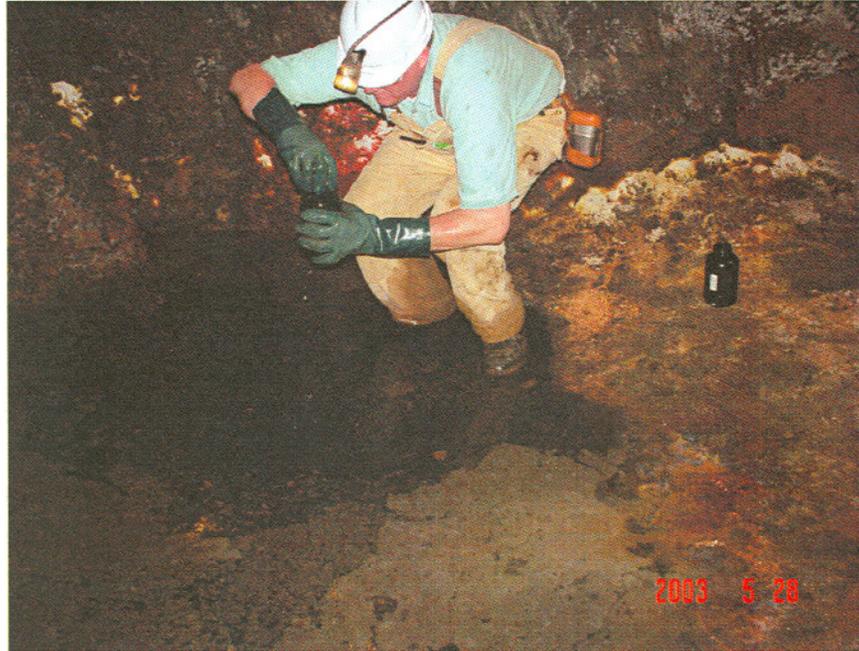
7400 Level, 21 Ledge Fuel Storage Area. This fuel storage area was located next to the 21 Ledge LHD shop. Homestake personnel cleaned this area similarly to the 4850 Level 17 Ledge Fuel Storage Area discussed previously. They reportedly removed bulk residues from the floor of this area, then placed absorbent on the floor and collected the contaminated absorbent after allowing it to set. They repeated this process until visual observations indicated significant quantities of additional petroleum residue were not being collected. Homestake left Spill Shark absorbent on the floor of this area after closure. During the inspection, only a slight petroleum odor was present in this abandoned fuel storage area (note; this fuel storage was inspected on April 26, 2002 and the odor was much stronger then). The floor areas were still visibly stained, but observations indicated the cleaning operations appeared thorough. The diesel fuel tank had been removed to facilitate the floor cleaning work but was observed abandoned nearby (see below). There was water accumulating in the floor of this area. Due to poor lighting, the inspectors could not verify whether the standing water had an oil sheen. DENR personnel collected a sample of the water accumulated on the floor of this fuel storage area. The water was estimated to be about six inches deep over an area of about 15 feet by 25 feet. A sign on the area said "2-11-02 clean TR".

Photo 6. Sampling water in bottom of 7400 Level fuel storage area.

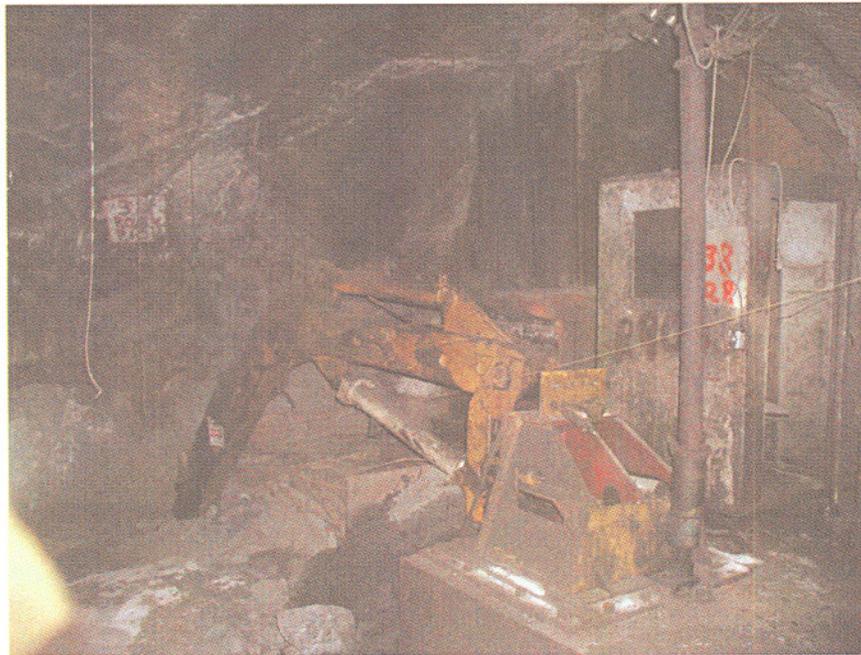
Abandoned Rock Pick. Below the 7550 Level we stopped at 38 Rock Pick, which Homestake had abandoned in place. This was a stationary hydraulic rock pick on a boom approximately 20 feet long that was used to break oversize ore. Homestake personnel reported that during decommissioning, they retracted the hydraulic cylinder rams fully, and completely drained the hydraulic oil. The hydraulic cylinders were left on the pick. The hydraulic reservoir was inspected, it was empty. Homestake had also left clean absorbent on the floor in this area after decommissioning the rock pick. Photos show the rock pick surfaces still have residual oil grime on them.

Photo 7. 38 Rock Pick below 7550 Level. Abandoned in place.

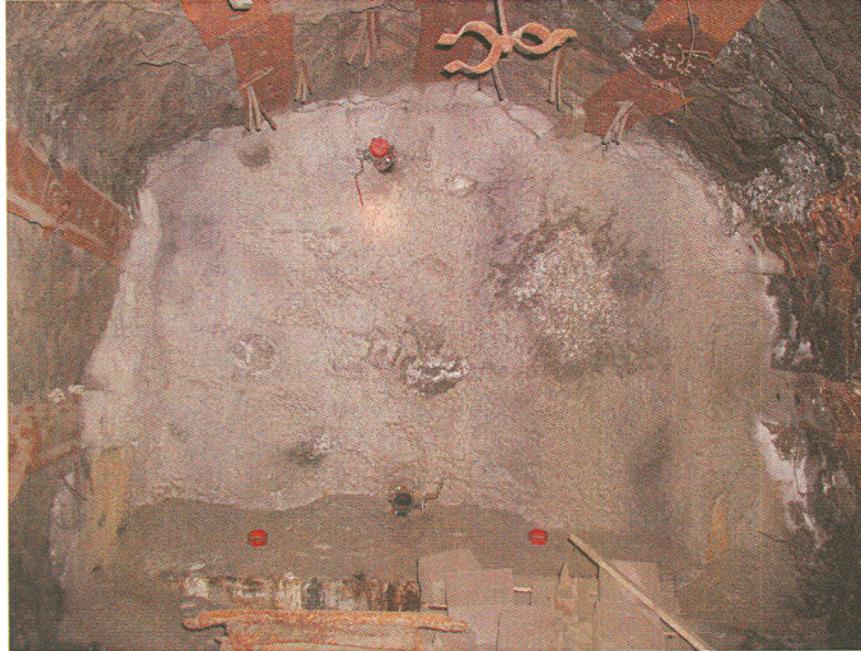
Backfilled Mine Openings and Stopes. Numerous sand backfill walls were noted along the ramp. The walls were built using cinder blocks. The inspectors noted unused cinder blocks were left abandoned on pallets at several locations. No water was observed draining from these backfills, although mineral precipitates were present indicating that water had drained from the backfills previously. No samples were collected at these locations due to time constraints.

Photo 8. Typical sand backfill wall along 21 Ledge ramp system.

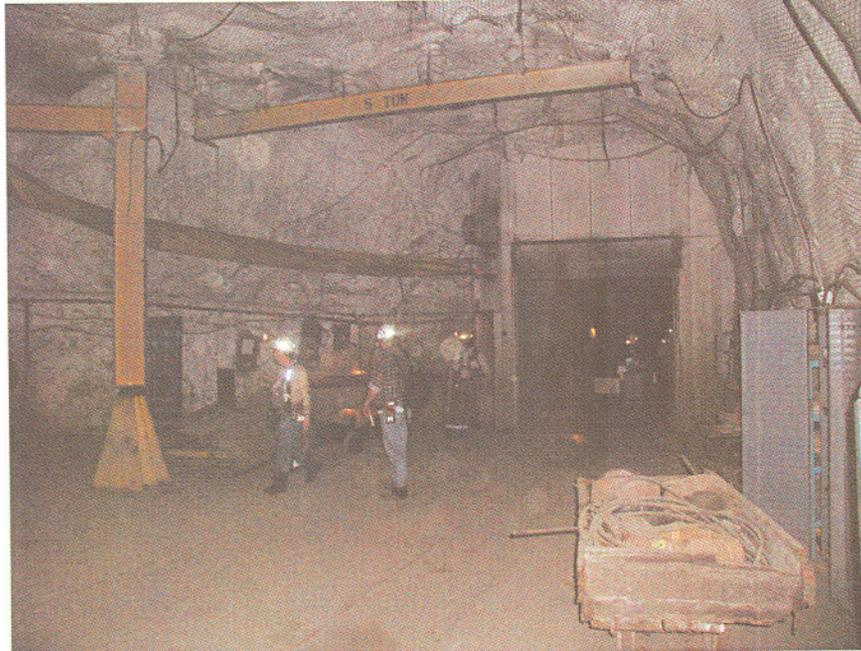
7700 Level Rail Car Shop. At 1:15 p.m. we inspected the car repair shop on the 7700 Level. Ten ton Granby ore cars were used for haulage on the 7700, and those cars were serviced in this shop. Considerable equipment and material was left in this shop and in an adjacent storage area: bins and shelves were stacked with spare parts (bearings, bolts, etc.), rail car wheels, tools, etc. The phone still worked. The oil reservoir of a pneumatic hoist (“tugger”) was checked, it had been drained, and only a slight oil residue remained. The inspectors noted grease on bearings of railcar wheels that were abandoned in the area. Outside the shop in the adjacent storage area there was a cabinet that had oil grime on the lower shelves. During the review of paperwork documentation on May 29, Homestake personnel said a crew was returning to that shop to clean the rail car wheels with solvent to remove the grease residue, and would clean the oily residue from the cabinet shelves. Some abandoned radiators from “swamp cooler” type air conditioning equipment were also abandoned in this area. Homestake had removed fluids from these radiators during the closure work.

Photo 9. 7700 Level rail car repair shop. All equipment and materials to be abandoned in place.

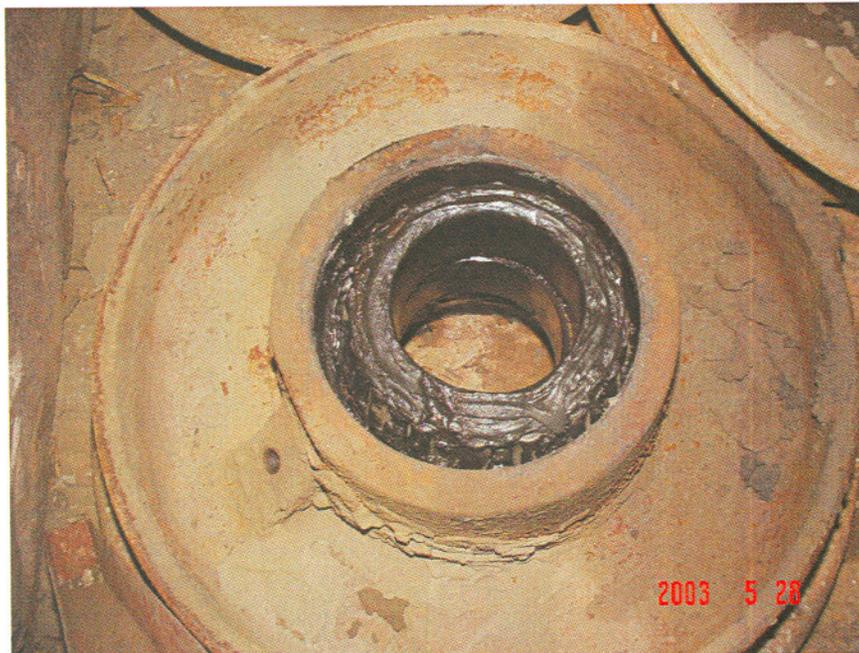
Photo 10. 7700 Level rail car repair shop, grease on rail car wheels.

The DENR personnel at the Ross Office conducted a review of closure documentation for the underground mine areas. During the review, Homestake personnel said they had crews returning to the 7700 Level rail car shop to clean up the grease observed on rail car wheels and the abandoned cabinet that were discussed during the inspection close-out meeting on May 28. Homestake personnel said they would be cleaning these items with solvent to remove gross petroleum residuals and removing the broken fluorescent lamp from the 4850 electrical shop. DENR personnel noted they had not requested Homestake remove these items, but rather were pointing out these items seemed representative of small amounts of potential contaminants that will remain in various mine areas after Homestake completes the underground mine closure operations.

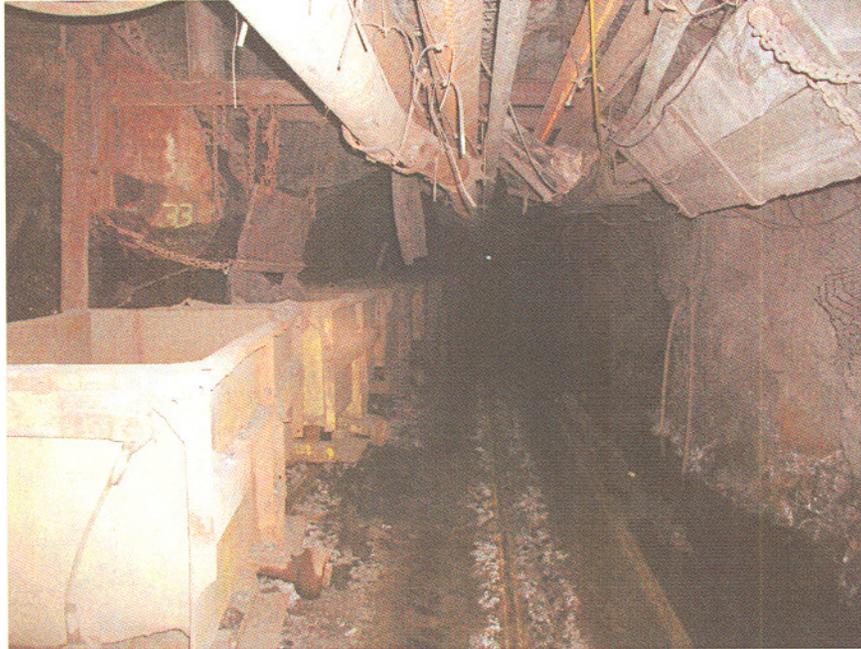
8000 Level Ore Car Train. Homestake abandoned several 5-ton Granby ore cars and ore handling infrastructure in this area (see photo next page).

Photo 11. 8000 Level ore cars and chute. Abandon in place.

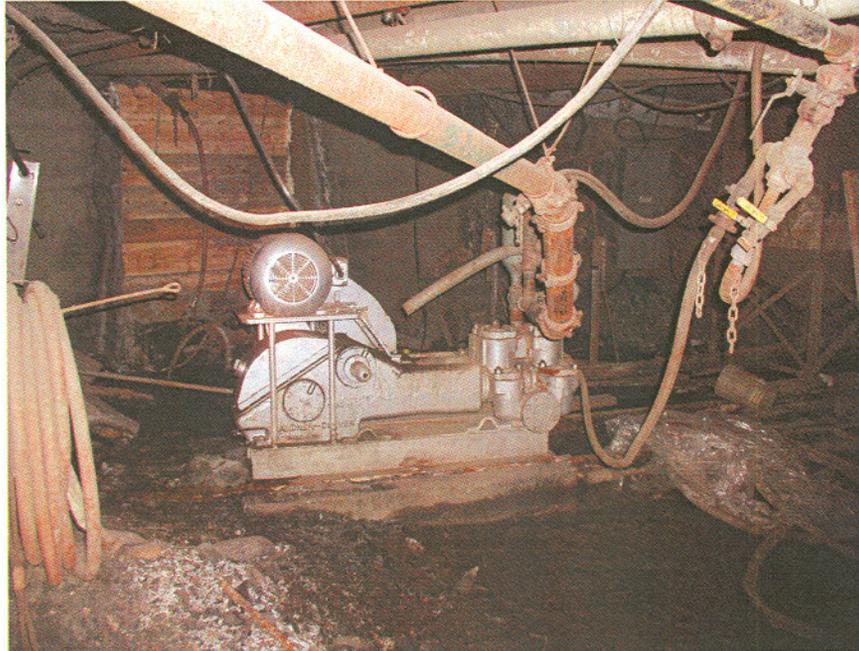
8000 Level Pumps. We did not have time to inspect the 8000 Level pump room. Homestake had set up a pump along the 8000 Level main line. Homestake personnel reported the oil would be removed from this pump during closure activity, but the pump would be abandoned in place. Near the No. 6 Shaft station Homestake had mounted the transformer for the 8000 Level pumps on a rail car (see below). When the pumps are shut off, Homestake will disconnect the transformer, roll it onto the No. 6 Shaft cage, and hoist it out. Homestake personnel told the inspectors they planned to cease pumping the lower levels on June 10, and close the entire mine by June 27. No one would be allowed in the mine after that date.

Photo 12. 8000 Level pump. Homestake will drain oil and abandon in place.

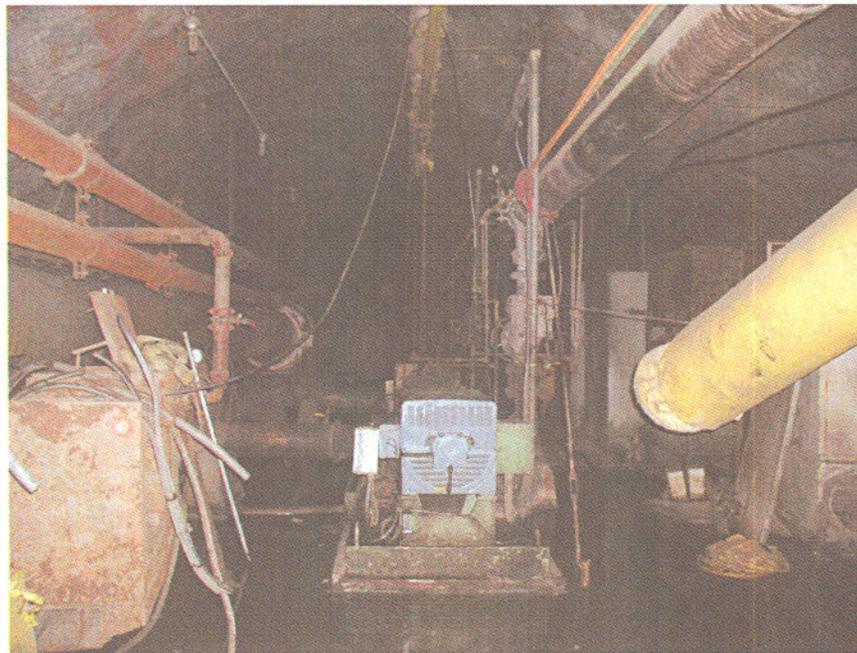
Photo 13. 8000 Level pump station. Homestake will drain oil and abandon in place.

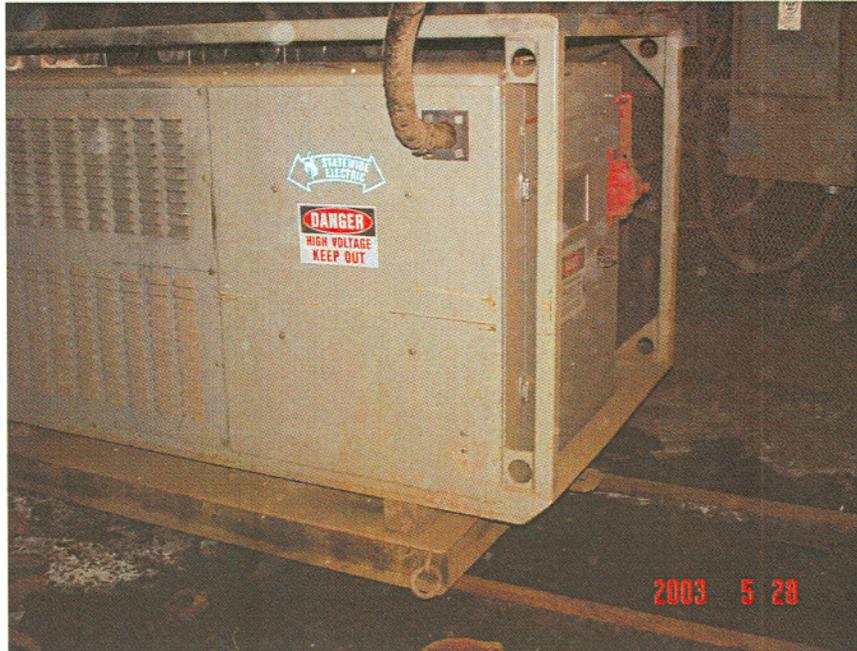
8000 Level Operational Transformer. Homestake had installed this transformer on a rail car for running the 8000 Level pumps during the mine closure period. Upon final closure, they will remove this transformer and bring it back to the surface.

Photo 14. 8000 Level, transformer for pump room on rail car for quick removal.
