**FAULT INVESTIGATION
COMPUTATION RESEARCH AND
THEORY BUILDING
LAWRENCE BERKELEY
NATIONAL LABORATORY
BERKELEY, CALIFORNIA**

Kleinfelder Job No.: 67929

September 27, 2006

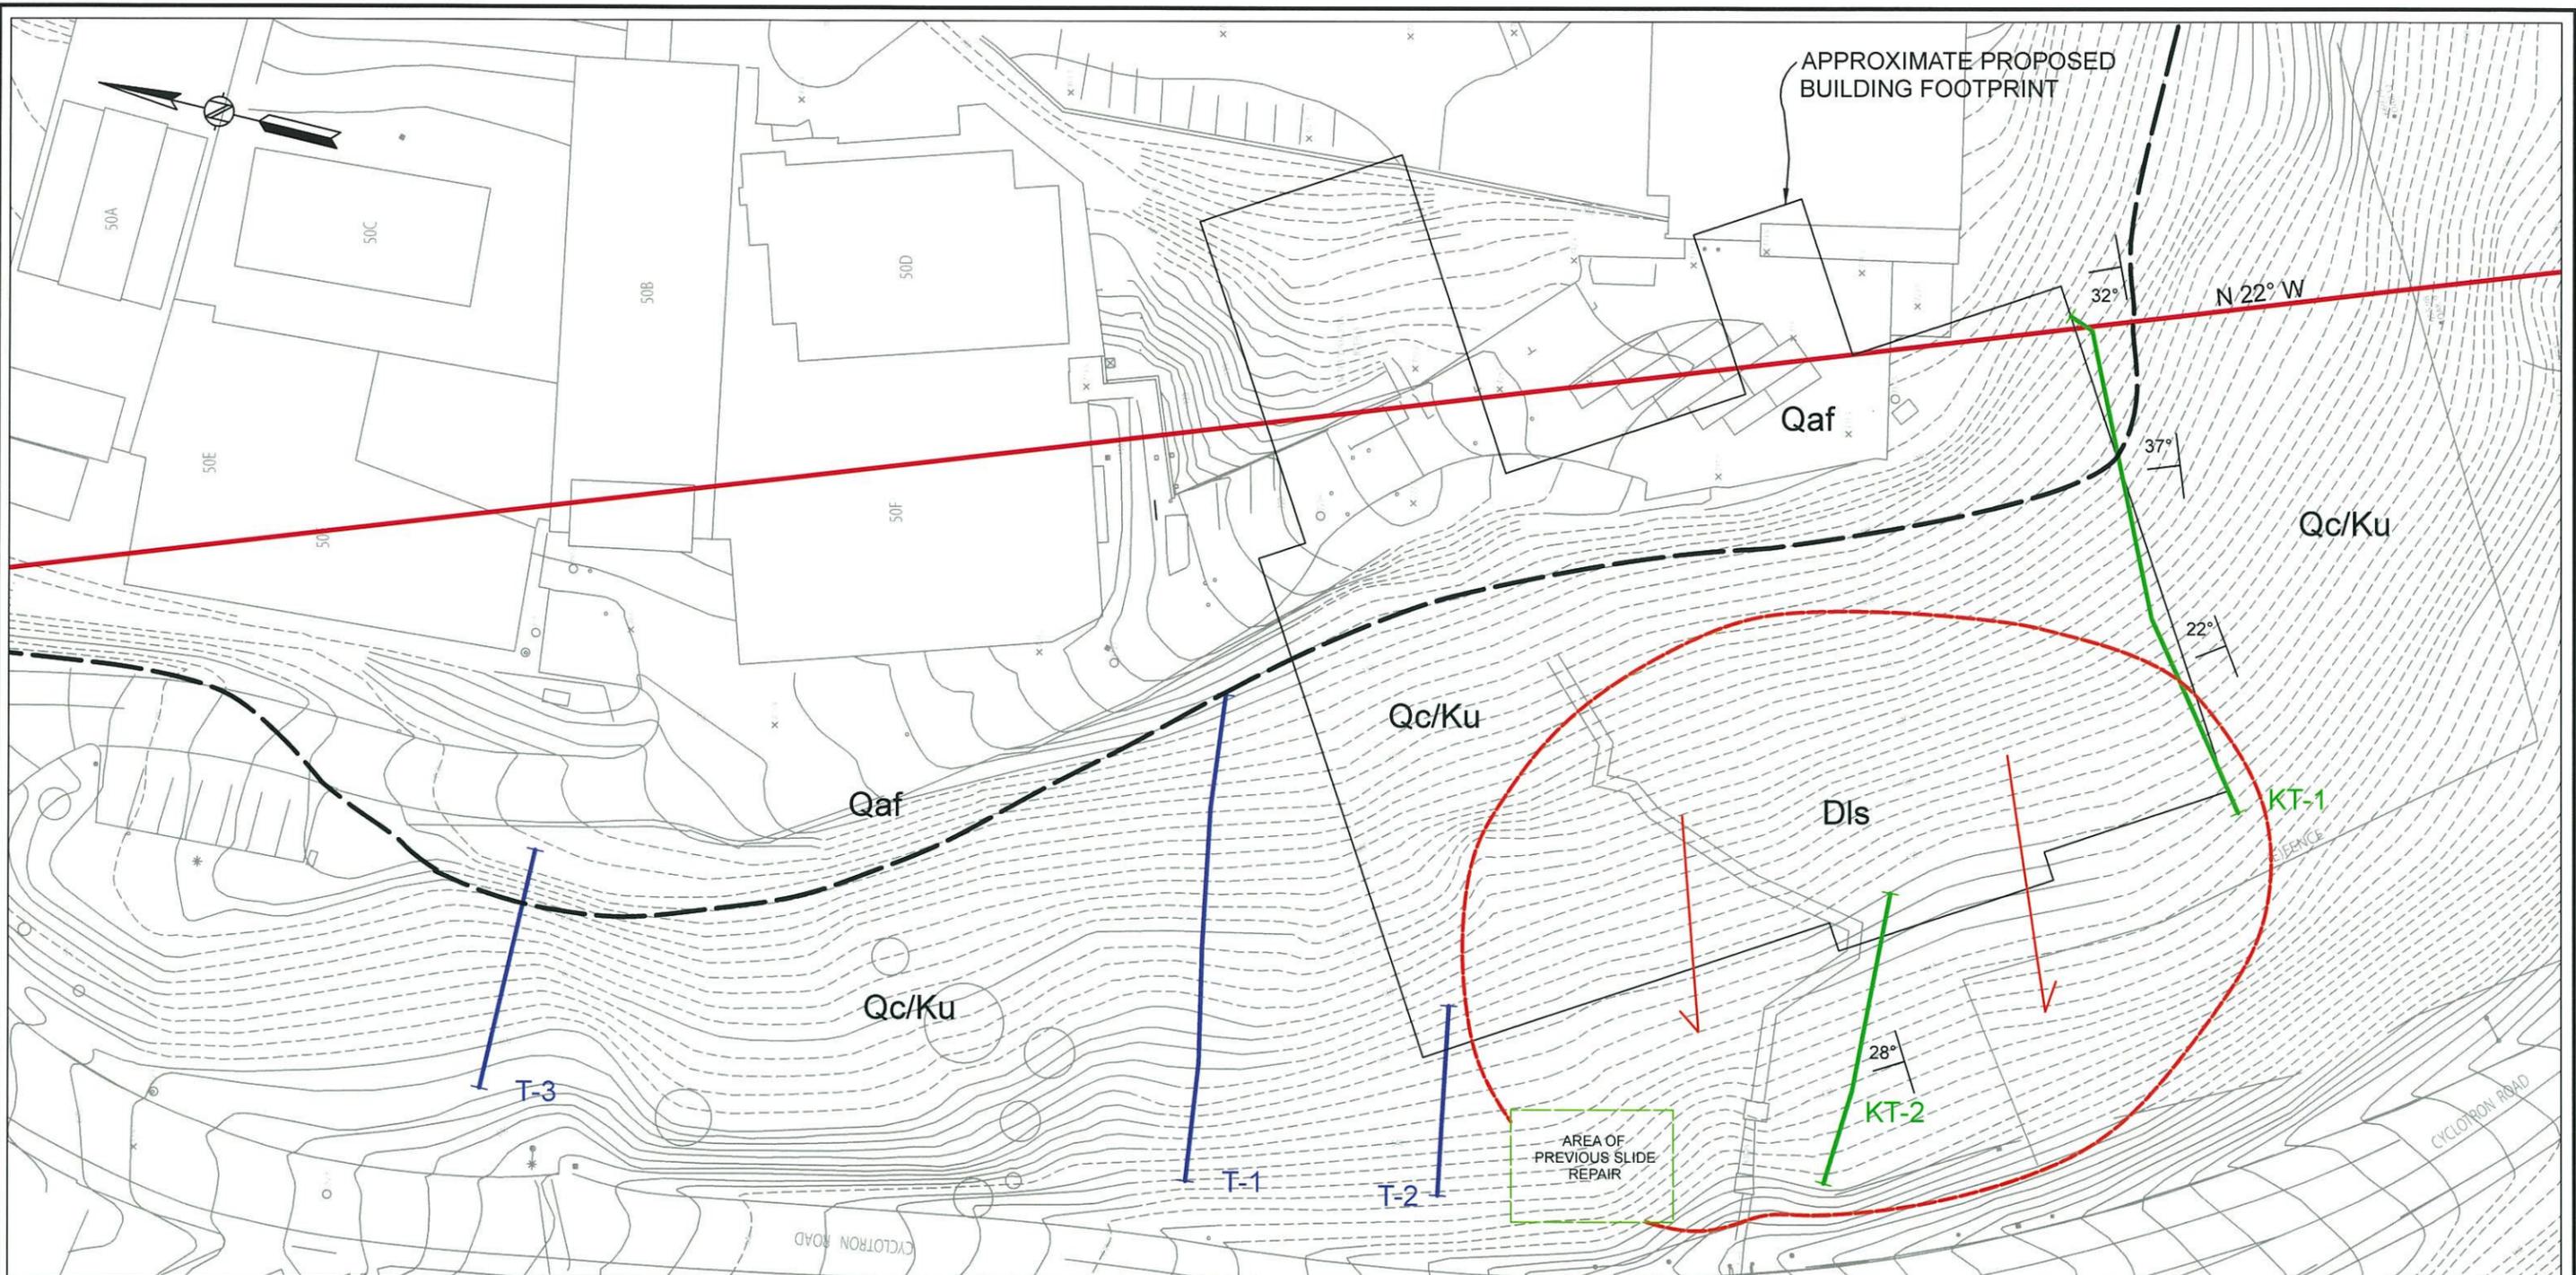
Our field exploration was performed on April 17-19, 2006, and consisted of excavating and logging of two fault trenches, KT-1 and KT-2, at the approximate locations shown on Plate 2. The trenches were excavated using a track-mounted excavator equipped with a 30-inch-wide bucket. The trench was excavated to depths up to 12 feet below existing ground surface and was shored for safety. Due to localized, loose, wet upper soils, the upper portion of the trench was benched laterally on each side approximately 2 to 3 feet and to depths of 2 to 3 feet to prevent these soils from falling into the trench. The resultant excavation and upper bench were approximately 9-feet-wide. A 30-inch-wide trench approximately 7- to 10-feet-deep below the bench elevation was then excavated down the center of the excavation to reach the appropriate depths.

In addition, our Professional Geologist performed geologic/geomorphic mapping of the site and vicinity in April of 2006. The purpose of the geologic mapping was to identify surficial geologic and geomorphic conditions including existing and potentially adverse geologic conditions that could affect the project. The main focus of the geologic reconnaissance was to identify and assess geomorphic features consistent with active faulting and previous surface rupture. The results of the geologic reconnaissance are summarized on the Site Plan and Geologic Map, Plate 2.

Based on the results of our investigation and analysis, we conclude that there is no evidence of active faulting or surface rupture at the planned CRT site. The nearest known active trace of the Hayward fault is located approximately 300 feet west of the site. As such, no fault-related building setbacks are required for this site.

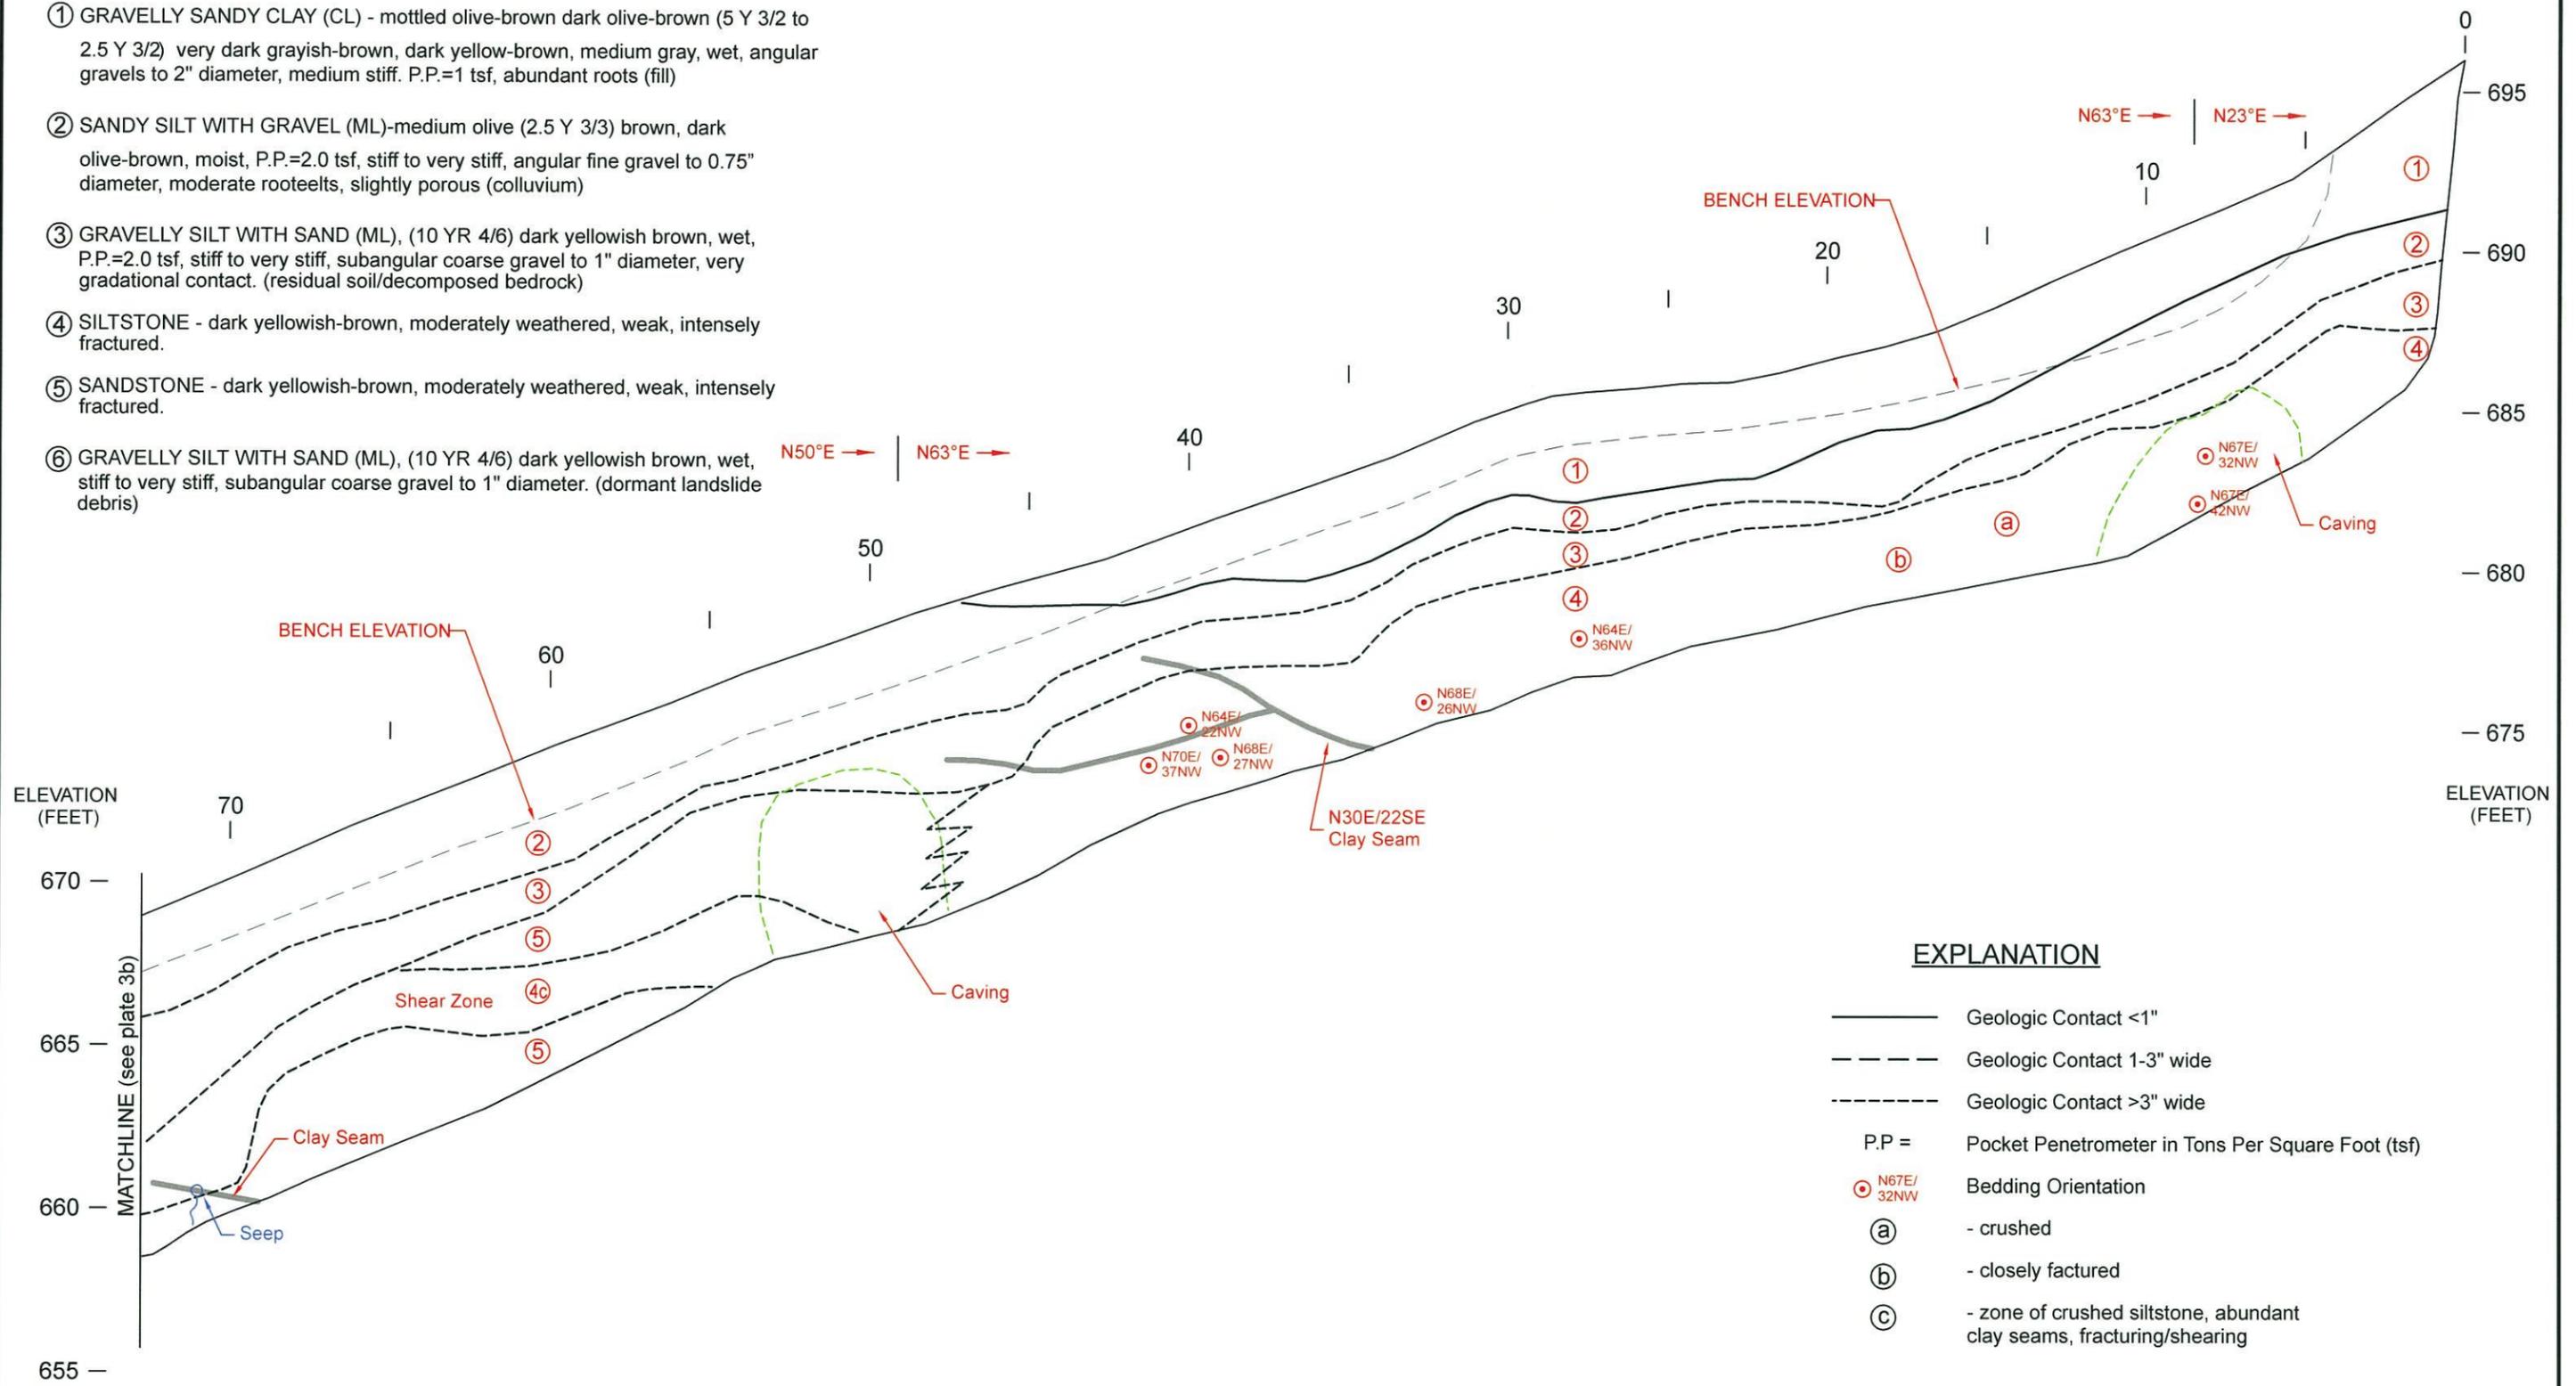
At the east end of trench KT-1, fill (Unit 1) extends along the surface for approximately 47 feet. The fill is described as gravelly, sandy clay that is wet and medium stiff, and is 2- to 3-feet-thick. Colluvium (Unit 2) underlies the fill and comprises the surface soil unit down-slope of the fill. This deposit consists of sandy silt with gravel and gravelly silt with sand that is moist to wet and stiff to very stiff. This layer is approximately 2- to 3-feet thick with a localized area that is approximately 8 feet thick at station 130 in the infilled head scarp region of a dormant landslide. The colluvium is locally underlain by residual soil (Unit 3) consisting of gravelly silt with sand. The residual soil is wet, stiff to

The bedrock units are locally brecciated in broad zones and also contain several more concise, clay-lined shears. In general, the shears are semicontinuous with no kinematic evidence suggesting recent activity. At station 40, two of these shears extend from the bedrock into the residual soil. The contact between the two units is not visibly offset, and as indicated above, no kinematic evidence for recent movement was observed along the shears. Hence these features are representative of old bedrock fractures or shears that can still be observed in the overlying residual soil unit, which is derived from highly weathered bedrock and is not considered to be related to active faulting along the Hayward fault. In addition, the shears strike N 30° E, and dip 22° to the southeast. Bedding within the bedrock units are consistent throughout the trench, striking between N 56° to 70° E and dipping 22° to 42° to the northwest.

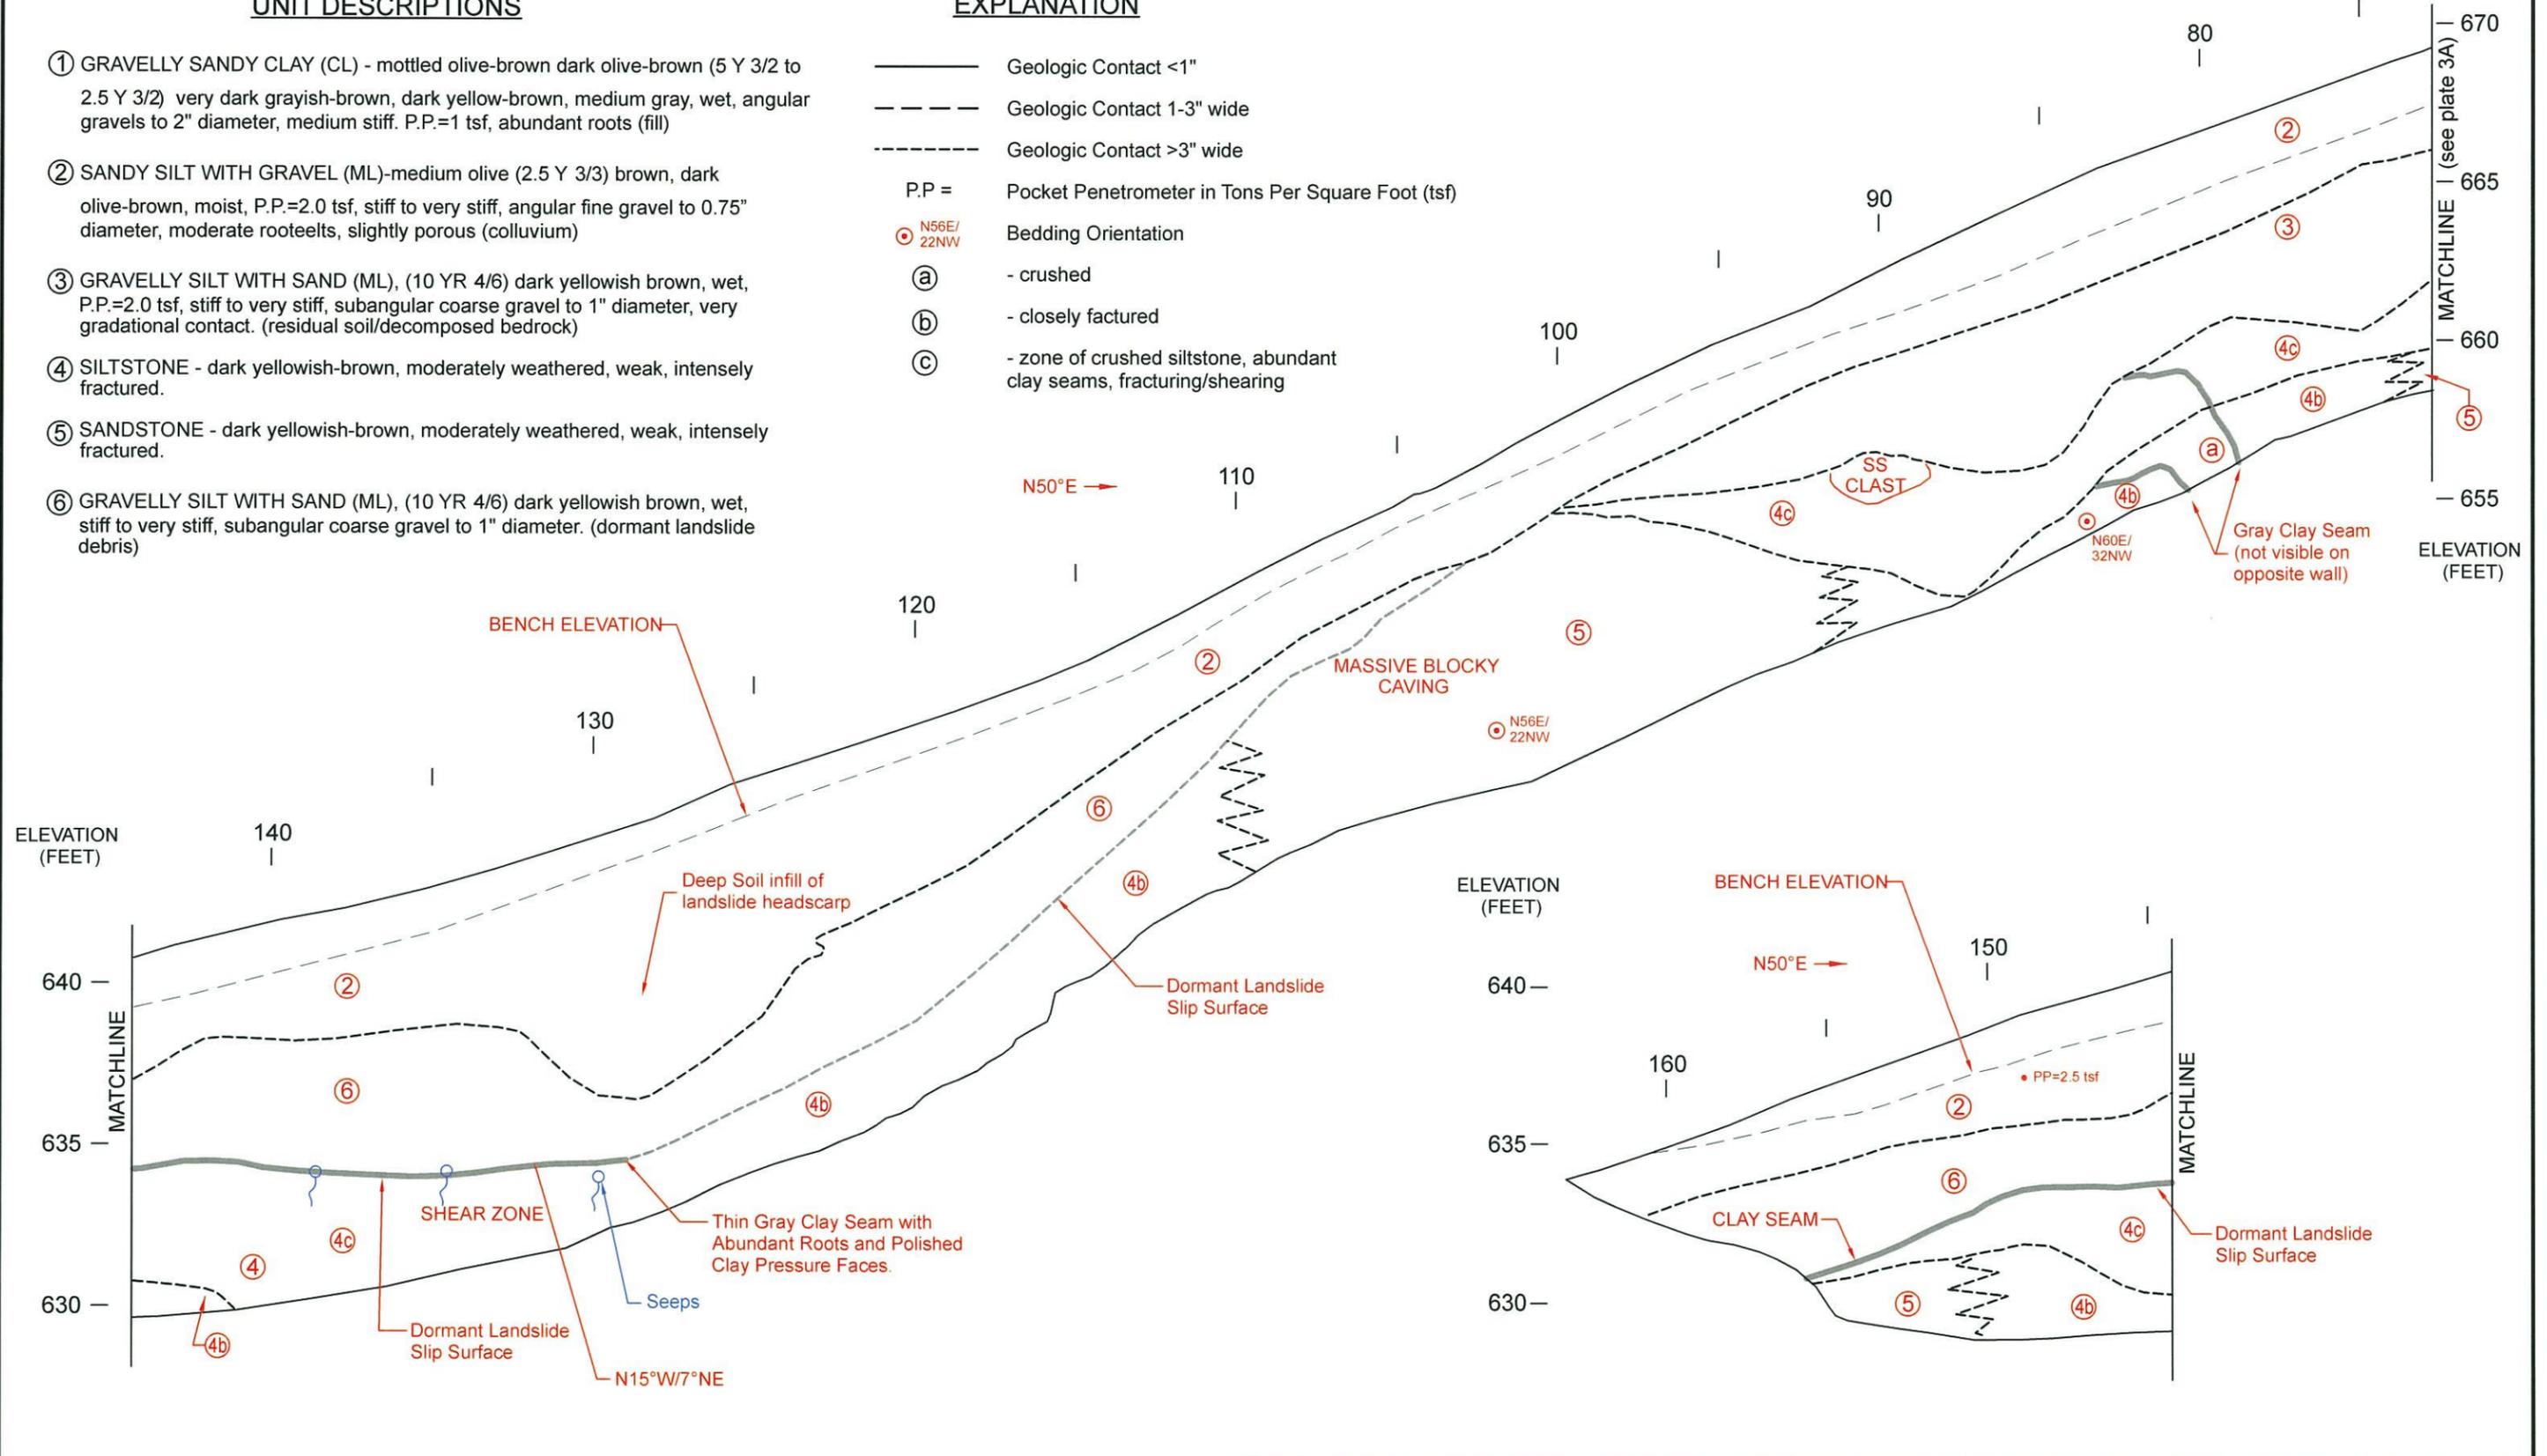
PROJECT NO.	67929	LOG OF FAULT TRENCH KT-1	PLATE 3B
	DRAWN	MAY 2009		
	DRAWN BY	JR	FAULT INVESTIGATION: CRT BUILDING LAWRENCE BERKELEY NATIONAL LABORATORY BERKELEY, CALIFORNIA	
	CHECKED BY	WM		
FILE NAME	Log_KT-1b.ai

The residual soil and dormant landslide deposits are underlain by sedimentary bedrock (Unit 4 and Unit 5) of the Great Valley Sequence. The contact between the landslide deposits and bedrock is defined by a continuous, polished (clay seam) slip surface, while the residual soil/bedrock contact is highly gradational. Unit 4 consists of siltstone and Unit 5 of sandstone, both of which are moderately weathered, weak, and intensely fractured and locally closely fractured and crushed. The siltstone laterally grades into sandstone in several locations. The Great Valley Sequence bedrock was encountered to the maximum depth explored.

Static groundwater level was not encountered in Trench KT-1. Minor seepage was observed in the landslide plane area and accumulated in the lower elevations of the trench.

In general, the shears and shear zones identified within Trenches KT-1 are interpreted to represent features associated with regional tectonic deformation as opposed to surface rupture along the Hayward fault or an associated fault splay. As previously discussed, clay lined shears within the bedrock (Units 4, 5) visibly extend into the residual soil (Unit 3) which overlies the bedrock. The contact between Units 3 and 4 is very highly gradational, and as Unit 3 represents a completely weathered surface of the bedrock it overlies, preservation of structure (including discontinuities and shears) is not infeasible. The orientations of the features are nearly perpendicular to the trend of Hayward fault in the vicinity. As such, the clay lined shears likely represent relic structural features from the underlying bedrock mass, as opposed to active fault surface rupture. This explains the lack of contact offset or kinematic evidence along the shears.

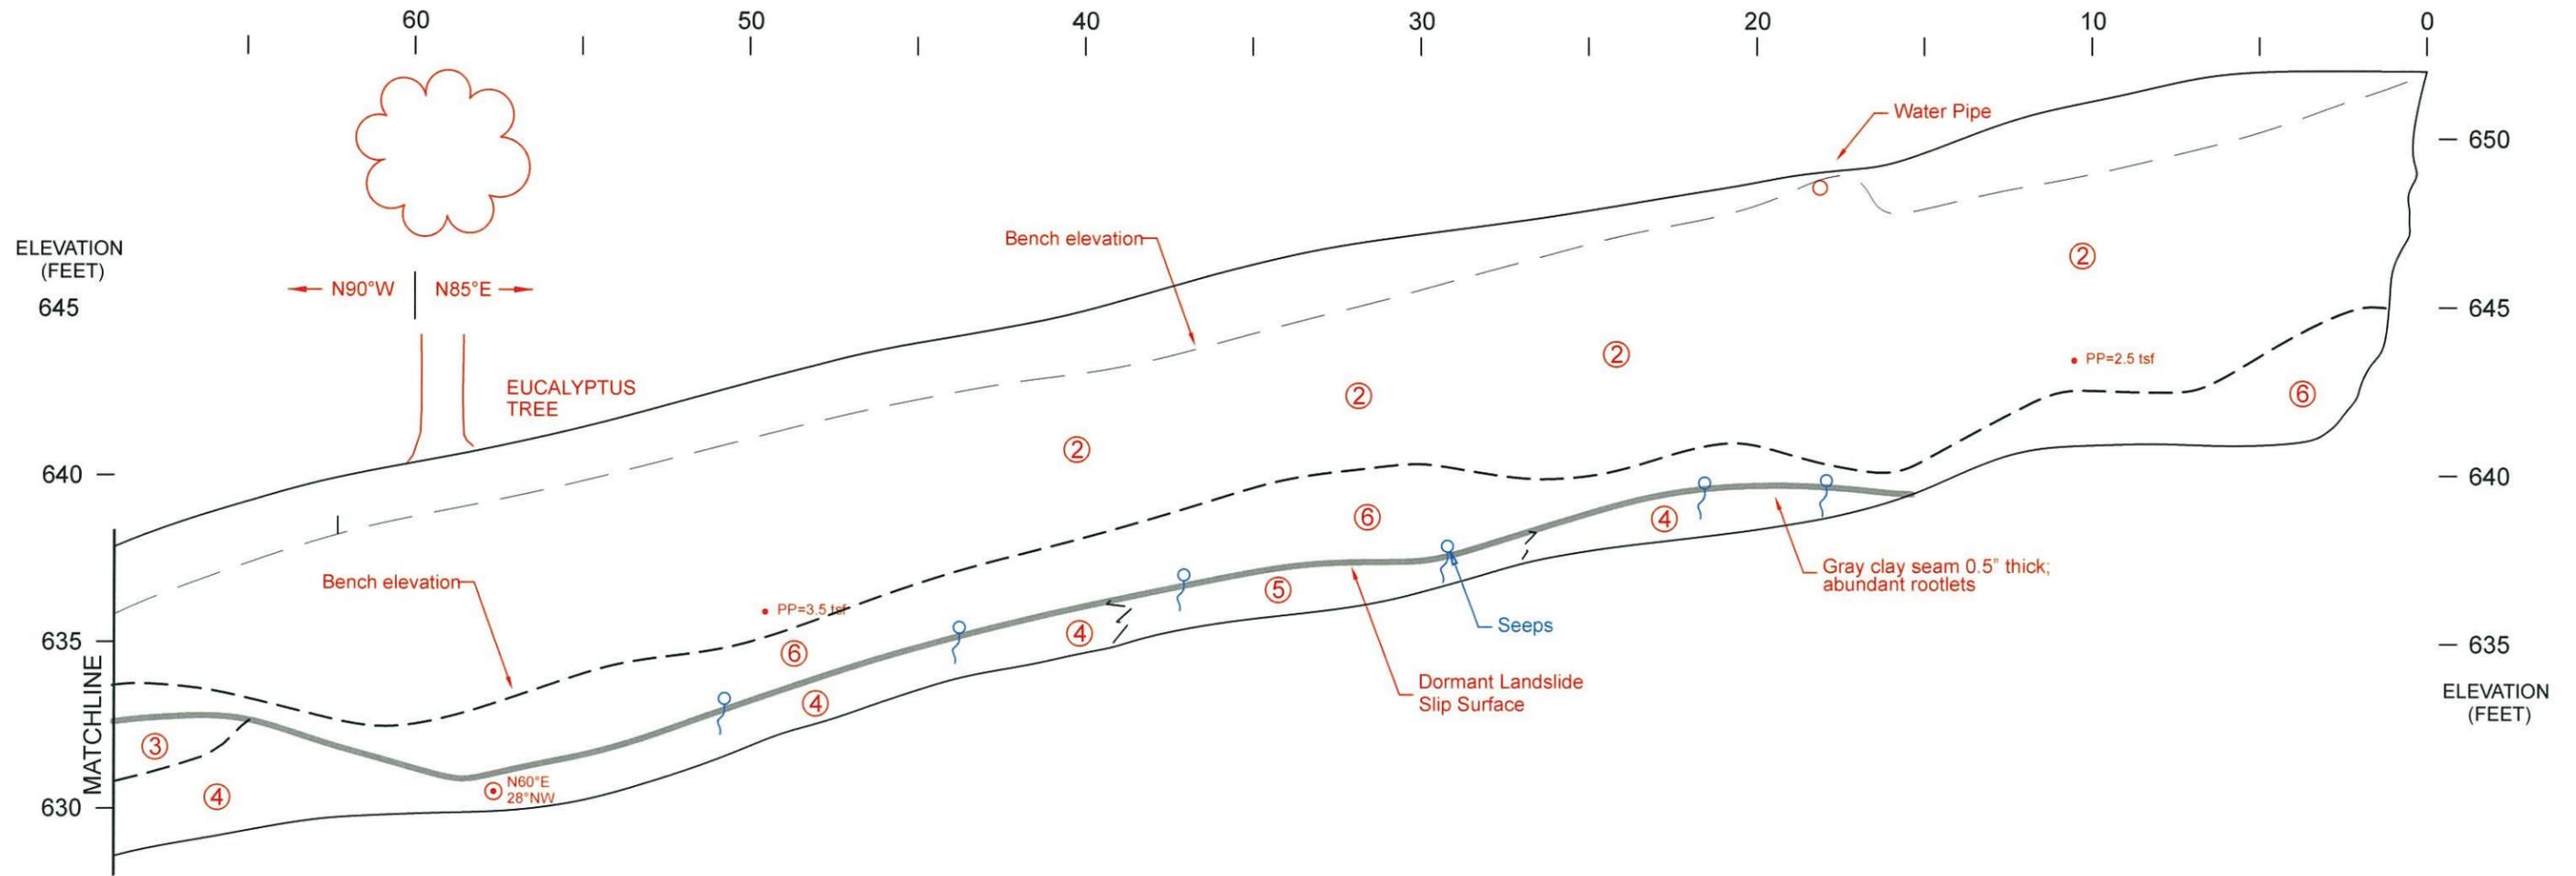
The subsurface conditions in Trench KT-2 are comparable to those encountered down slope of station 103 in Trench KT-2. The colluvium (Unit 2) ranges in thickness between 4 and 9 feet. These deposits are underlain by dormant landslide debris (Unit 6) 0.5 to 2.5 feet thick. As in Trench KT-1, the landslide debris directly overlies Great Valley Sequence bedrock along a polished clay slip surface throughout the majority of the trench. Residual soil (Unit 3) underlies the slip surface at the west end of the trench. Bedding orientation of the bedrock in Trench KT-2 is consistent with KT-1, striking at N 60° E and dipping 28° to the northwest.

Static groundwater level was not encountered in Trench KT-2. Minor seepage was observed in the landslide plane area and accumulated in the lower elevations of the trench.

The relative consistency of the northwest dipping siltstone and sandstone beds correlative between Trenches KT-1 and KT-2 and visible on either margin of the shears/shear zones, coupled with the lack of geomorphic features on trend with the shears/shear zones exposed in the trenches further precludes previous fault surface rupture at the site. The consistency of bedding orientation and lack of disaggregation implies the landslide event which occurred at the site did not extend further into the bedrock than the depth of the slip surface identified. Thus the shears and shear zones within the bedrock are unrelated to said landslide event. In addition, no concise shears or shear zones were identified in Trench KT-2.
