ALAN KROPP
& ASSOCIATES, INC.

April 2, 2010
2335-7B, L-28884

RE: Geologic and Geotechnical Investigation Report
Building 85 Stabilization
Lawrence Berkeley National Laboratory
Berkeley, California
(Subcontract No. 6859200)

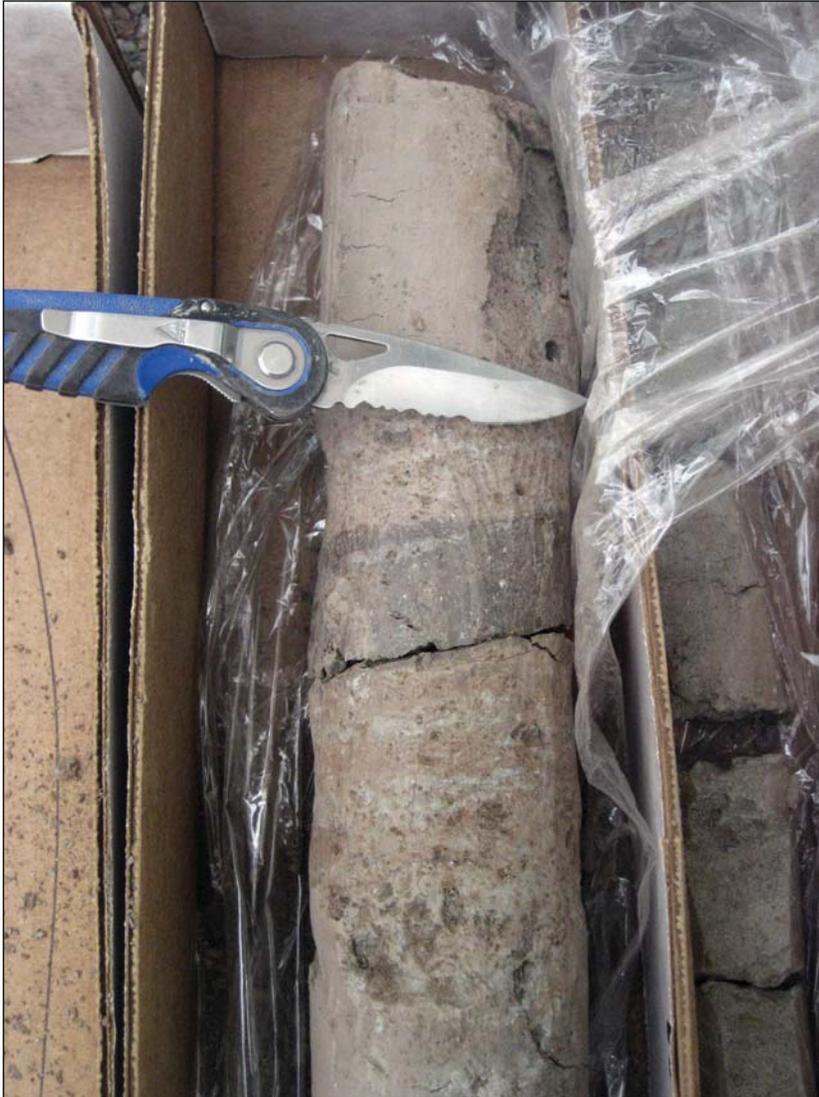
Photograph A-1. Core from boring AKA-8 at 17.5 feet showing possible bedding noted by seam.

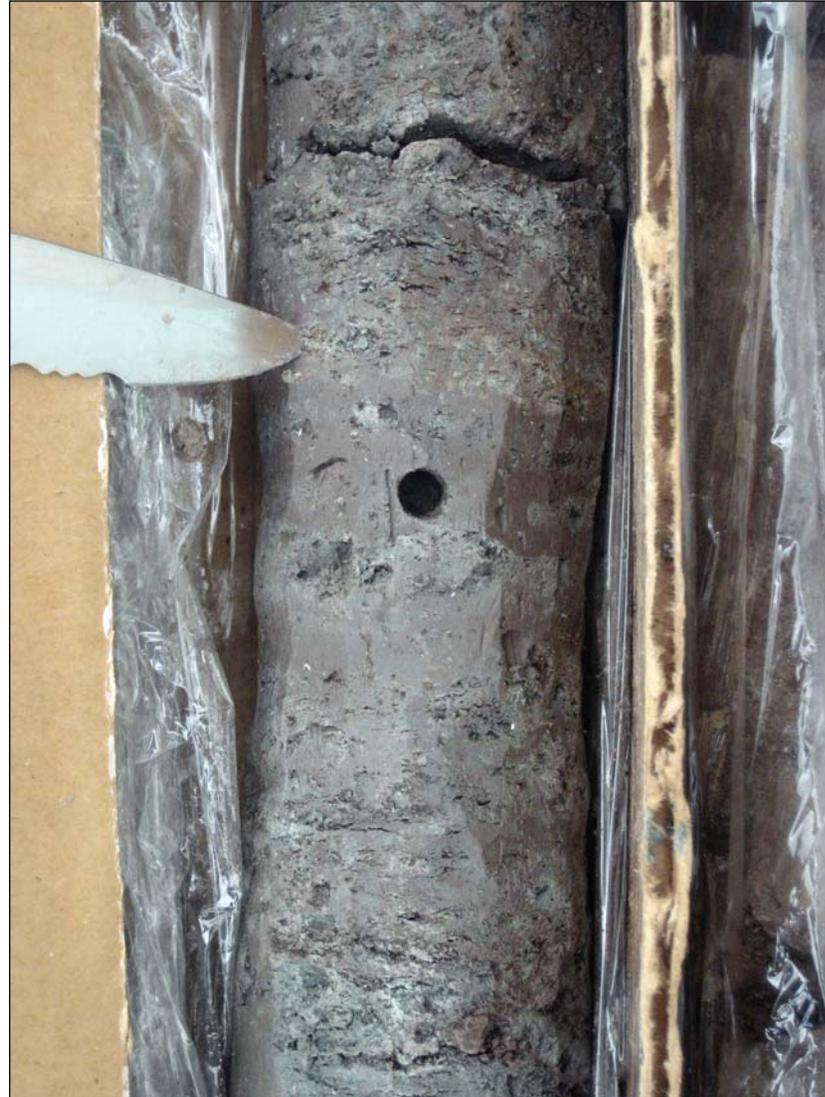
Photograph A-2. Core from boring AKA-8 at 44 feet showing clay seams within the Orinda Formation.

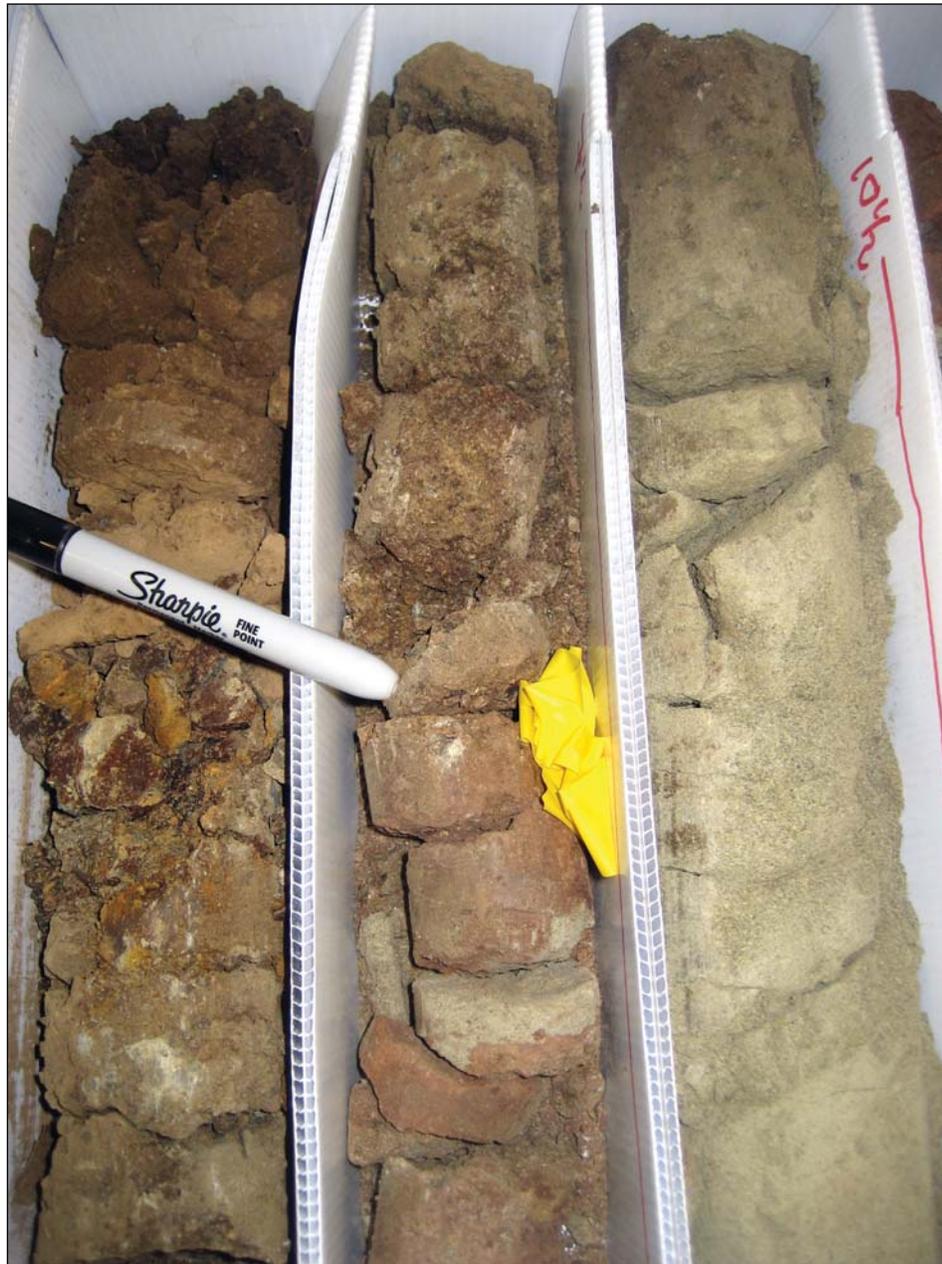
Photograph A-11. Core from boring AKA-15 at 8 feet showing approximate contact between Moraga volcanics (blocky brownish color) and Orinda Formation (light gray).

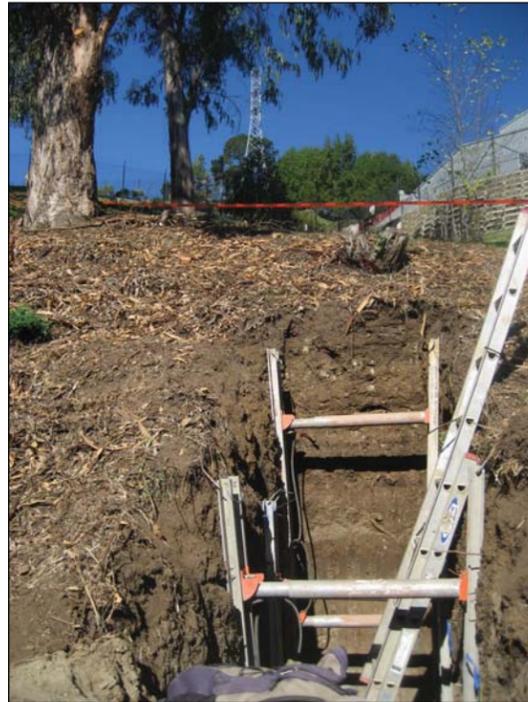
Photograph 1. View to west showing location of test pit TP-1.

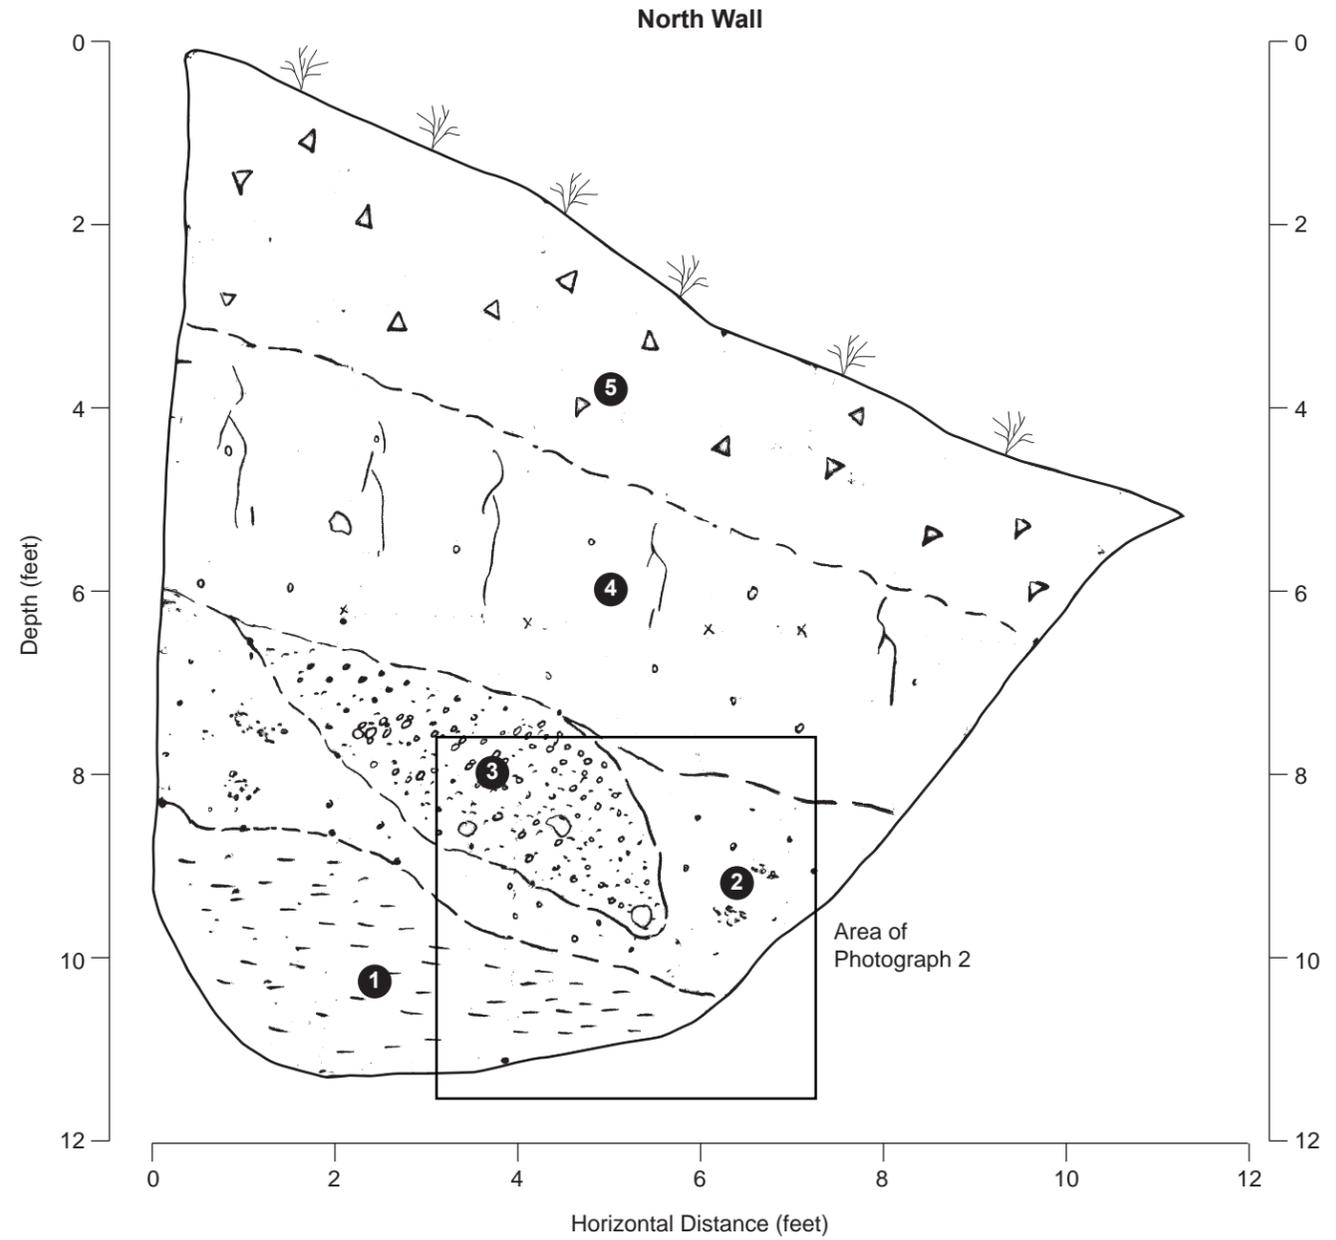
Photograph 2. View to north wall showing relations of base of test pit TP-1.

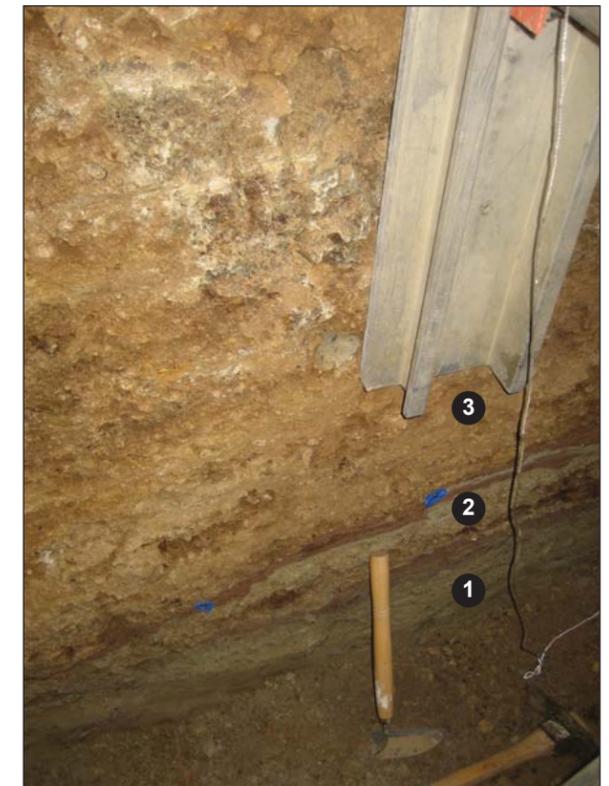
Photograph 2. View of north wall of test pit TP-2. Blue flags at base of Unit 3.

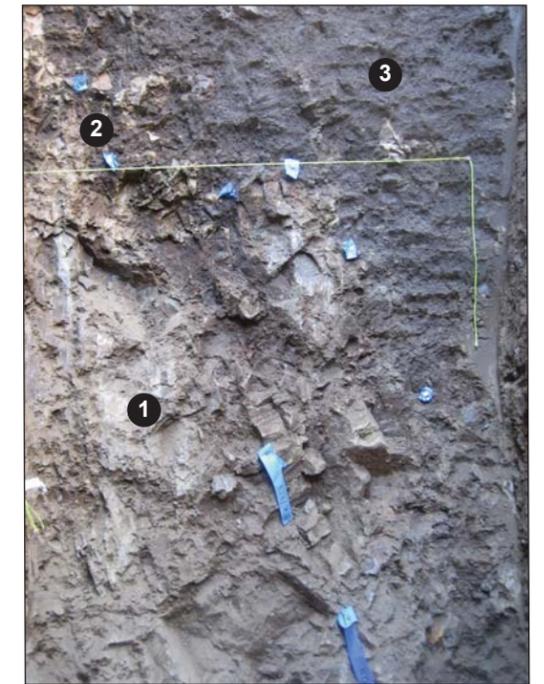
Photograph 2. View of northwest wall (back wall) showing stratigraphic relations and dip of colluvium to northeast.

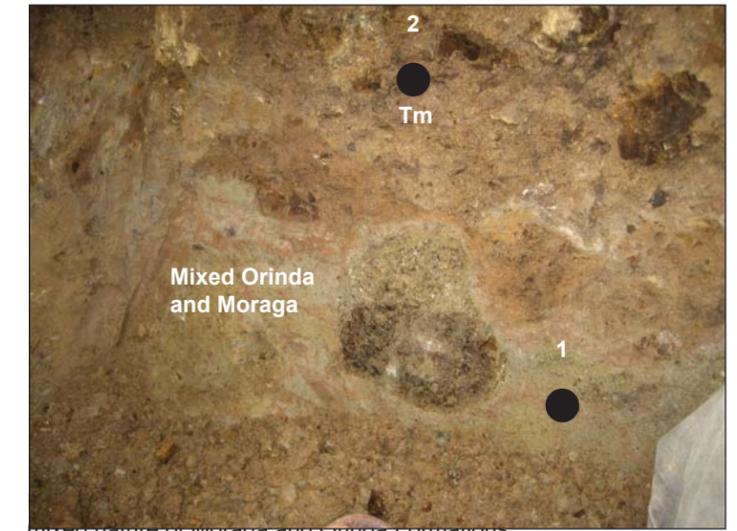
Mixed nature of Moraga and Orinda Formations.
