**FAULT INVESTIGATION
COMPUTATION RESEARCH AND
THEORY BUILDING
LAWRENCE BERKELEY
NATIONAL LABORATORY
BERKELEY, CALIFORNIA**

Kleinfelder Job No.: 67929

September 27, 2006

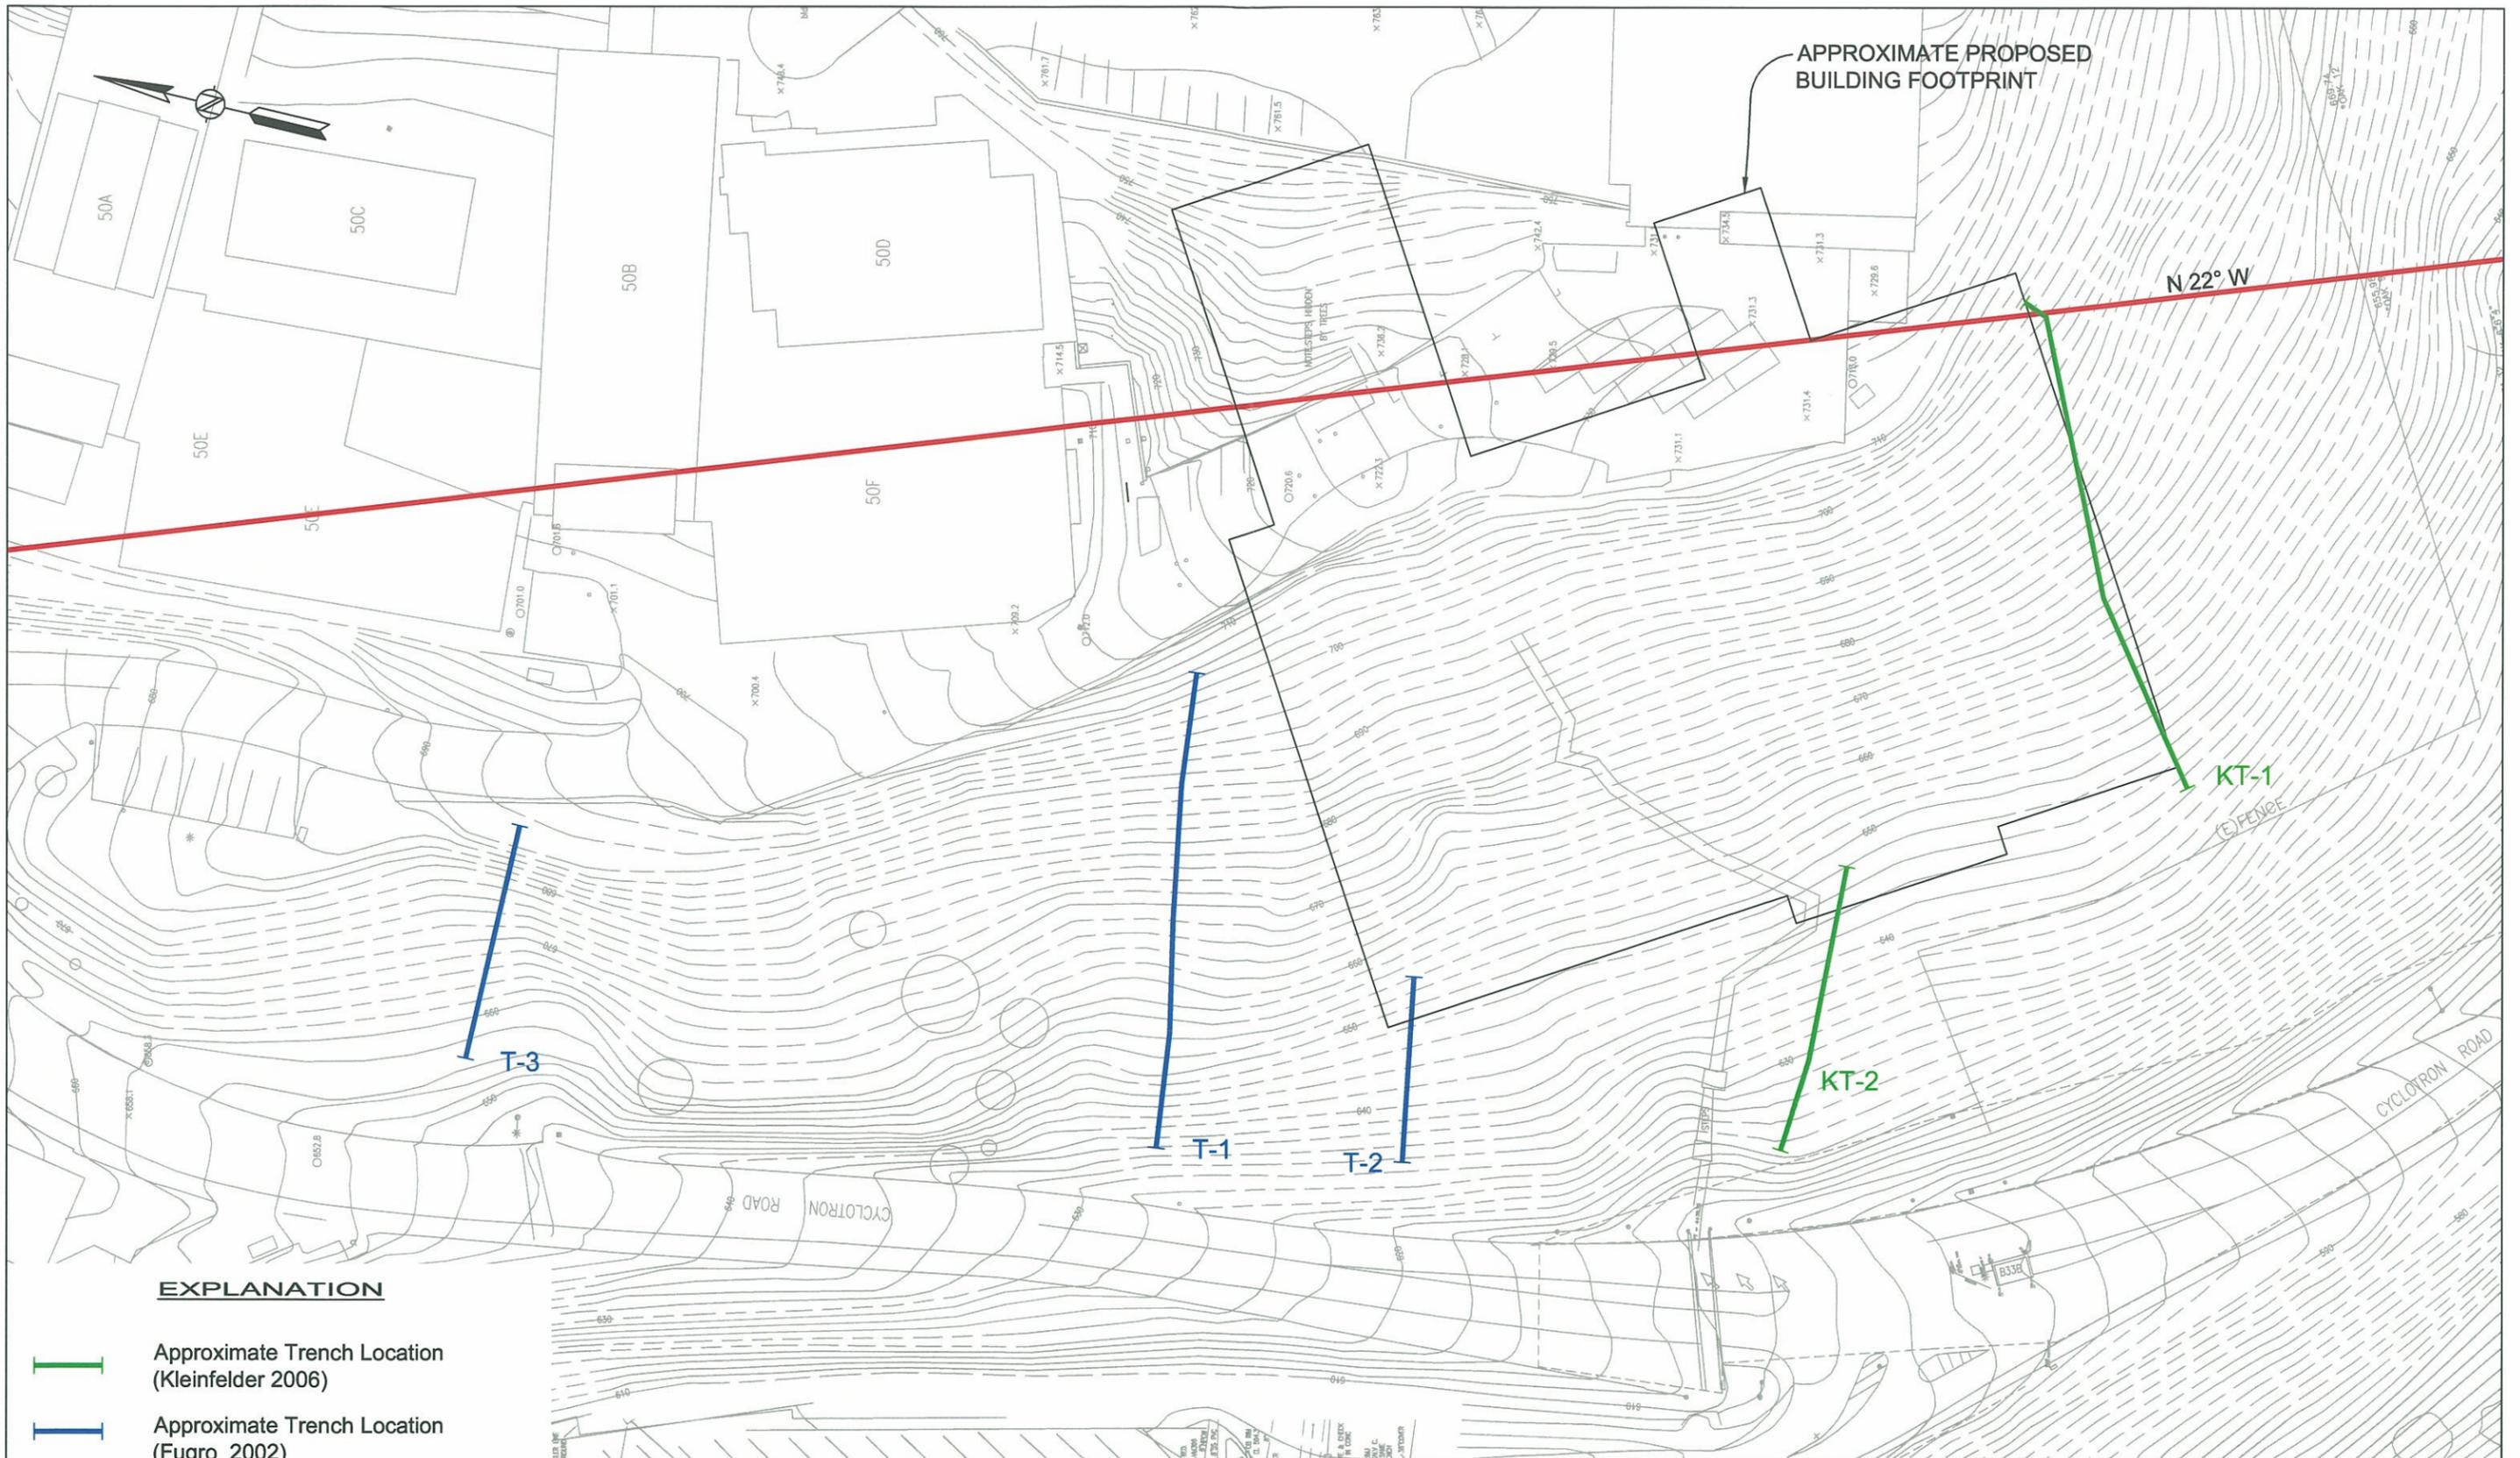
SITE PLAN
 Fault Investigation
 CRT Building
 Lawrence Berkeley National Laboratory
 Berkeley, California

Our field exploration was performed on April 17-19, 2006, and consisted of excavating and logging of two fault trenches, T-1 and T-2, at the approximate locations shown on Plate 2. The trenches were excavated using a track-mounted excavator equipped with a 30-inch-wide bucket. The trench was excavated to depths up to 12 feet below existing ground surface and was shored for safety. Due to localized, loose, wet upper soils, the upper portion of the trench was benched laterally on each side approximately 2 to 3 feet and to depths of 2 to 3 feet to prevent these soils from falling into the trench. The resultant excavation and upper bench were approximately 9-foot-wide. A 30-inch-wide trench approximately 7- to 10-feet-deep below the bench elevation was then excavated down the center of the excavation to reach the appropriate depths.

Trench T-1 extended from the southeast corner of the proposed building site, west for 163 feet, along a trend of approximately N50-63°E. Trench T-2 was excavated from the west edge of the planned building area toward Cyclotron Road along a trend of approximately N85-90°E. The trenches were oriented roughly perpendicular to the general mapped trend of the Hayward fault in the vicinity of the investigation for the possible existence of the main trace and any secondary traces or splays extending from this main trace. The excavations were logged by our Professional Geologists and Staff Geologist on a full-time basis under the supervision of our Certified Engineering Geologist.

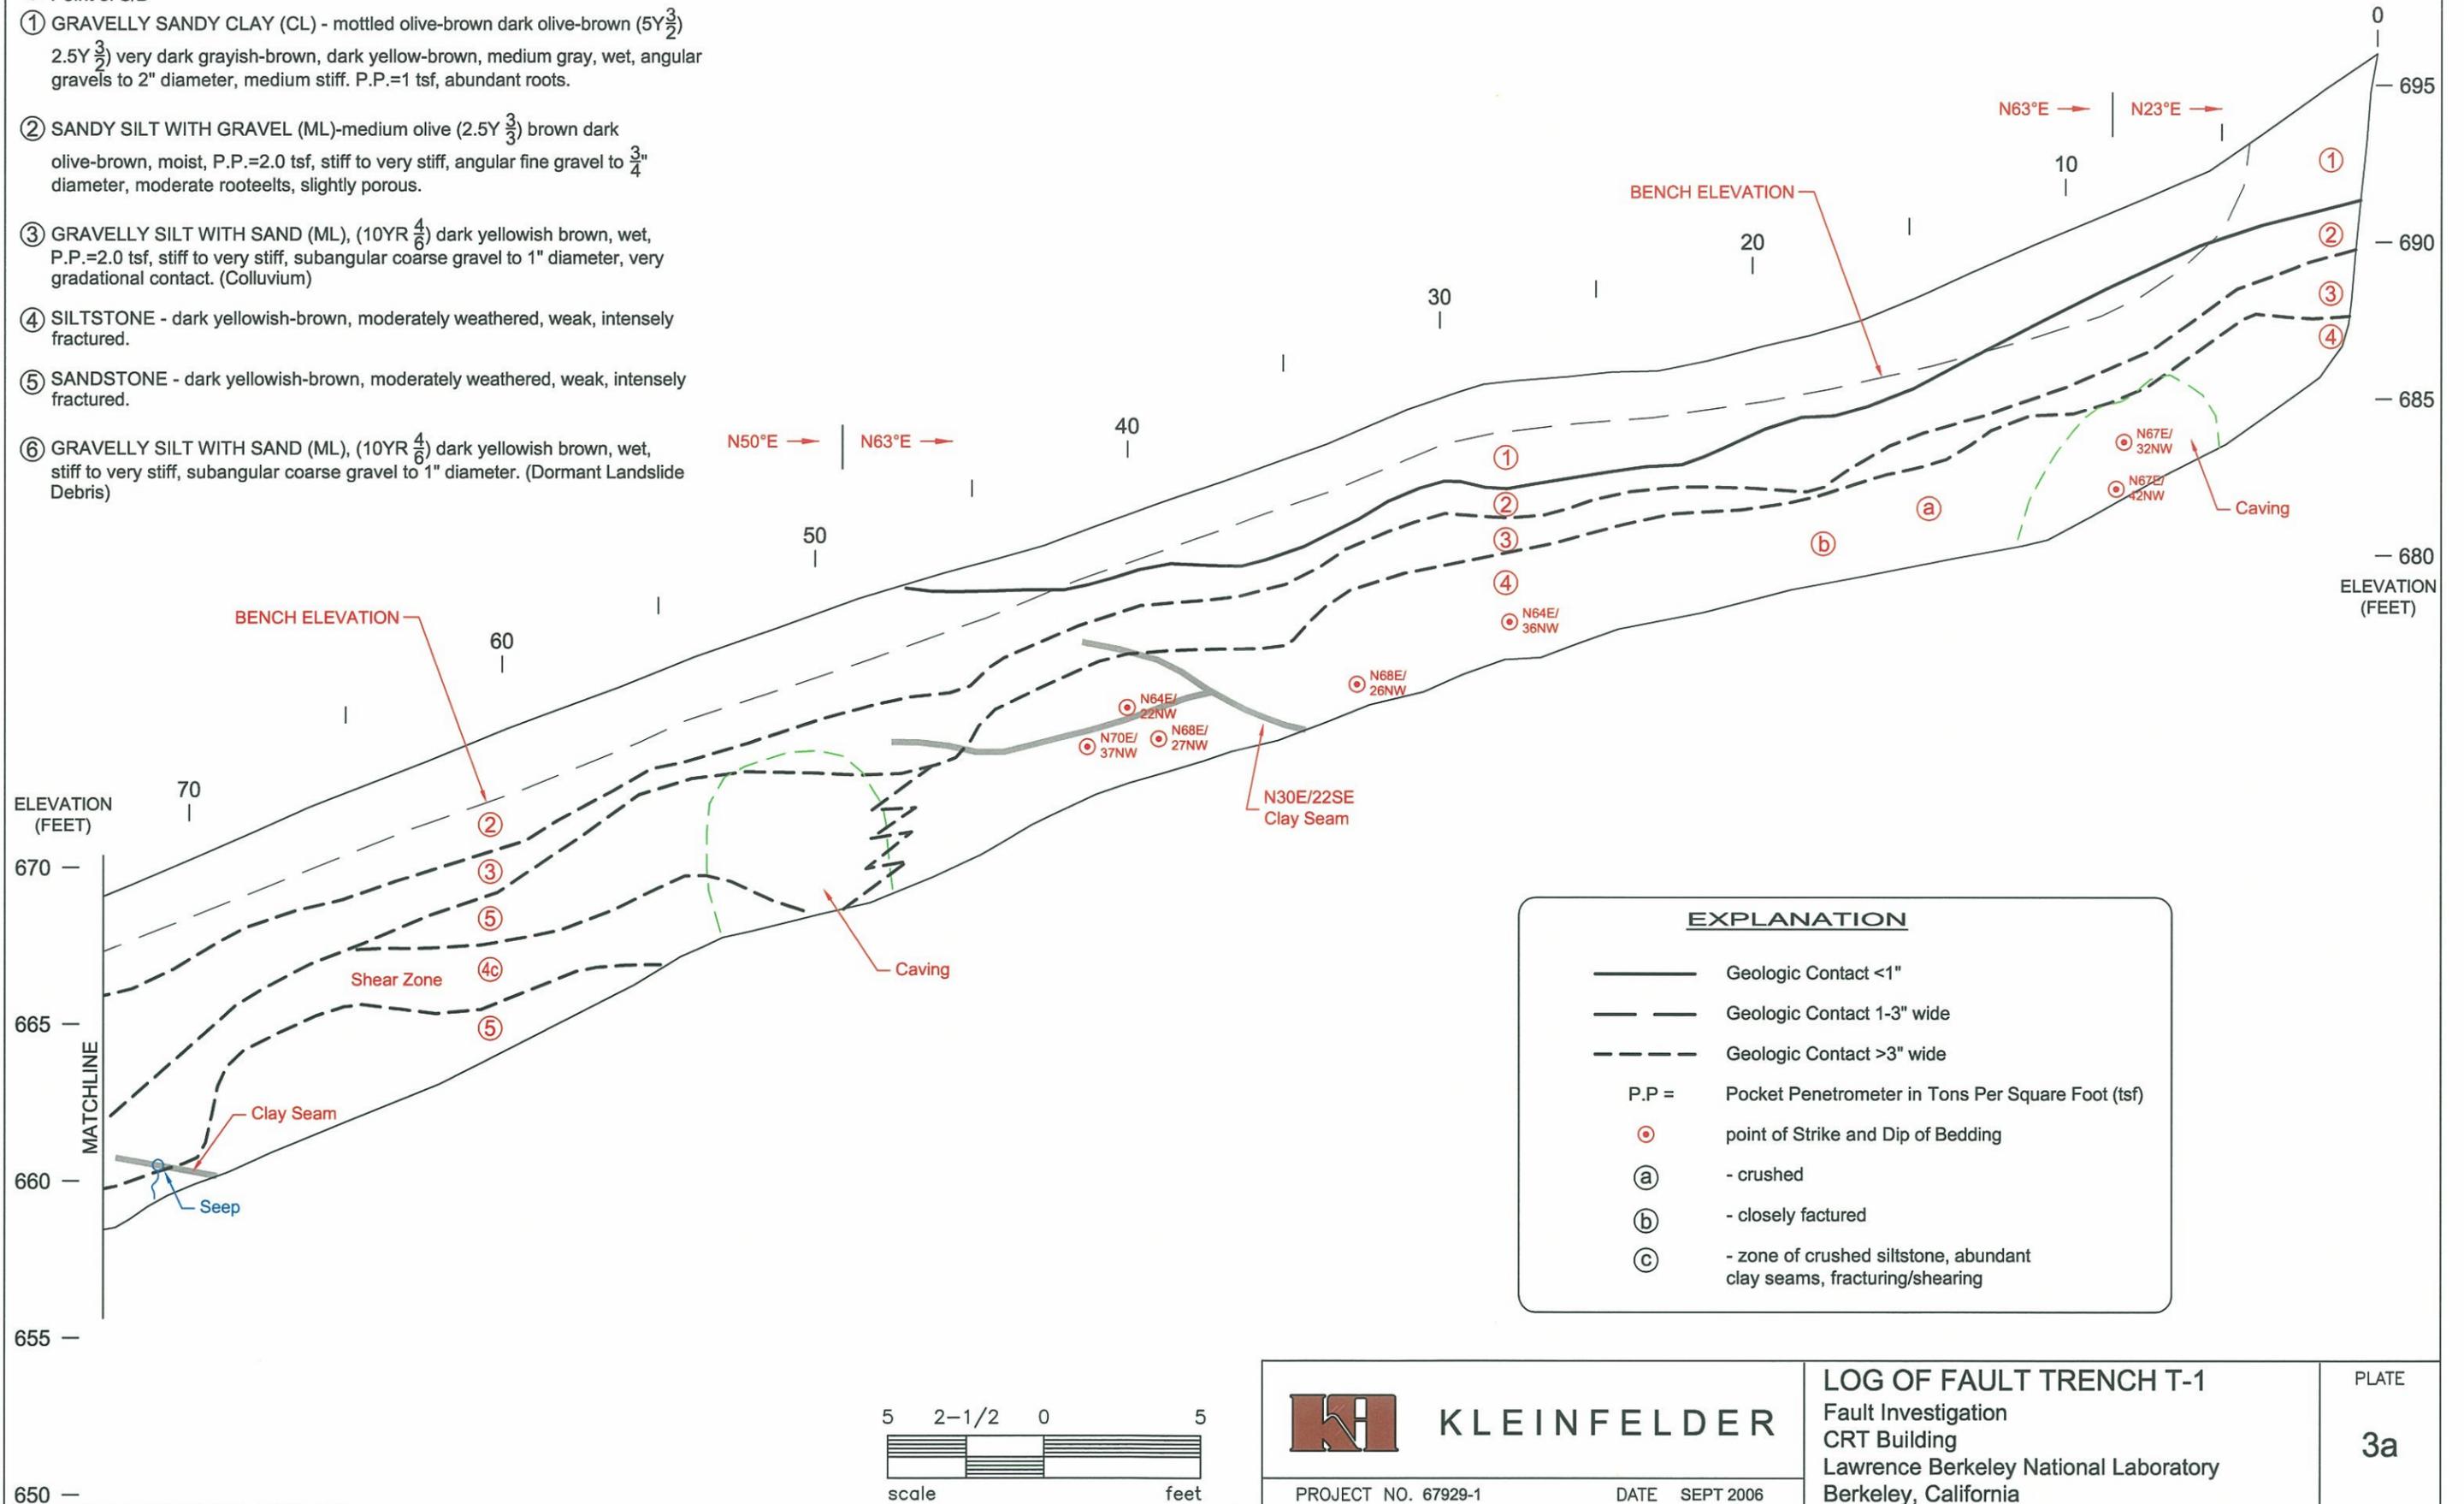
<p>KLEINFELDER</p> <p>PROJECT NO. 67929-1 DATE SEPT 2006</p>	<p>LOG OF FAULT TRENCH T-1</p> <p>Fault Investigation CRT Building Lawrence Berkeley National Laboratory Berkeley, California</p>	<p>PLATE</p> <p>3a</p>
---	--	---	-------------------------------

Evidence of faulting was not observed in Trench T-1 or T-2. Exposures within the trenches consisted of colluvial deposits overlying completely weathered bedrock (residual soil) over less weathered bedrock. No shears or offsets of the layers/geologic contacts were observed in the trench. Geologic data collected in the form of strike and dip of bedding was consistent throughout the trenches. Evidence of landsliding, however, was observed in both trenches.

The east end of trench T-1 is fill (Unit 1) that extends along the upper portion of the trench approximately 47 feet along the trench line. The fill is described as gravelly, sandy clay that is wet and medium stiff. The fill is 2- to 3- feet thick. Underlying the fill is colluvium (Unit 2 and 3) consisting of sandy silt with gravel and gravelly silt with sand that is moist to wet and stiff to very stiff. This layer is approximately 2- to 6-feet thick with a localized area that is approximately 8 feet thick. Unit 4 and 5, located beneath Unit 3, varied in thickness from 0.5 to 5 feet. Units 4 and 5 are siltstone and sandstone, respectively, that is moderately weathered, weak, and intensely fractured and locally closely fractured and crushed. The siltstone laterally grades into sandstone in several locations throughout the trenches (Unit 5). The bedrock unit displays zones of sheared material associated with tectonic activity. These shear zones and clay shear seams are not consistent with the trend of the Hayward fault. Unit 6 is landslide debris that has been classified as gravelly silt with sand that is wet and stiff to very stiff.

At approximately Station 130 of trench T-1, a gray clay dormant landslide plane was encountered. The slide plane continues to the end of the trench and was also observed in trench T-2. The feature is further recognized by the presence of deep soil infill of what appears to be a landslide headscarp and the absence of residual soil upslope.

The presence of landslide deposits should be addressed in the site-specific geotechnical investigation for the project.

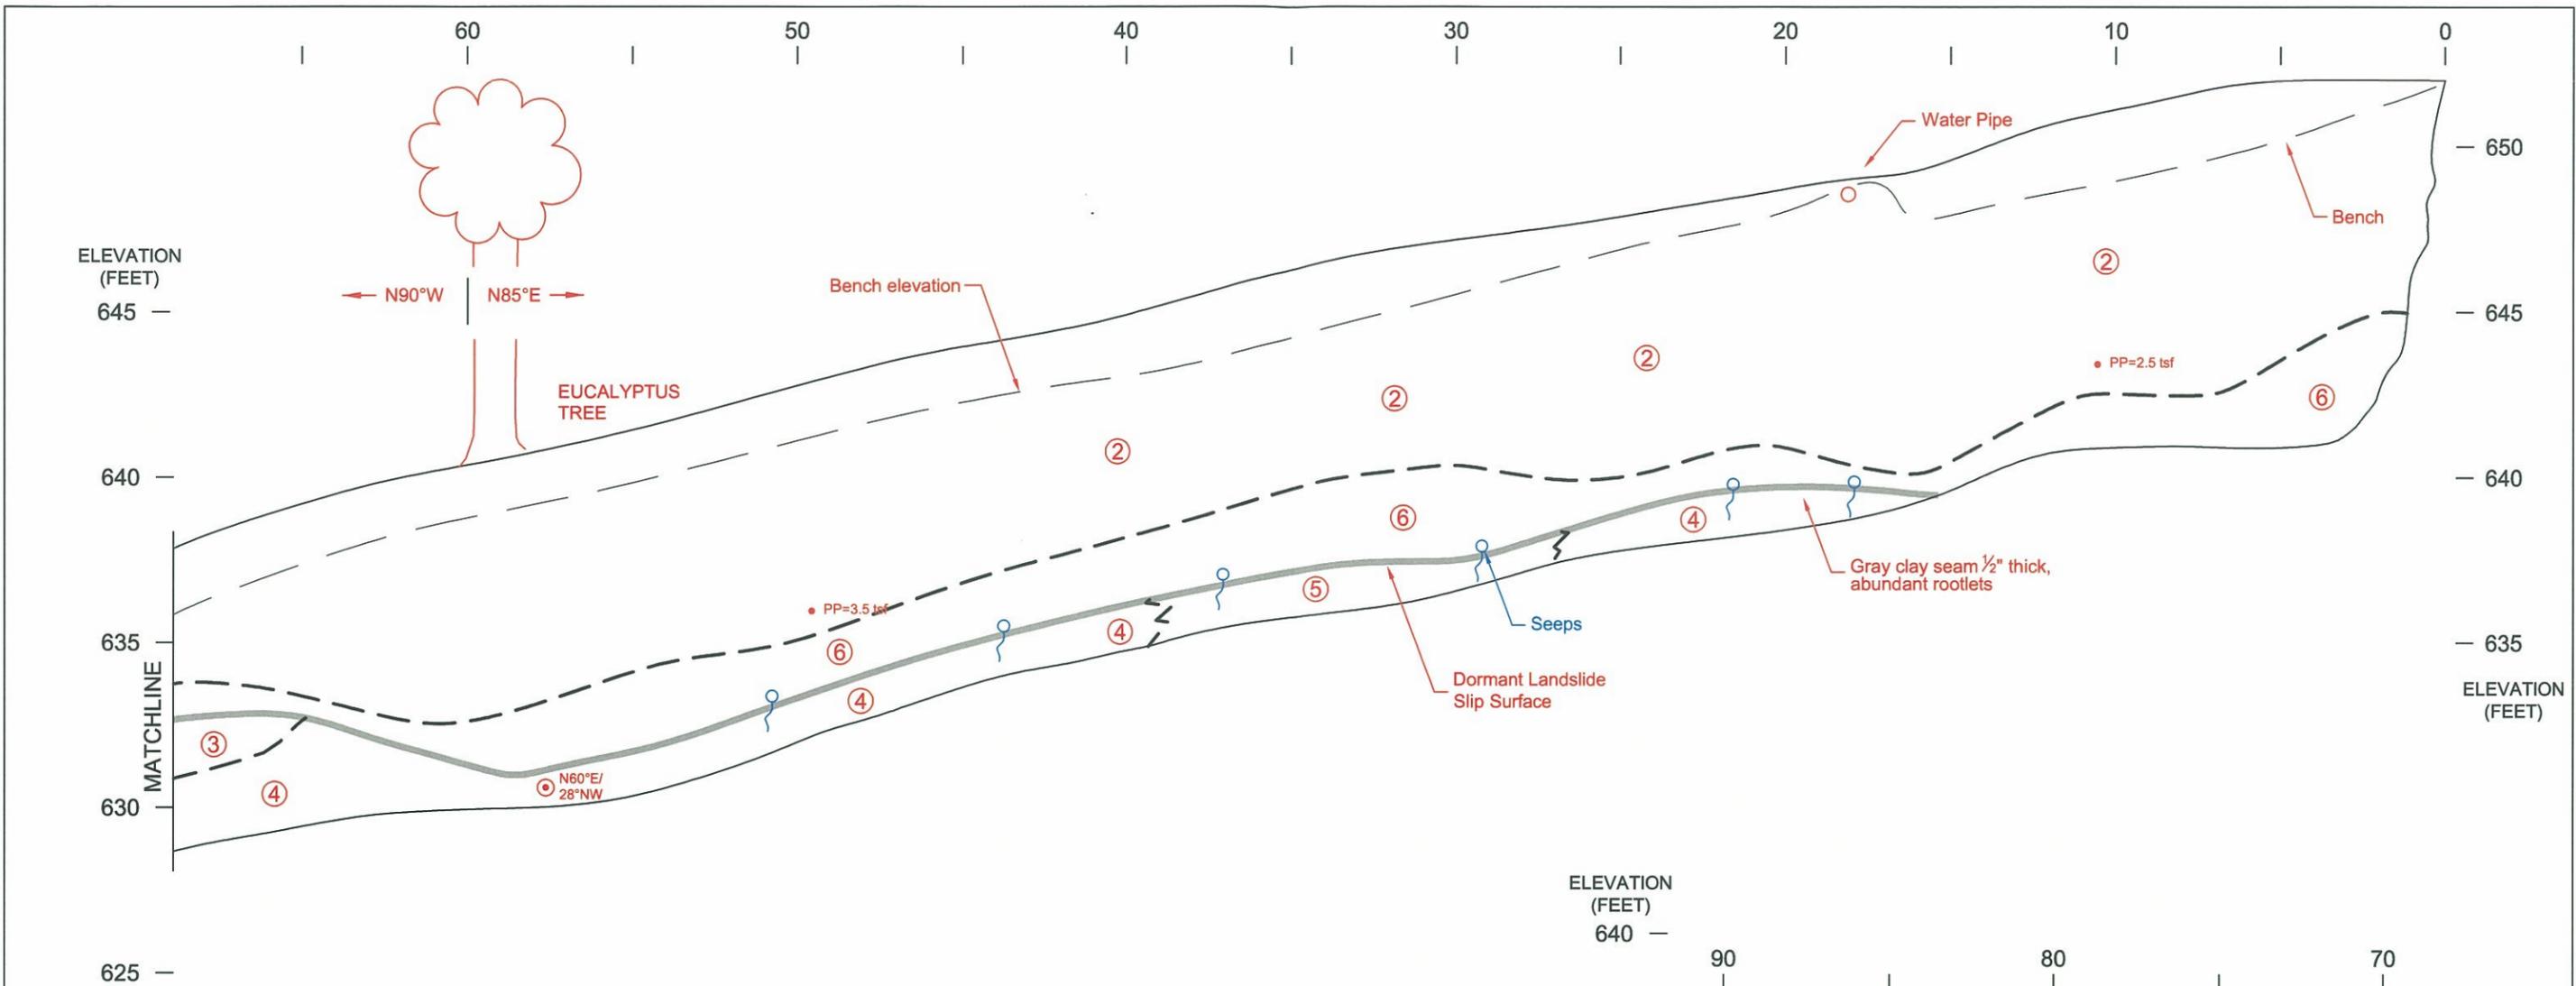
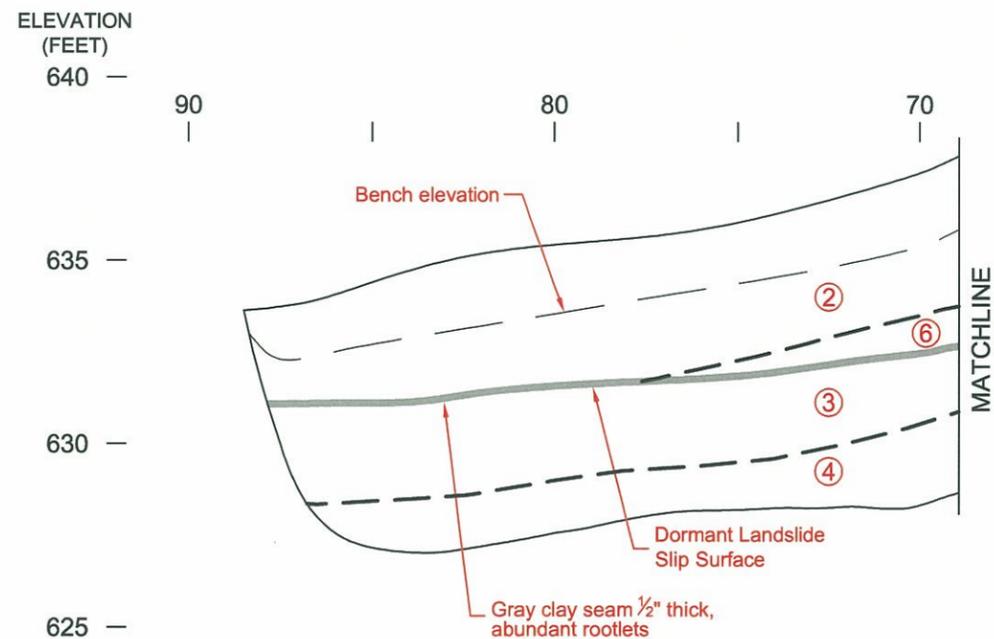
LOG OF FAULT TRENCH T-2

The static groundwater table was not encountered in trench T-1 or T-2. Minor seepage was observed in the landslide plane area and water pooled in the lower elevations of the trenches.
