ALAN KROPP
& ASSOCIATES, INC.

April 2, 2010
2335-7B, L-28884

RE: Geologic and Geotechnical Investigation Report
Building 85 Stabilization
Lawrence Berkeley National Laboratory
Berkeley, California
(Subcontract No. 6859200)

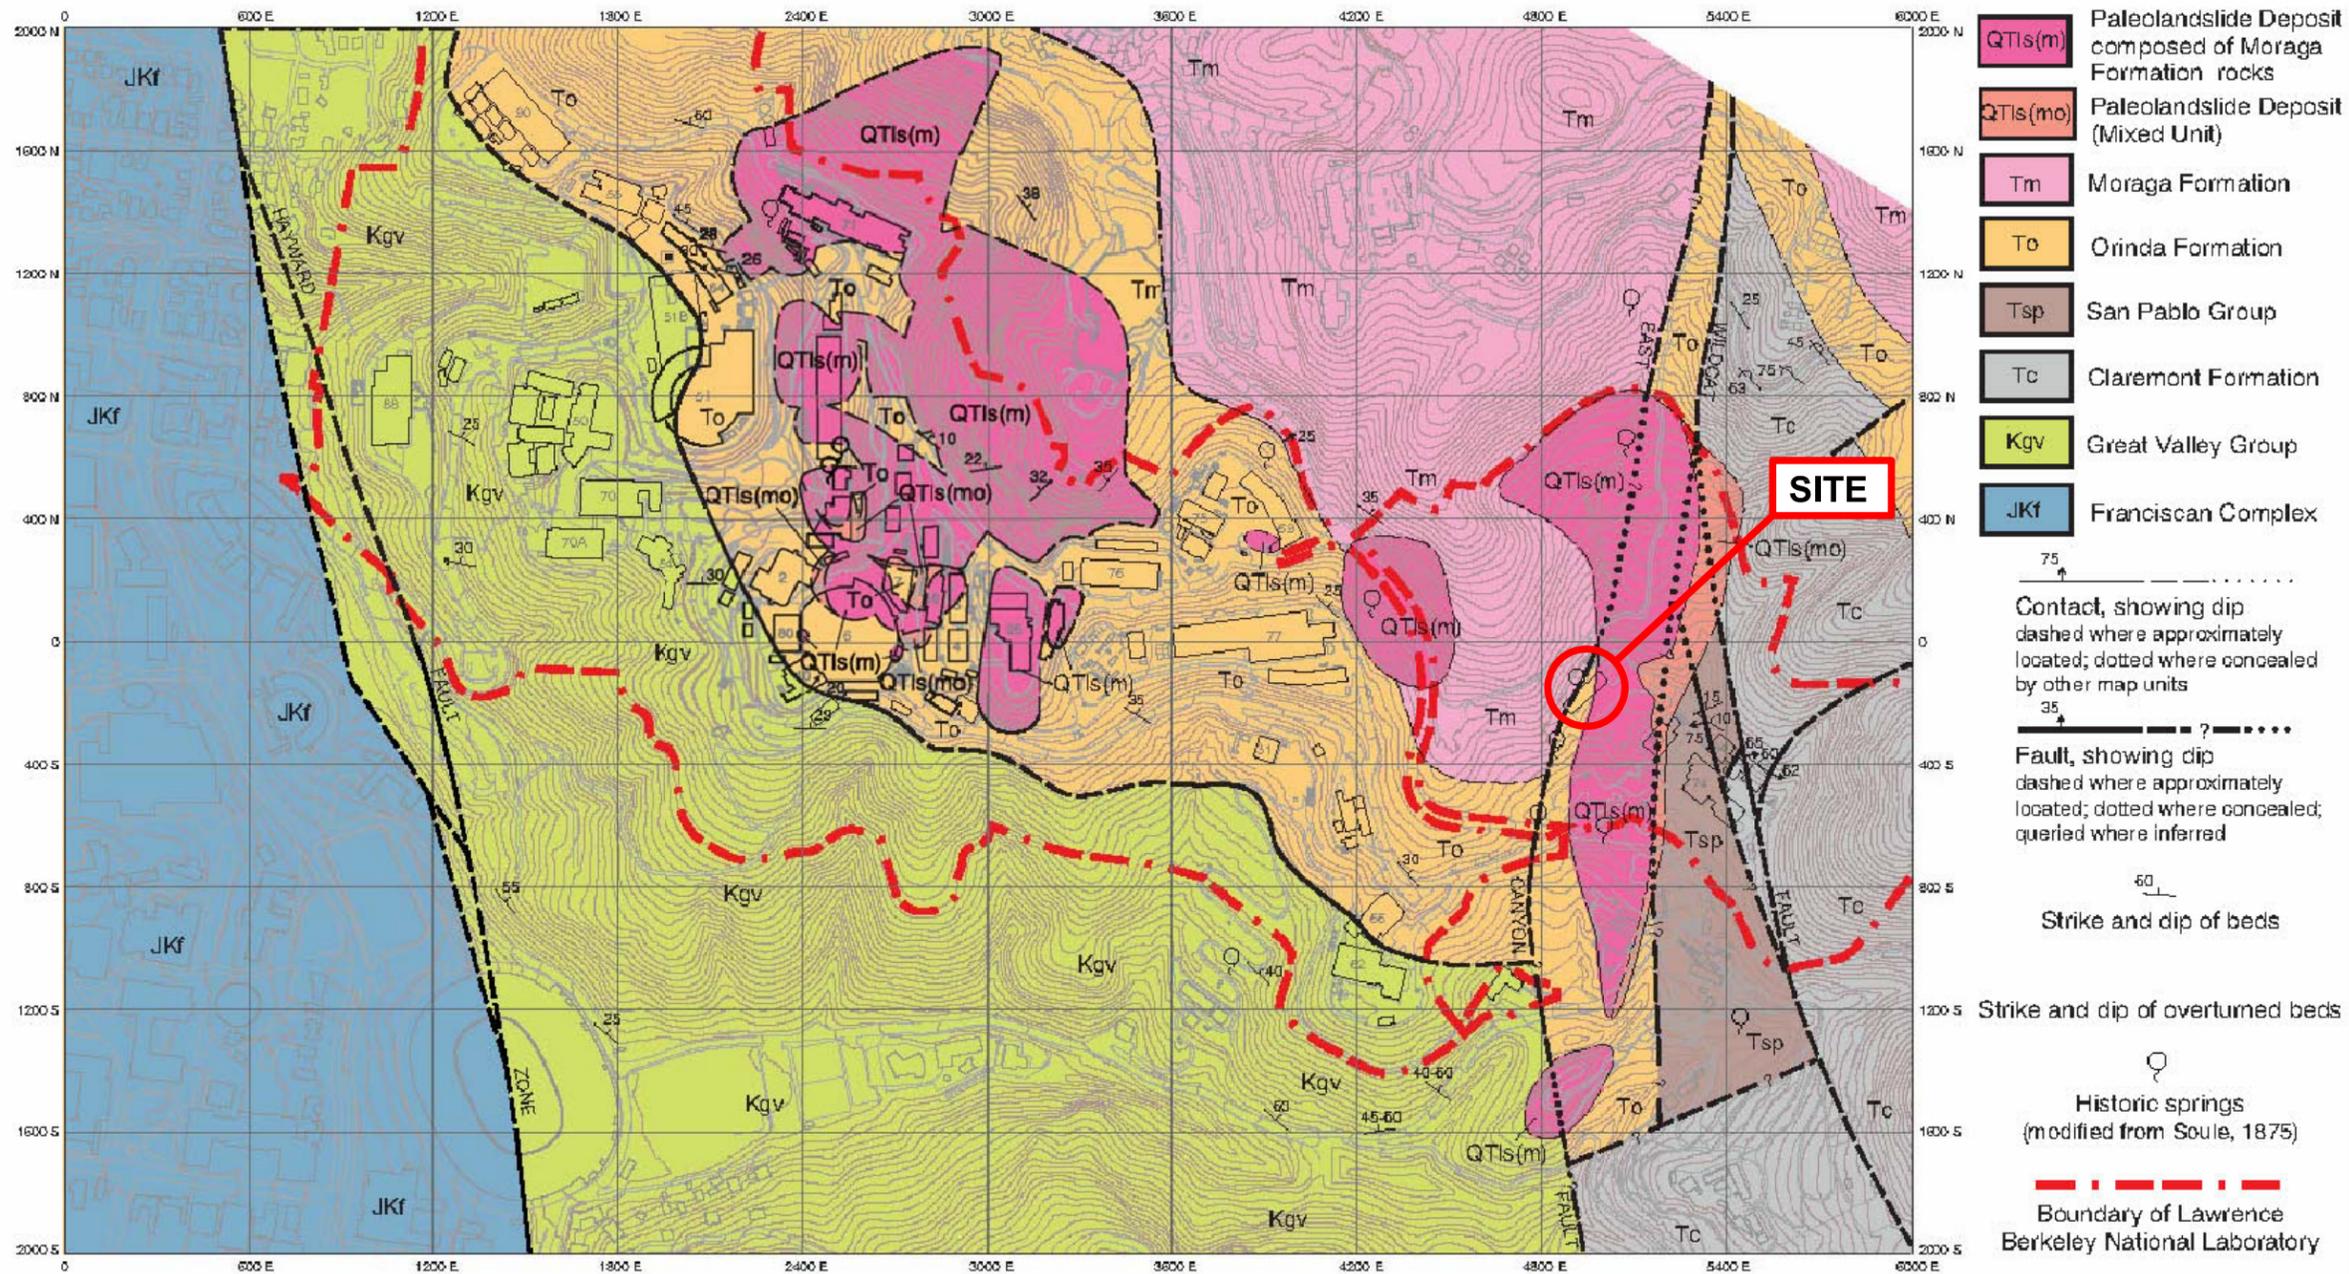
FIGURE **8**

The Bedrock Geologic Map presented in the RFI Report (Figure 8) shows the upslope areas directly north and northwest of Buildings 85 and 85A capped by Moraga Formation bedrock of great areal extent. This mapping is generally consistent with the regional syncline mapped by Graymer (2000) and Lawson and Palache (1901) (presented on Figures 5 and 6, respectively). The southeastern limit of the Moraga Formation rock is proximate to LBNL Buildings 85 and 85A and generally corresponds to the near-linear alignment of historical springs depicted in the historical 1875 map by Soulé (shown on Figure 8).

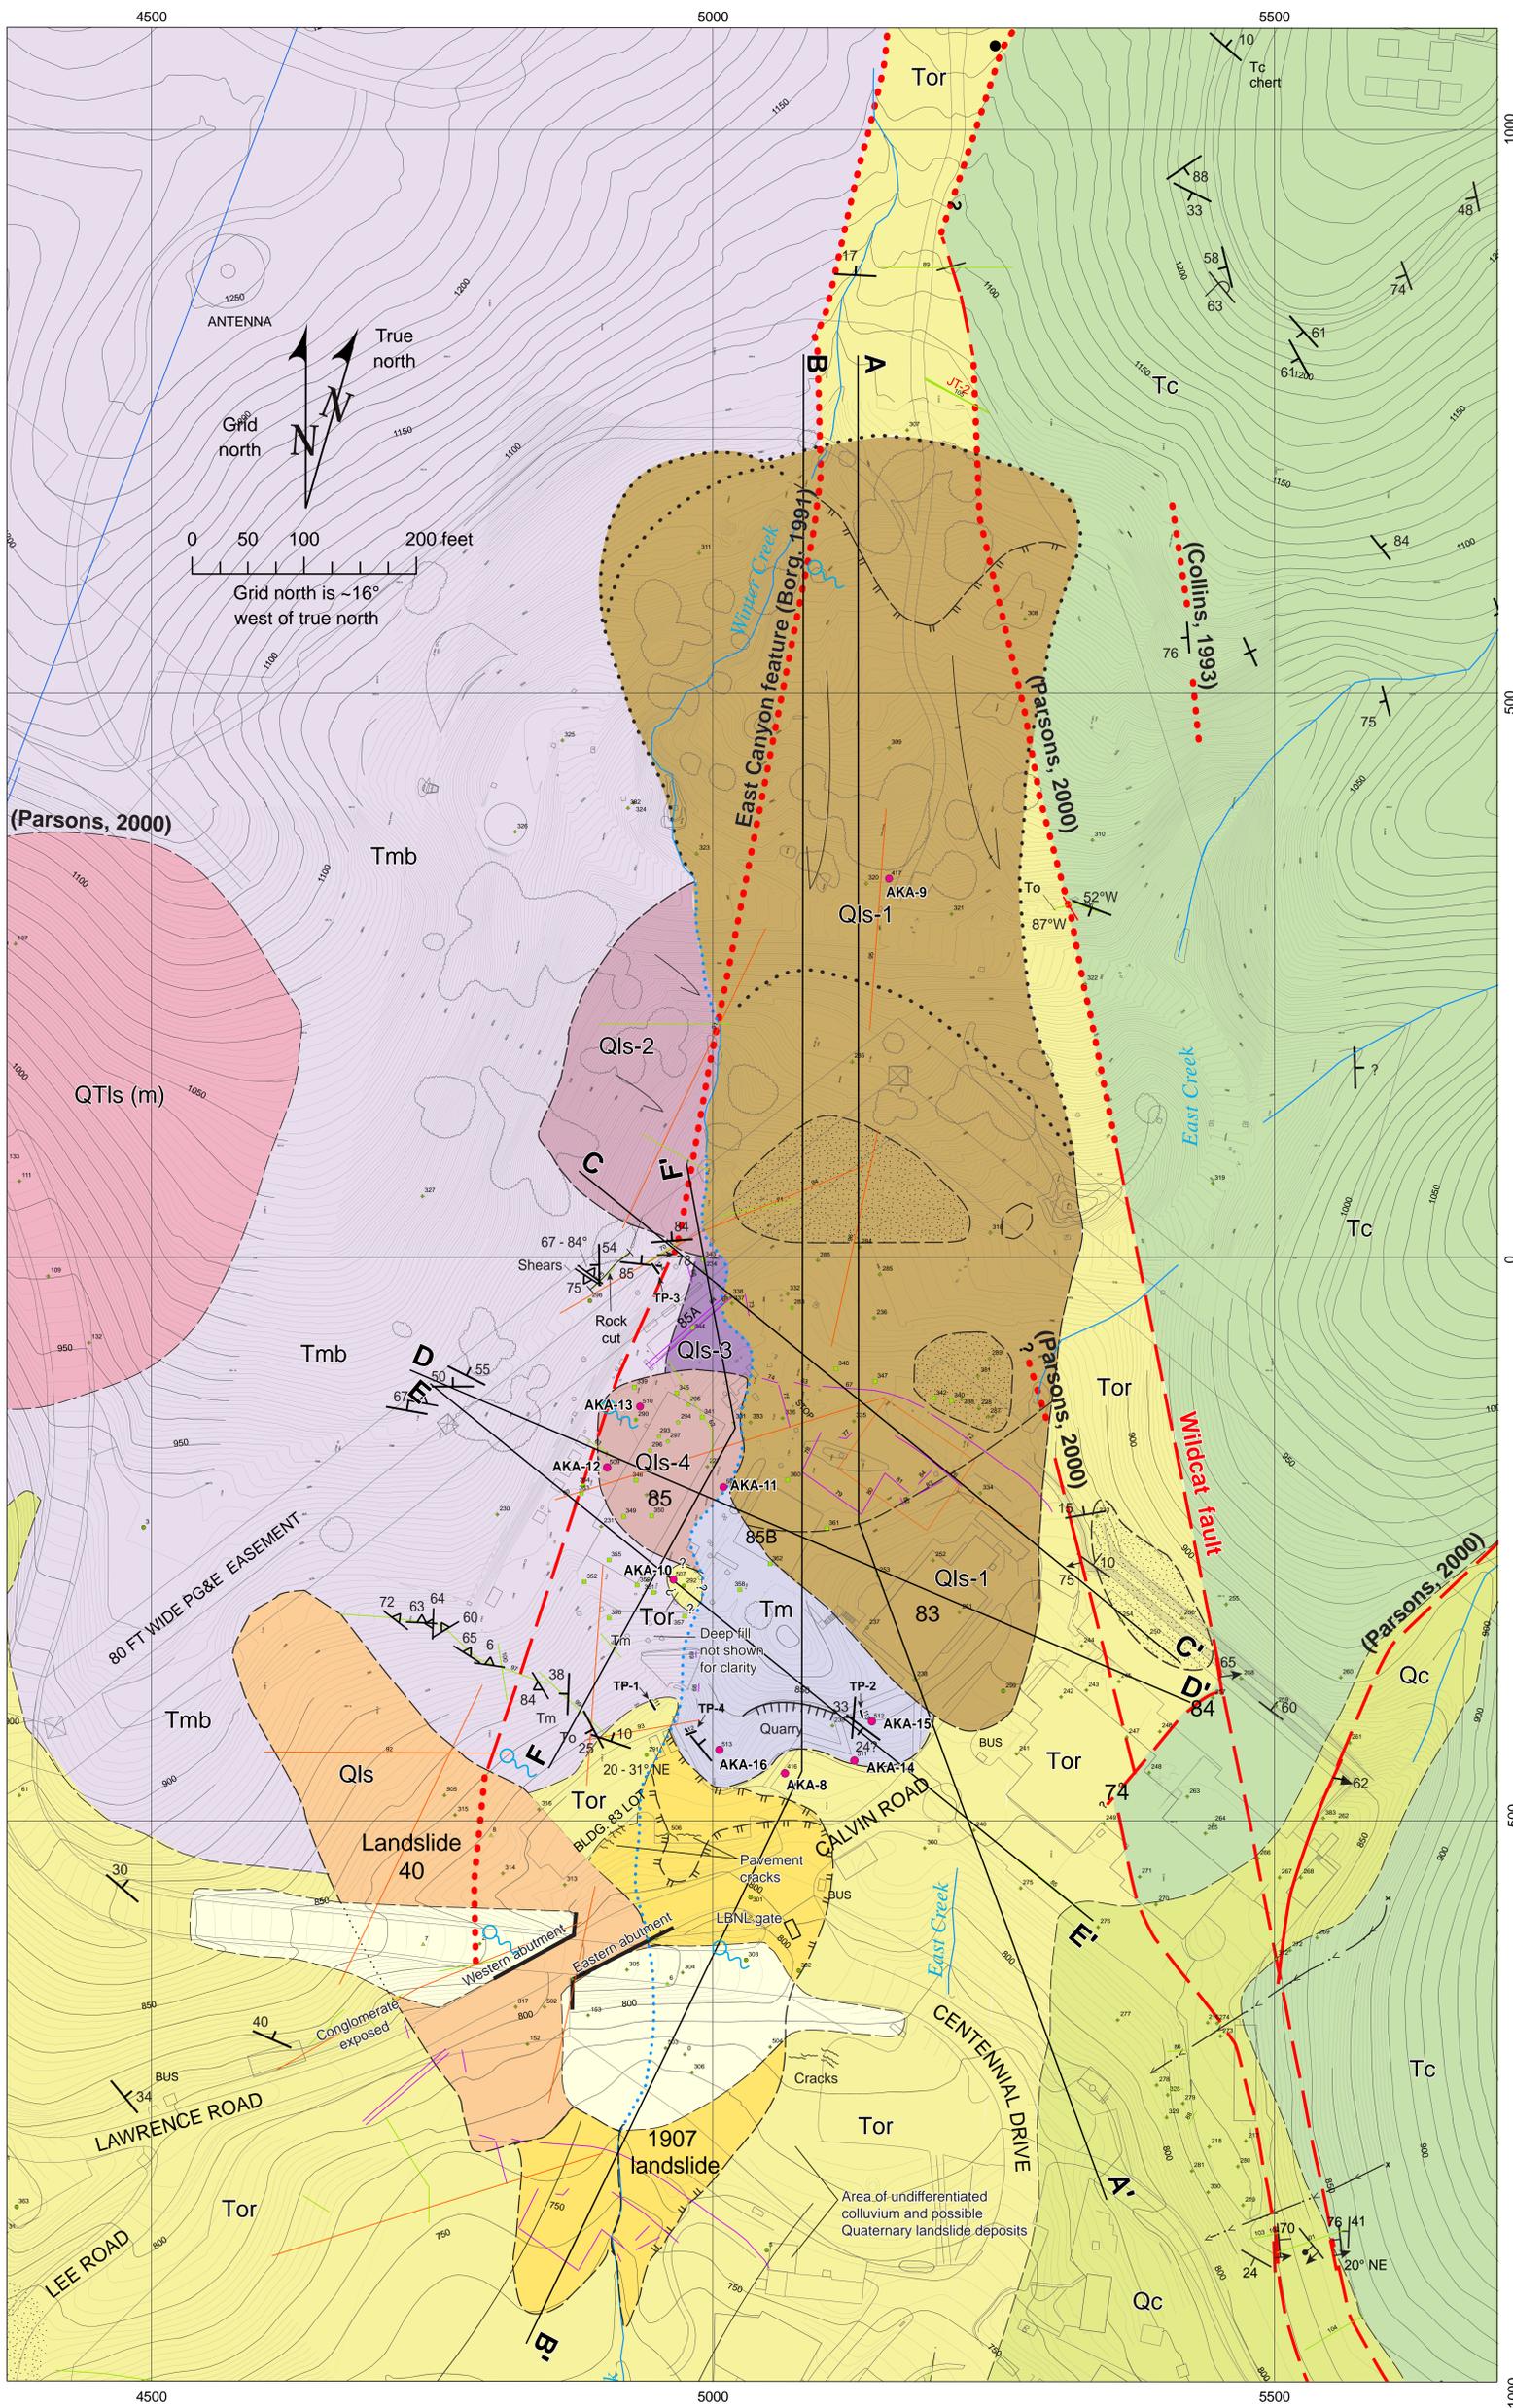
Site Geologic Map
FIGURE 9

Repaired landslide
	1907 landslide
	Landslide 40
	QIs-1 - Quaternary landslide deposits
	QIs-2 - Quaternary landslide deposits
	QIs-3 - Quaternary landslide deposits
	QIs-4 - Quaternary landslide deposits

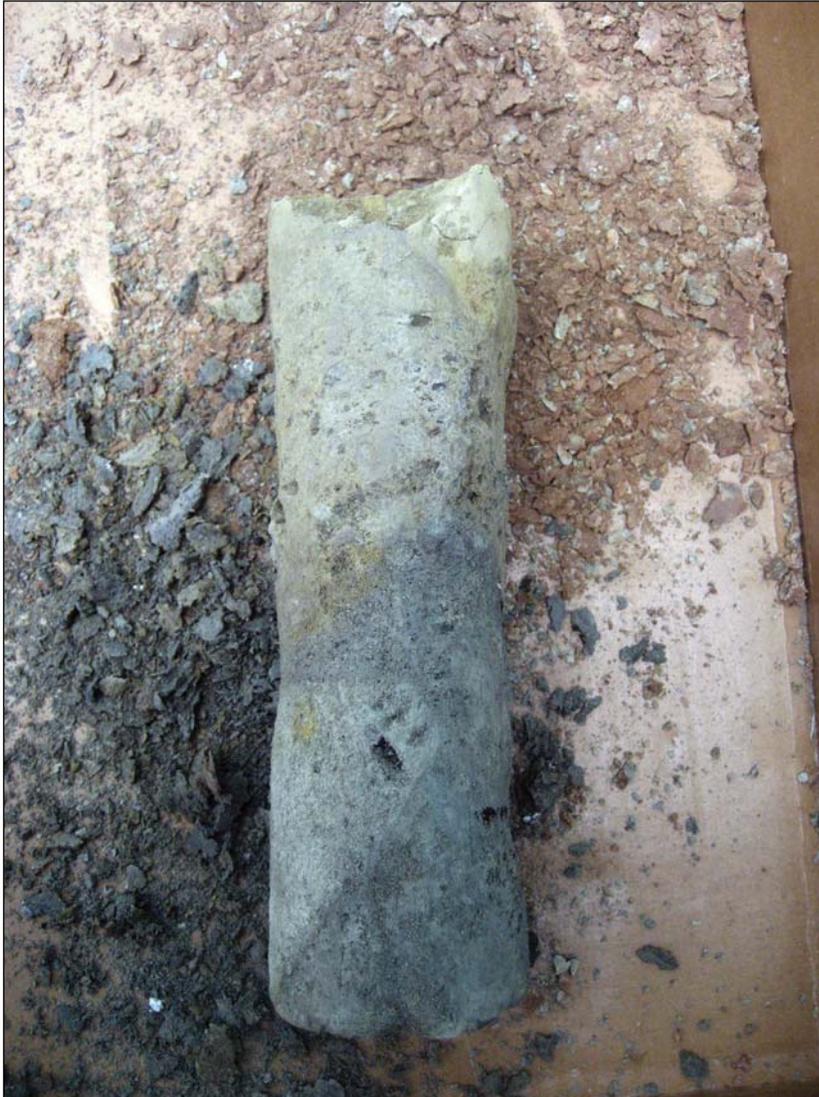
Photograph A-3. Core from boring AKA-9 at 30.5 feet showing a steeply inclined contact within the Orinda Formation.

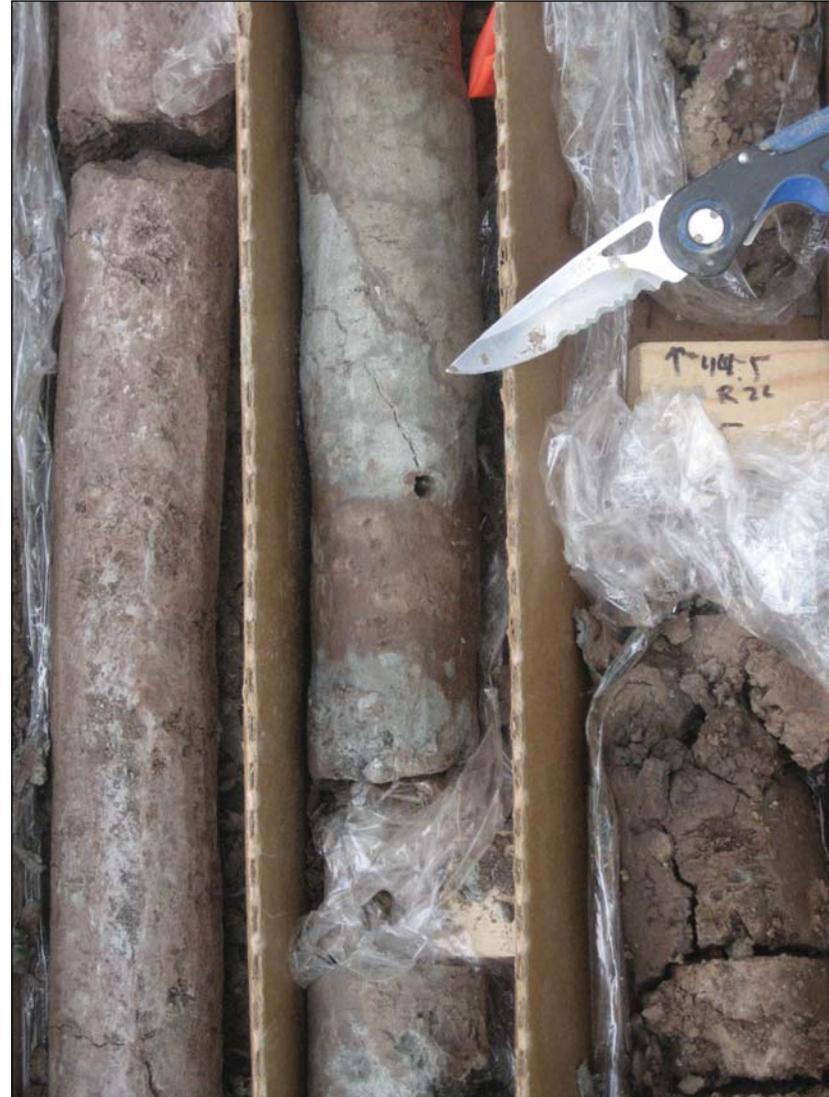
Photograph A-4. Core from boring AKA-9 at 45.5 to 46.5 feet showing approximate contact and shear between Moraga and Orinda Formations.

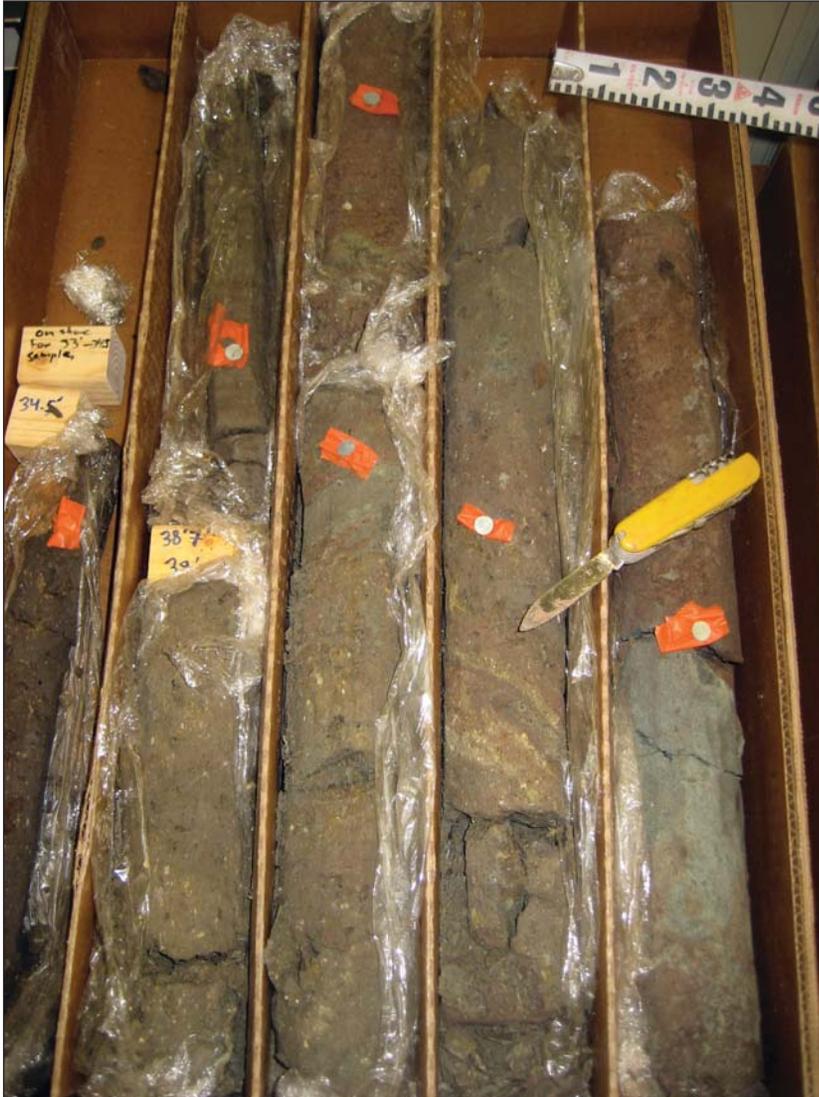
Photograph A-5. Core from boring AKA-10 at 42.5 feet showing clay laminations. Note the laminations are similar to bedding (red vs. gray units).

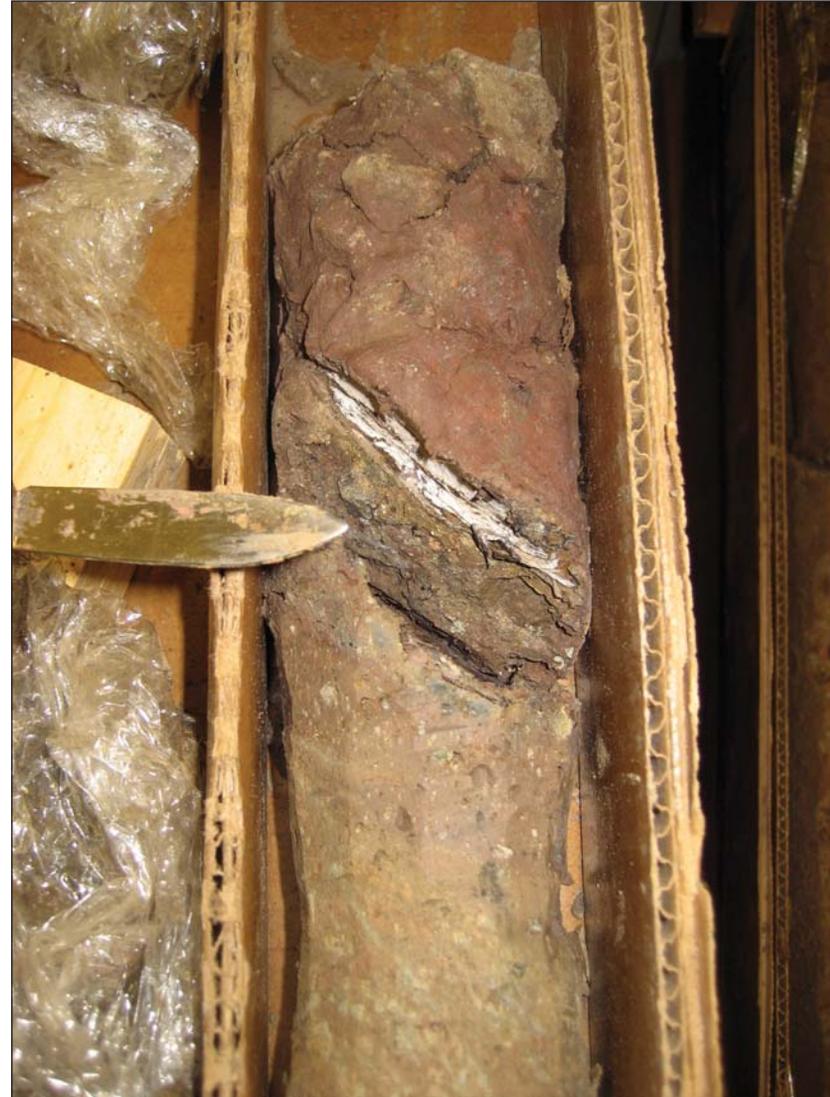
Photograph A-6. Core from boring AKA-11 at 22 feet showing inclined seam with Moraga Formation above and Orinda Formation below.

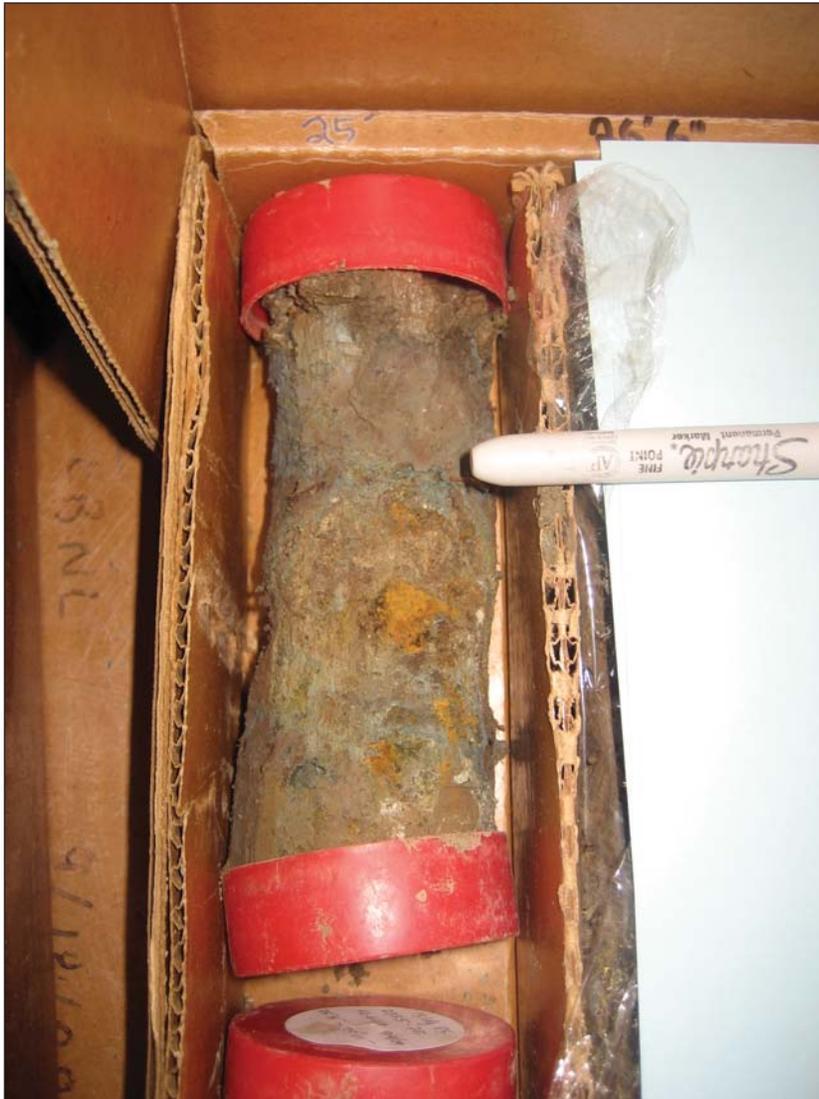
Photograph A-7. Sample from boring AKA-12 at 25 feet showing clay seam and weathered and mixed Moraga Formation.

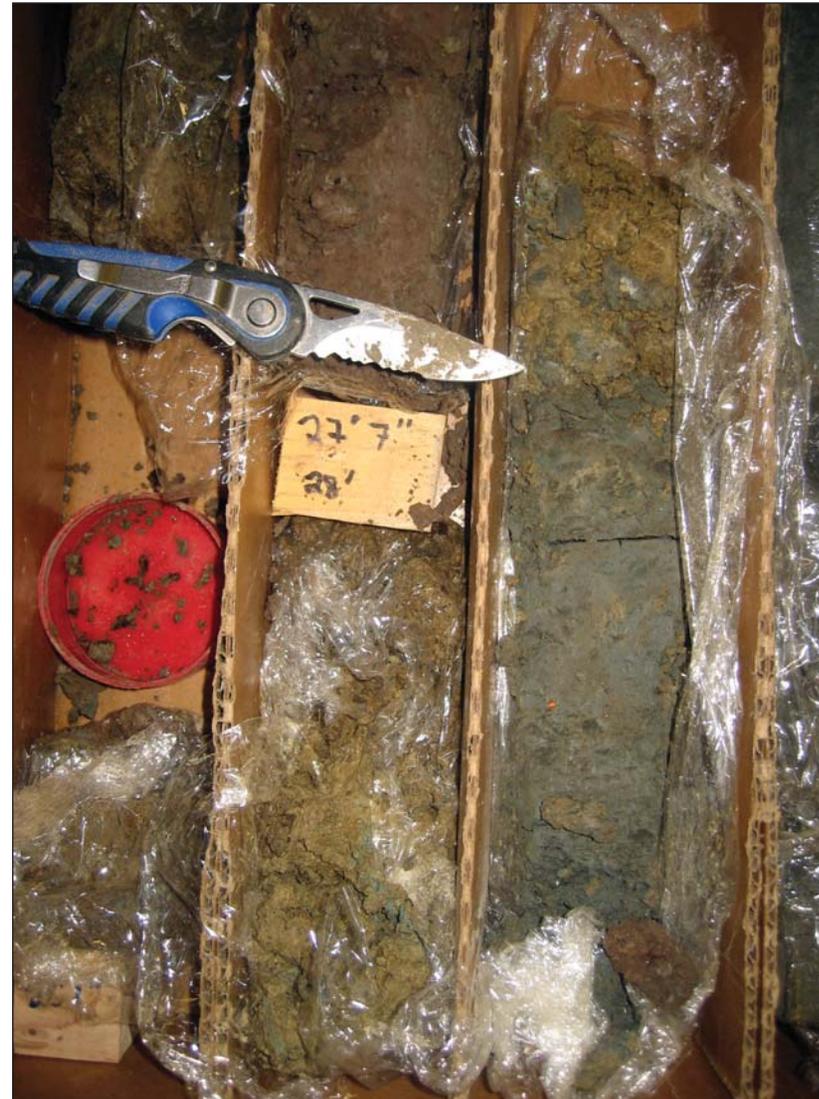
Photograph A-8. Core from boring AKA-12 at 27 to 30 feet showing mixed Moraga (reddish) and Orinda Formation siltstone (gray).

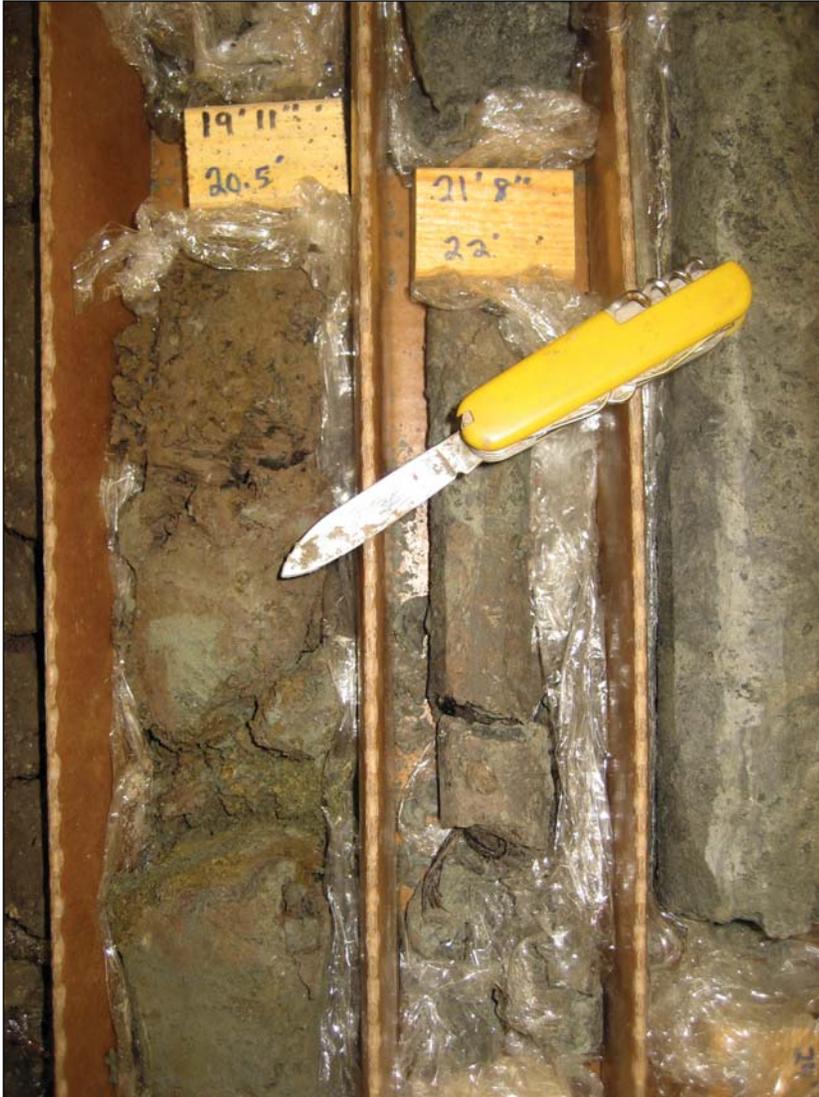
Photograph A-9. Core from boring AKA-13 at 20 feet showing gravelly Moraga Formation overlying Orinda Formation siltstone along a "seamy" contact.

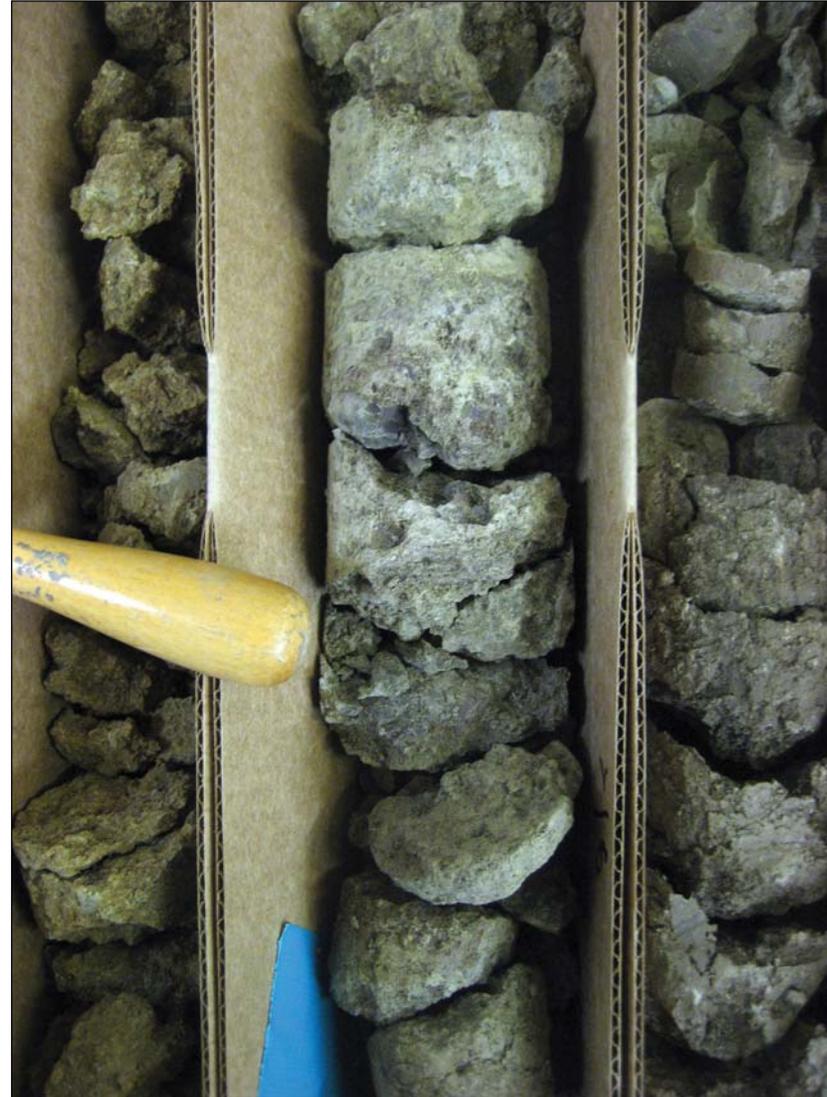
Photograph A-10. Core from boring AKA-14 at 9 to 11 feet showing Moraga Formation (far left) and Orinda Formation (grayish color).

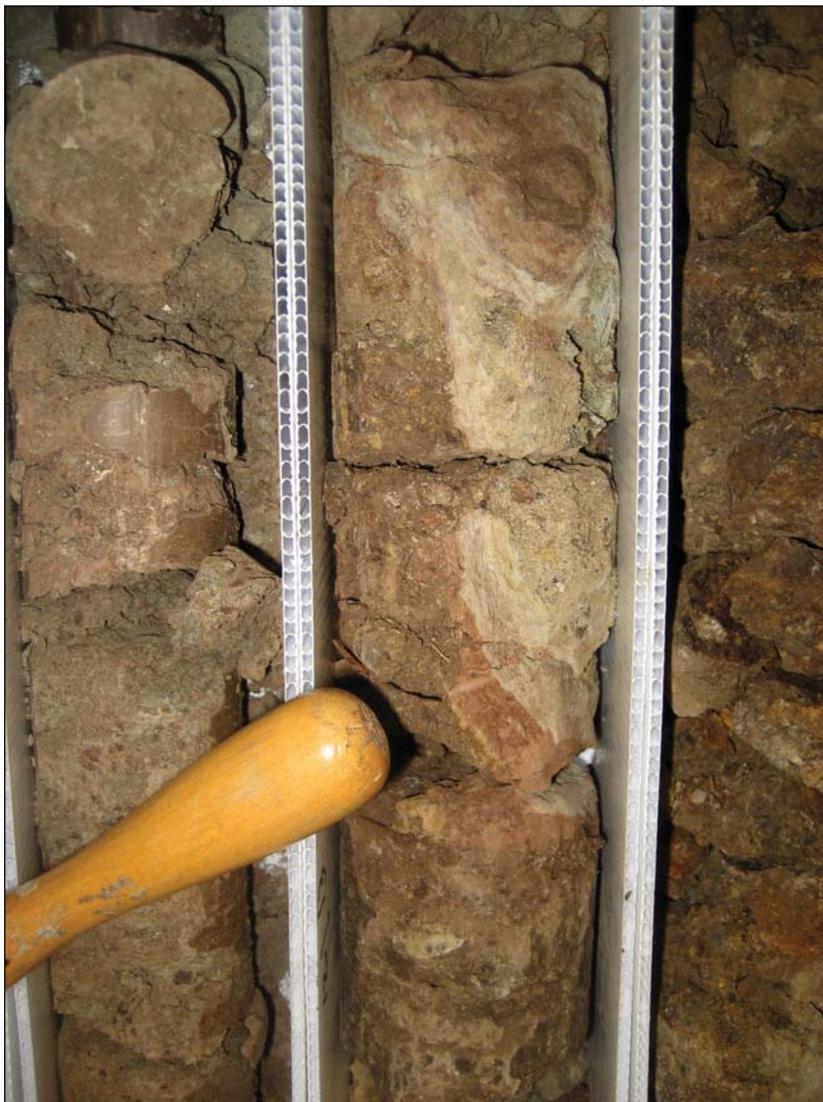
Photograph A-12. Core from boring AKA-16 at 17.5 feet showing contact between Moraga and Orinda Formations along steeply inclined plane.

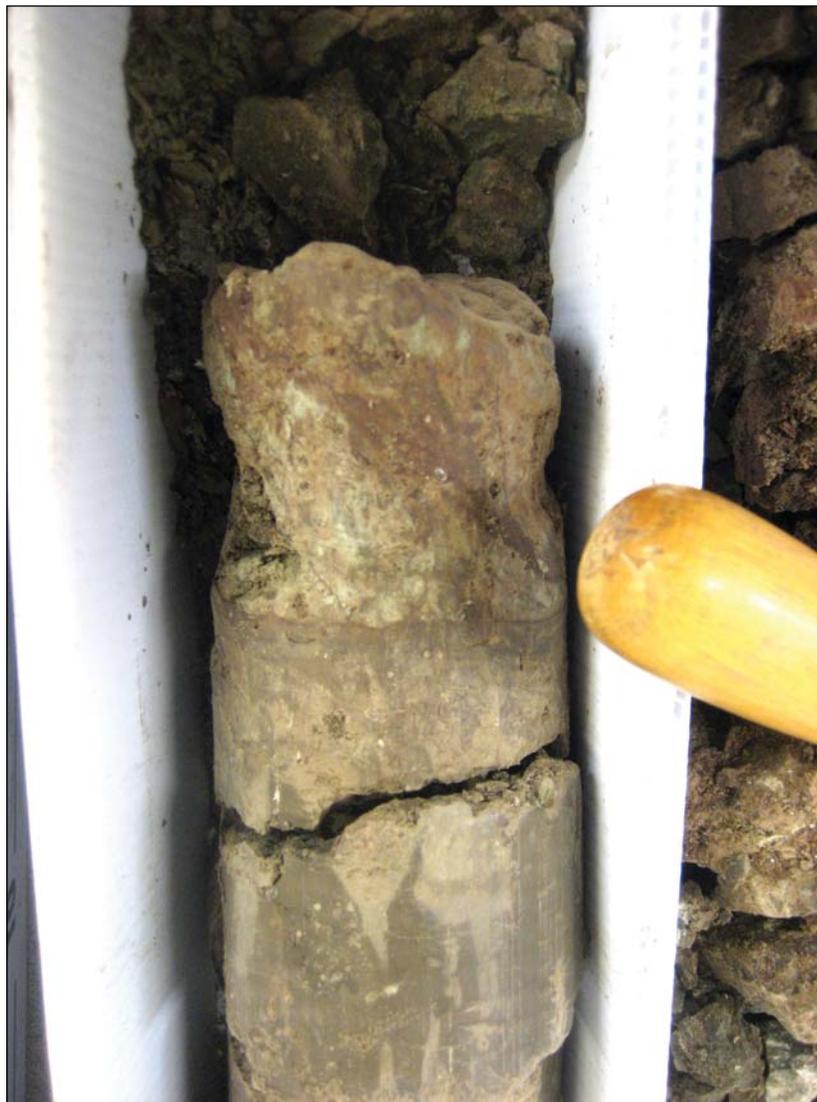
Photograph A-13. Core from boring AKA-16 at 25 feet showing 1/4 inch thick clay seam within siltstone of Orinda Formation.
