LIST OF FIGURES

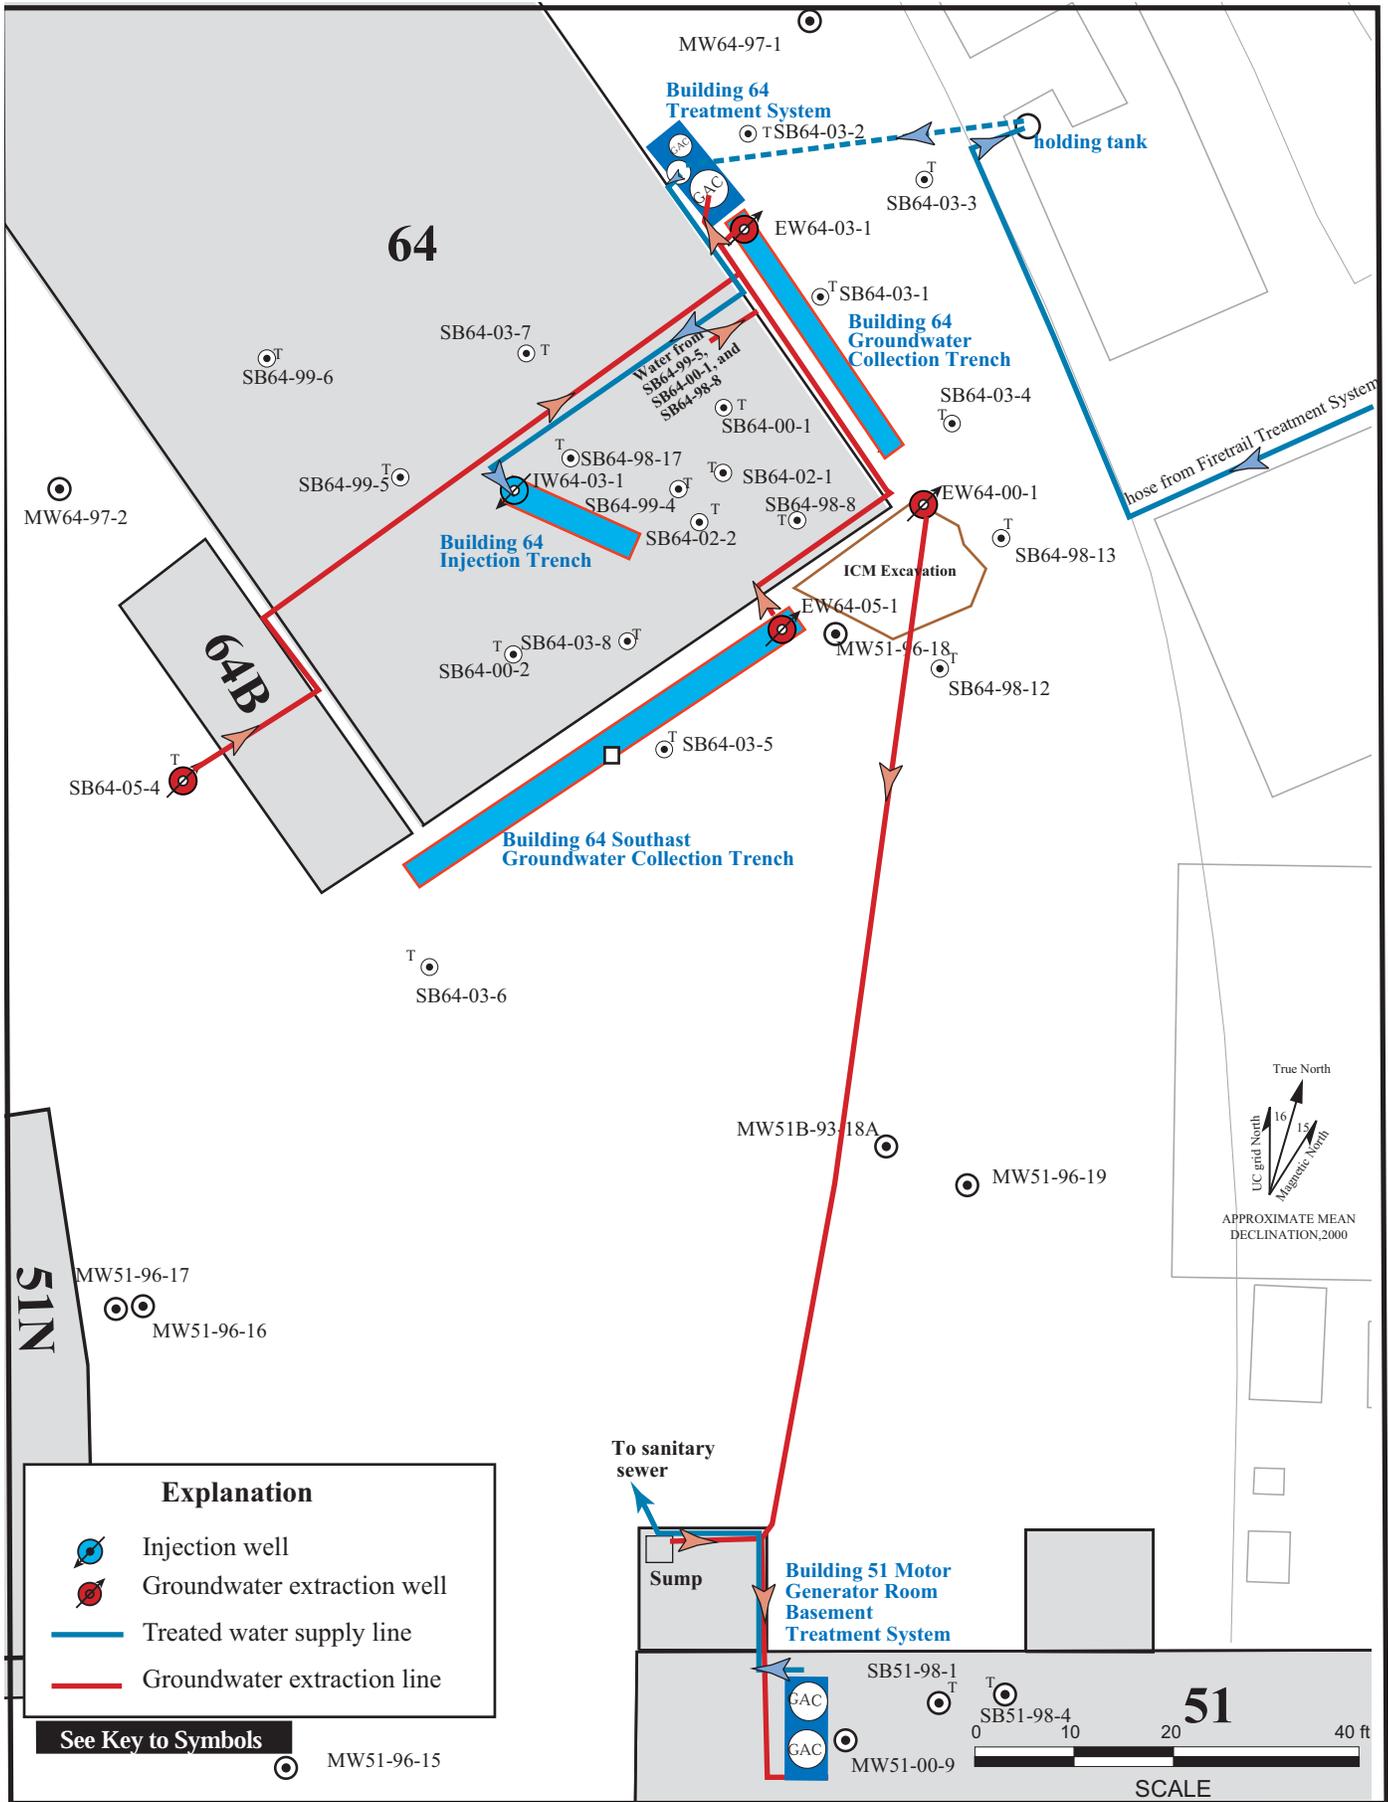
Figure 2.1. Soil Flushing System, Building 51/64 Groundwater Solvent Plume Source Area.

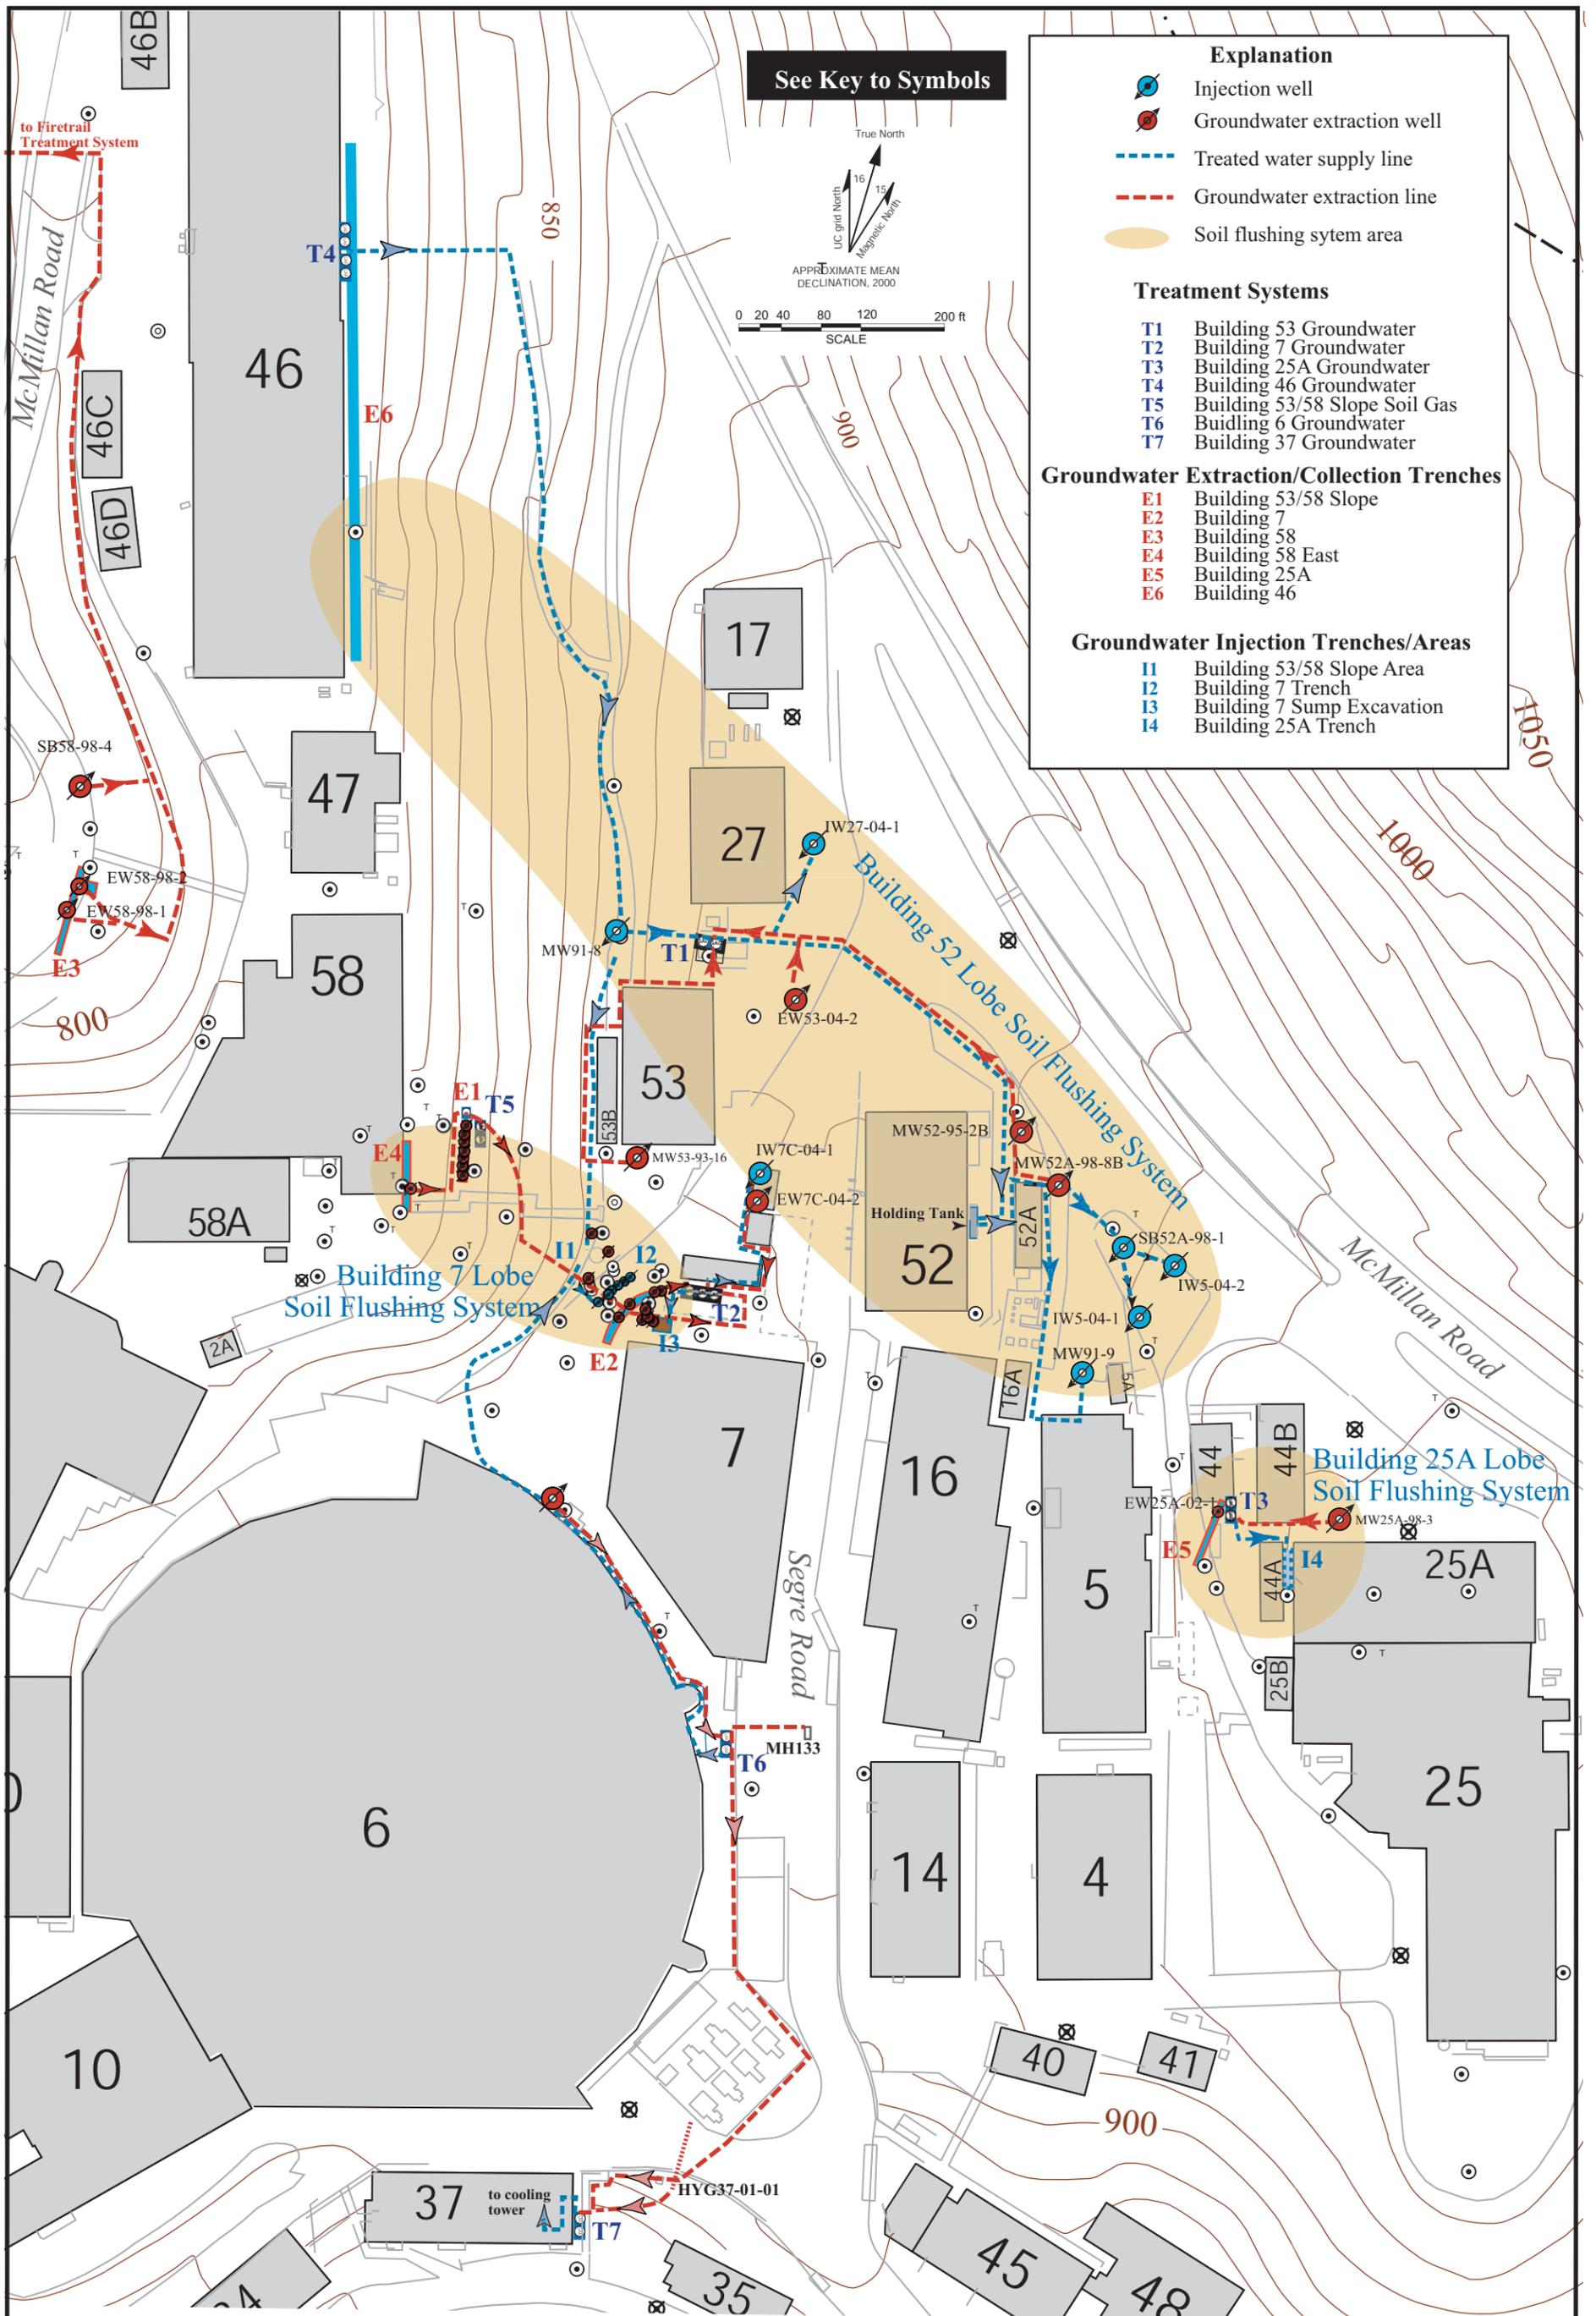
Figure 2.3. Soil Flushing and Groundwater Migration Control Systems, Old Town Groundwater Solvent Plume.

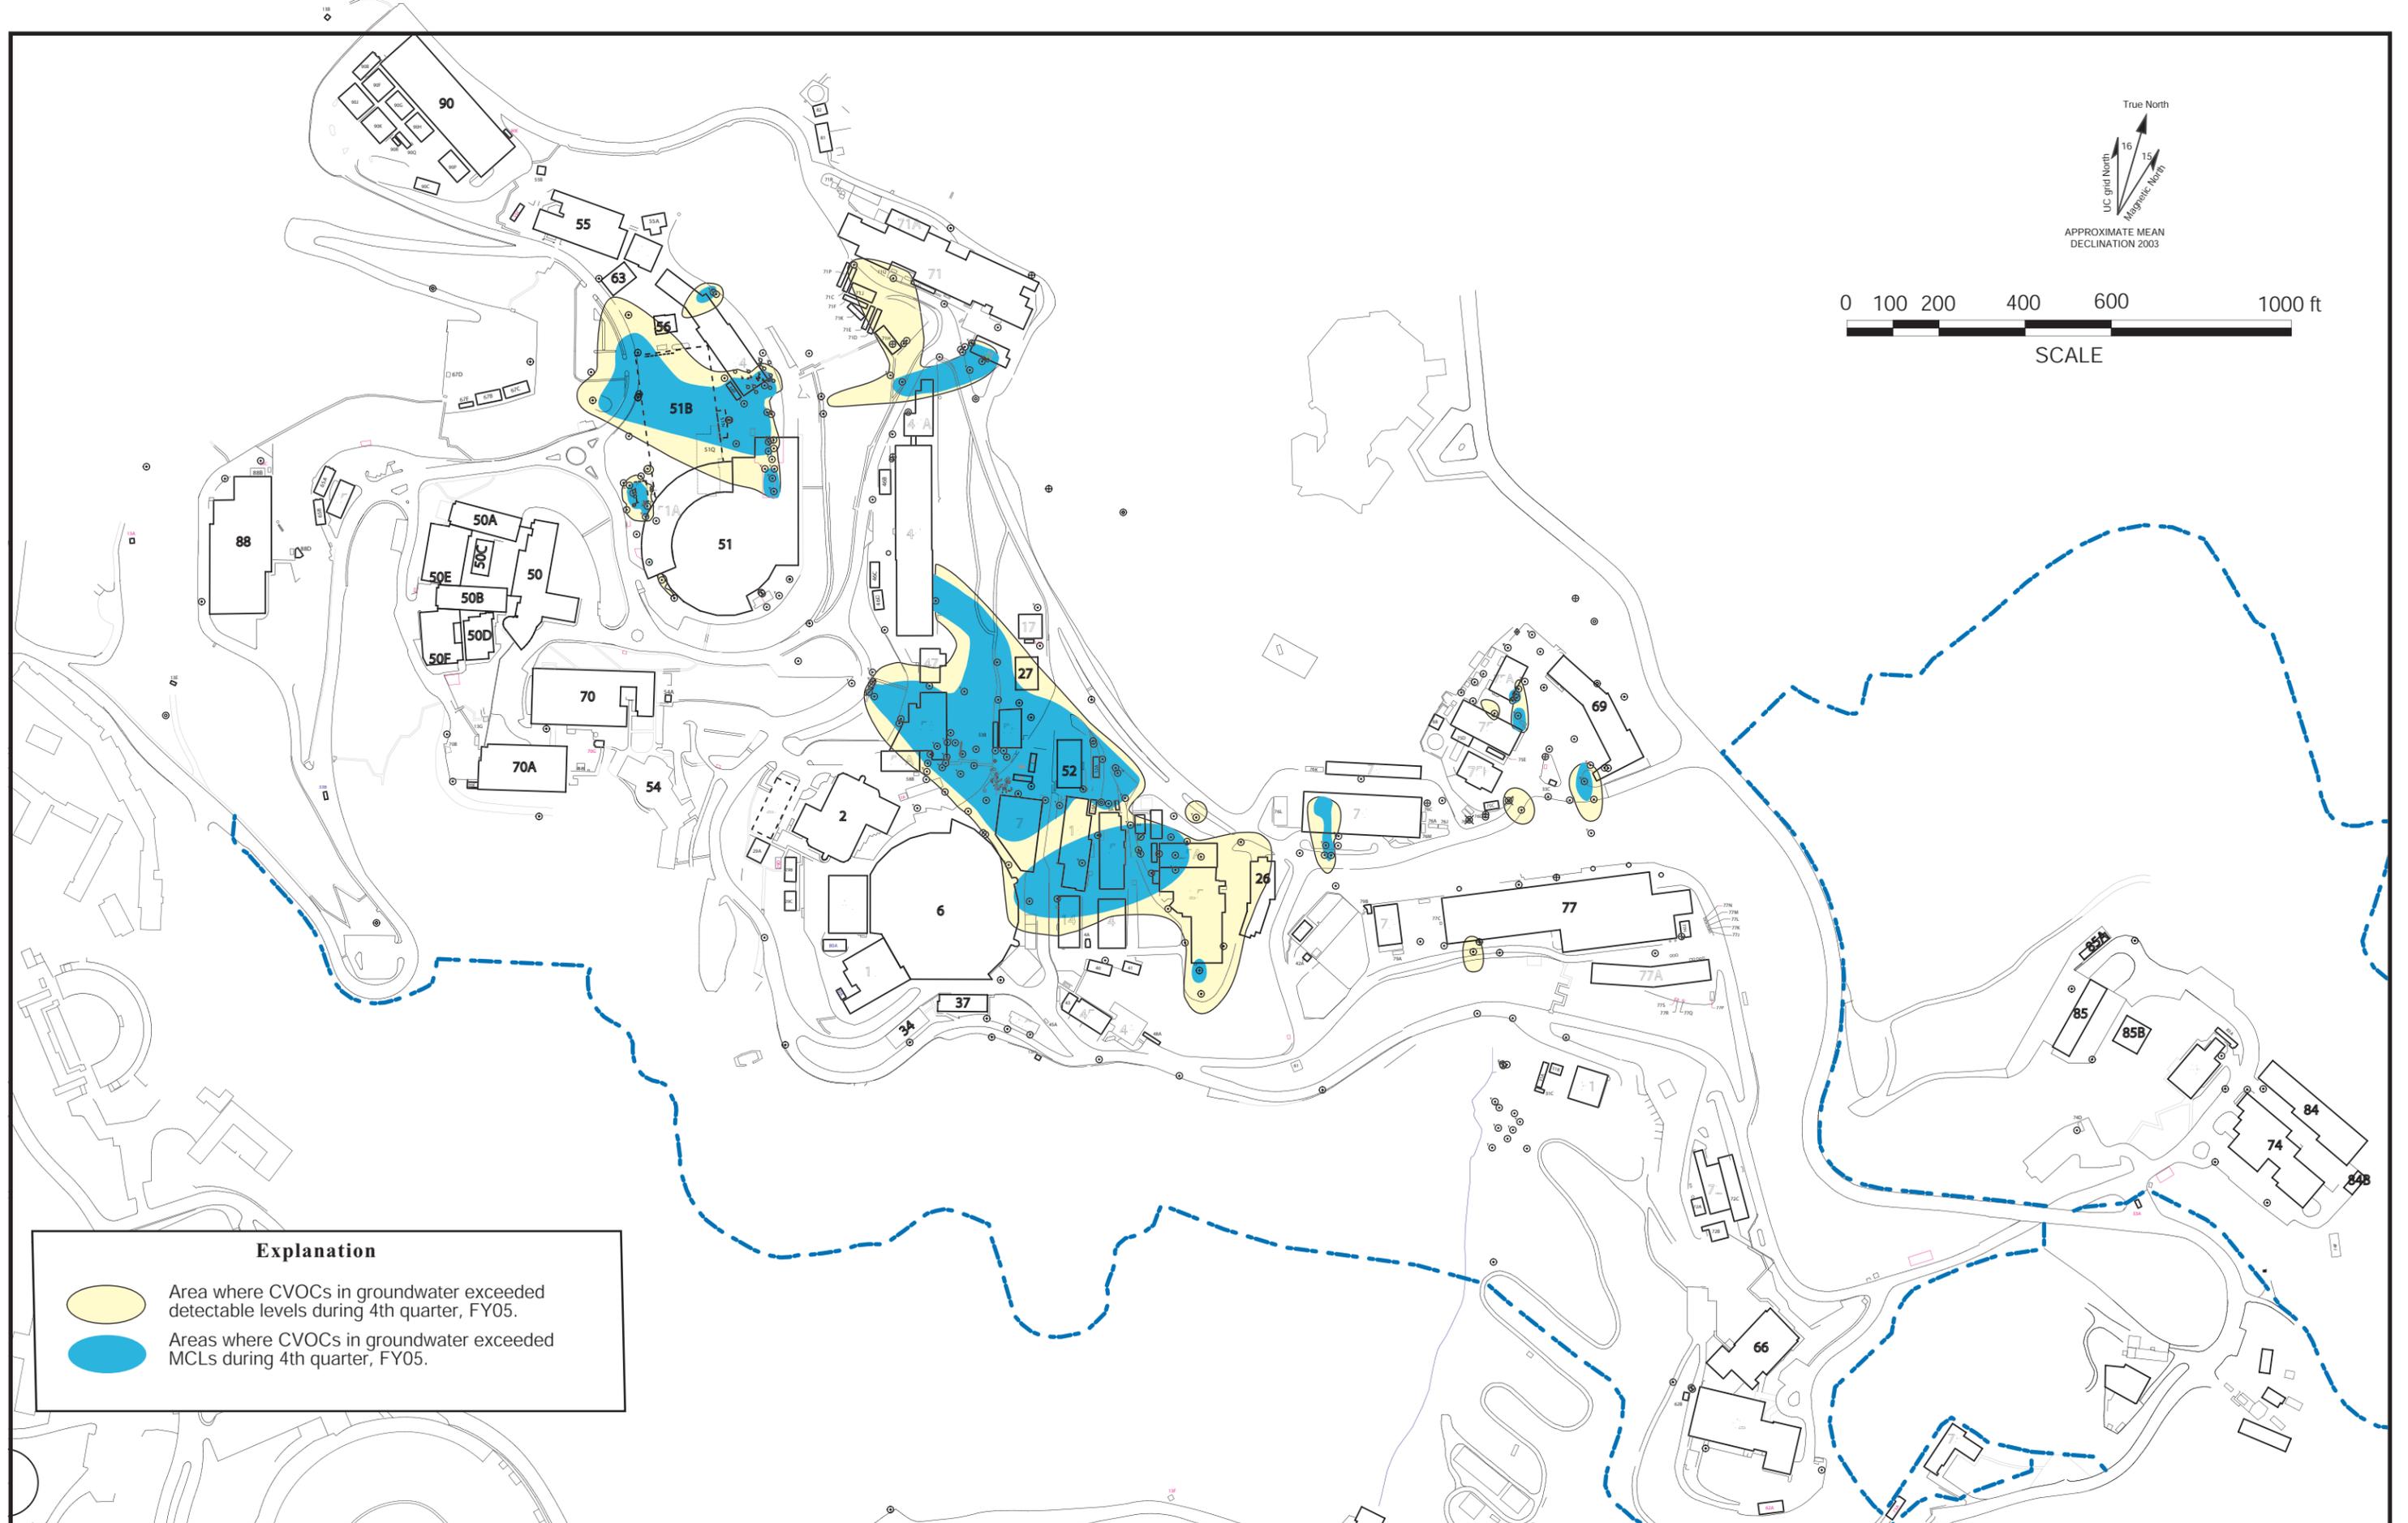
- Area where CVOCs in groundwater exceeded detectable levels during 4th quarter, FY05.
- Areas where CVOCs in groundwater exceeded MCLs during 4th quarter, FY05.

Figure 4.1. Berkeley Lab Groundwater CVOC Plumes.

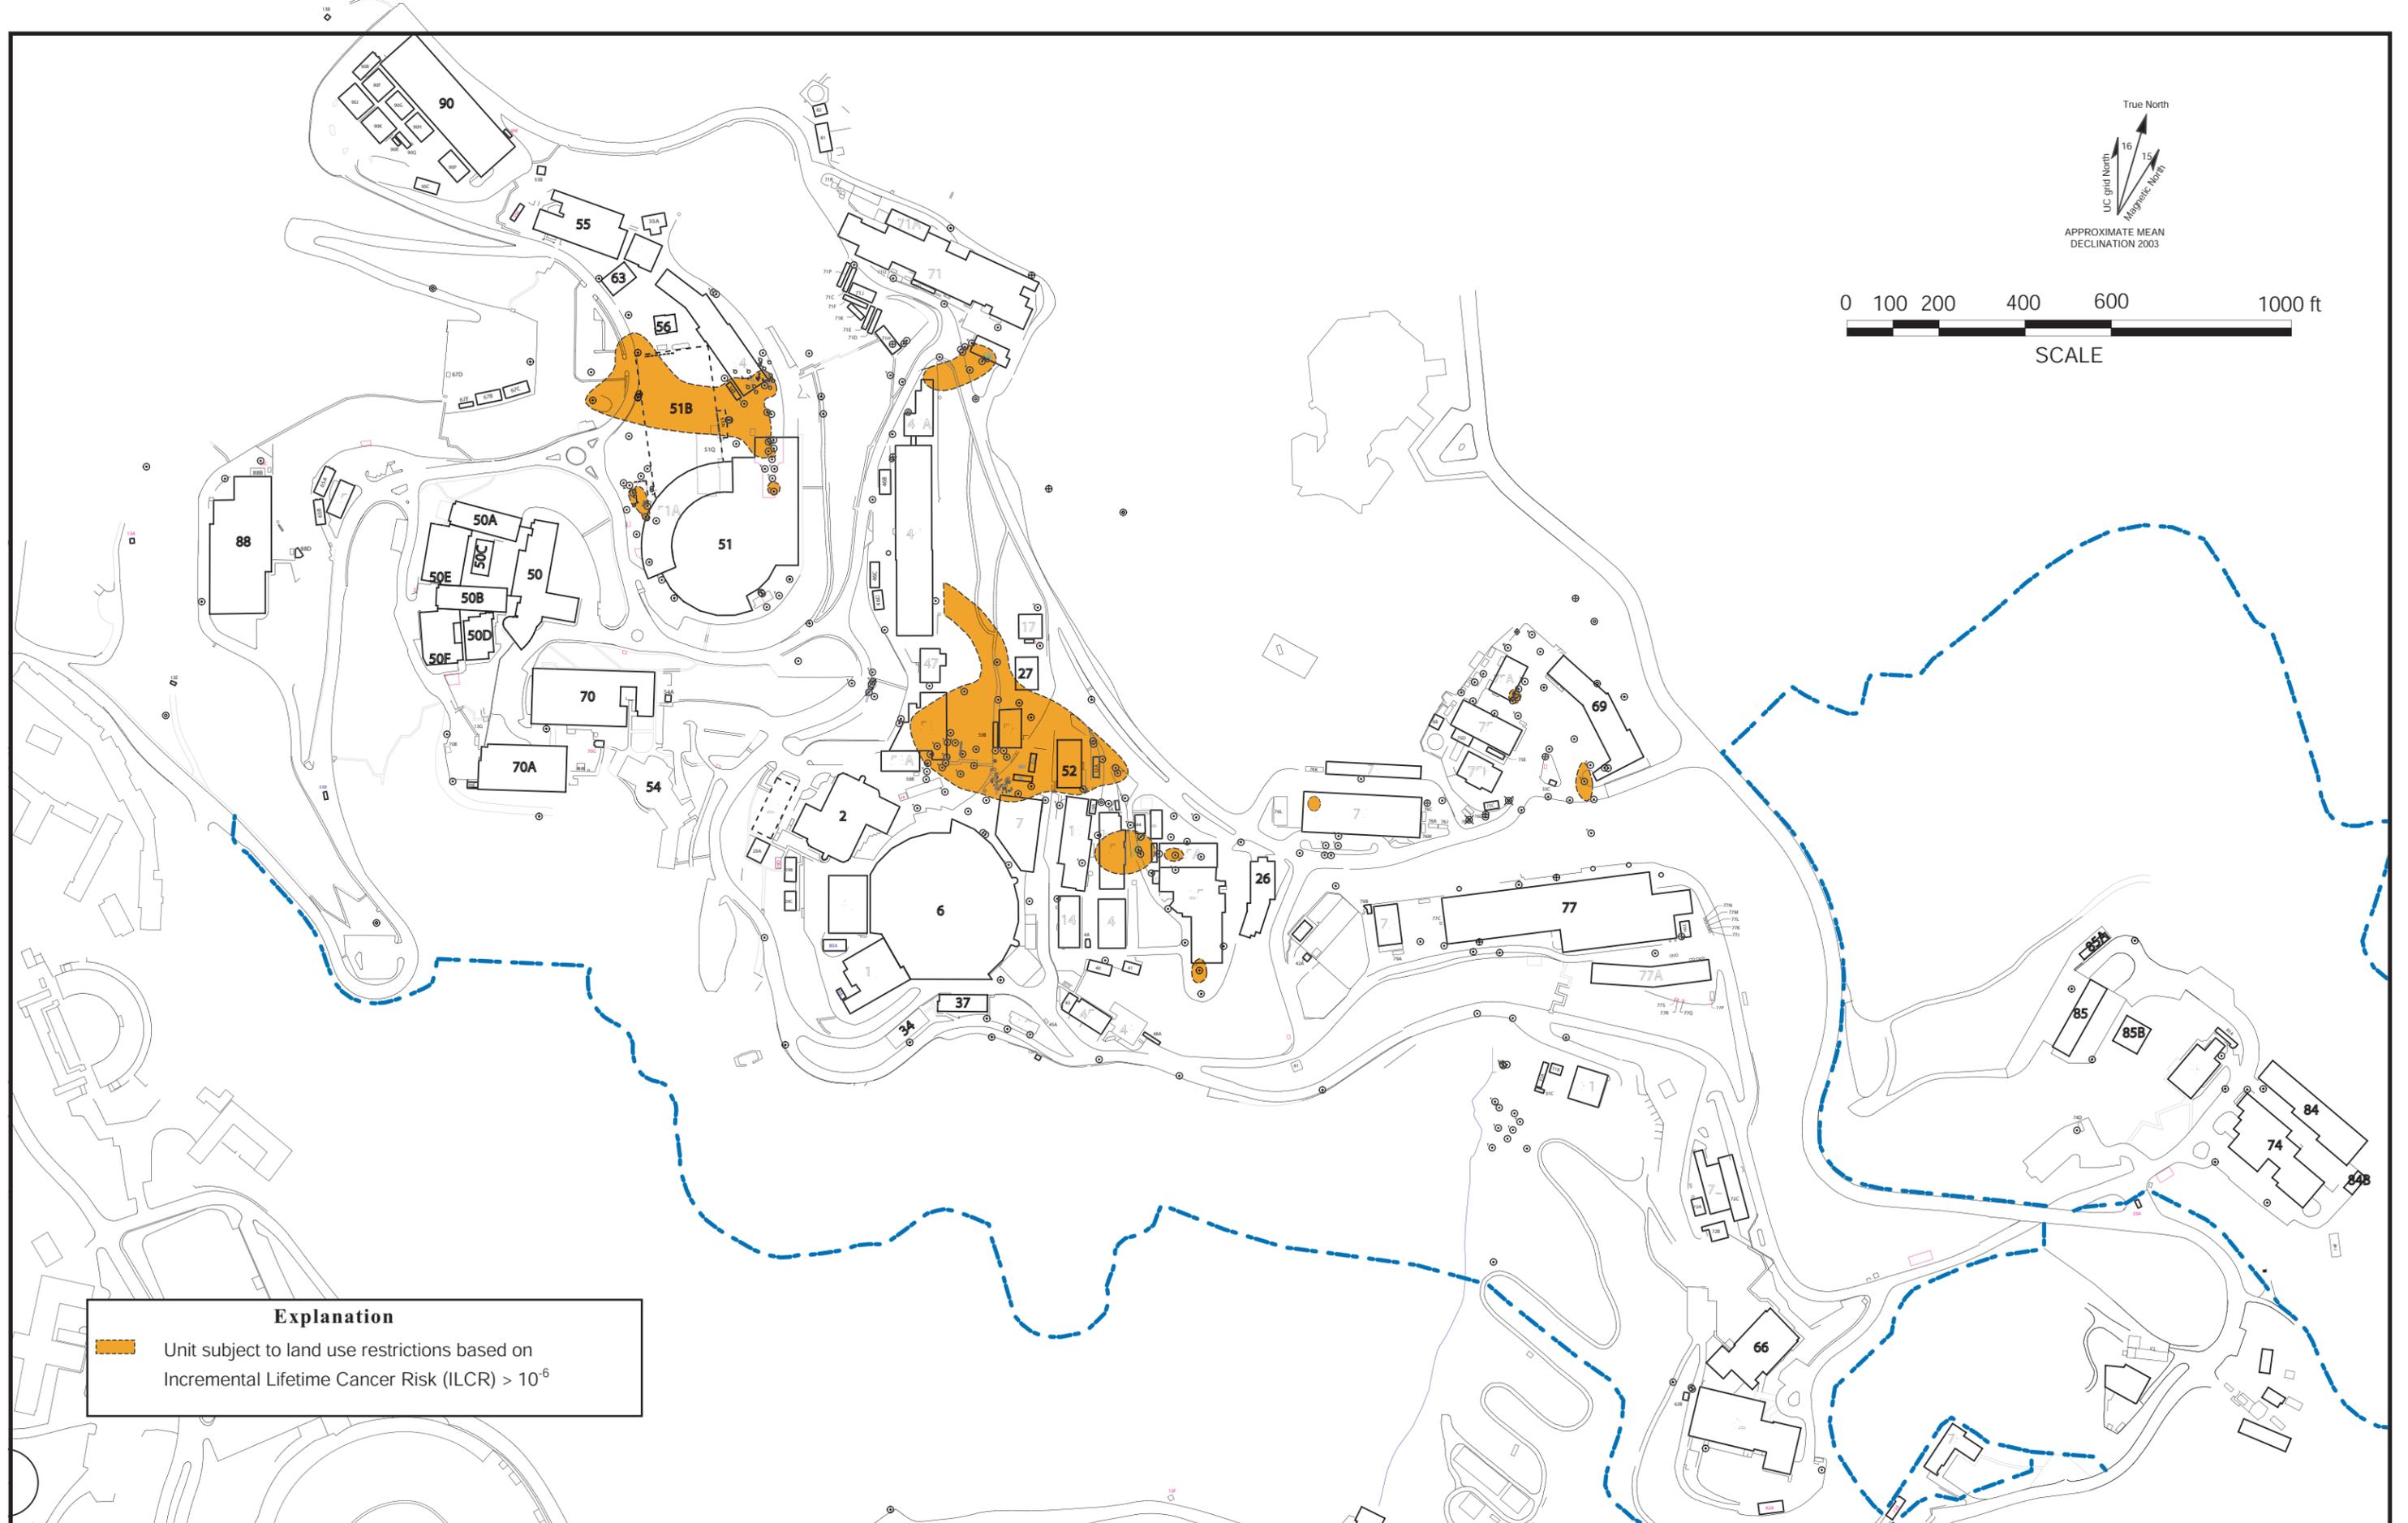
Unit subject to land use restrictions based on Incremental Lifetime Cancer Risk (ILCR) > 10⁻⁶

Figure 4.2. Extent of Land Not Suitable for Residential Use at Non-Radiological Units.

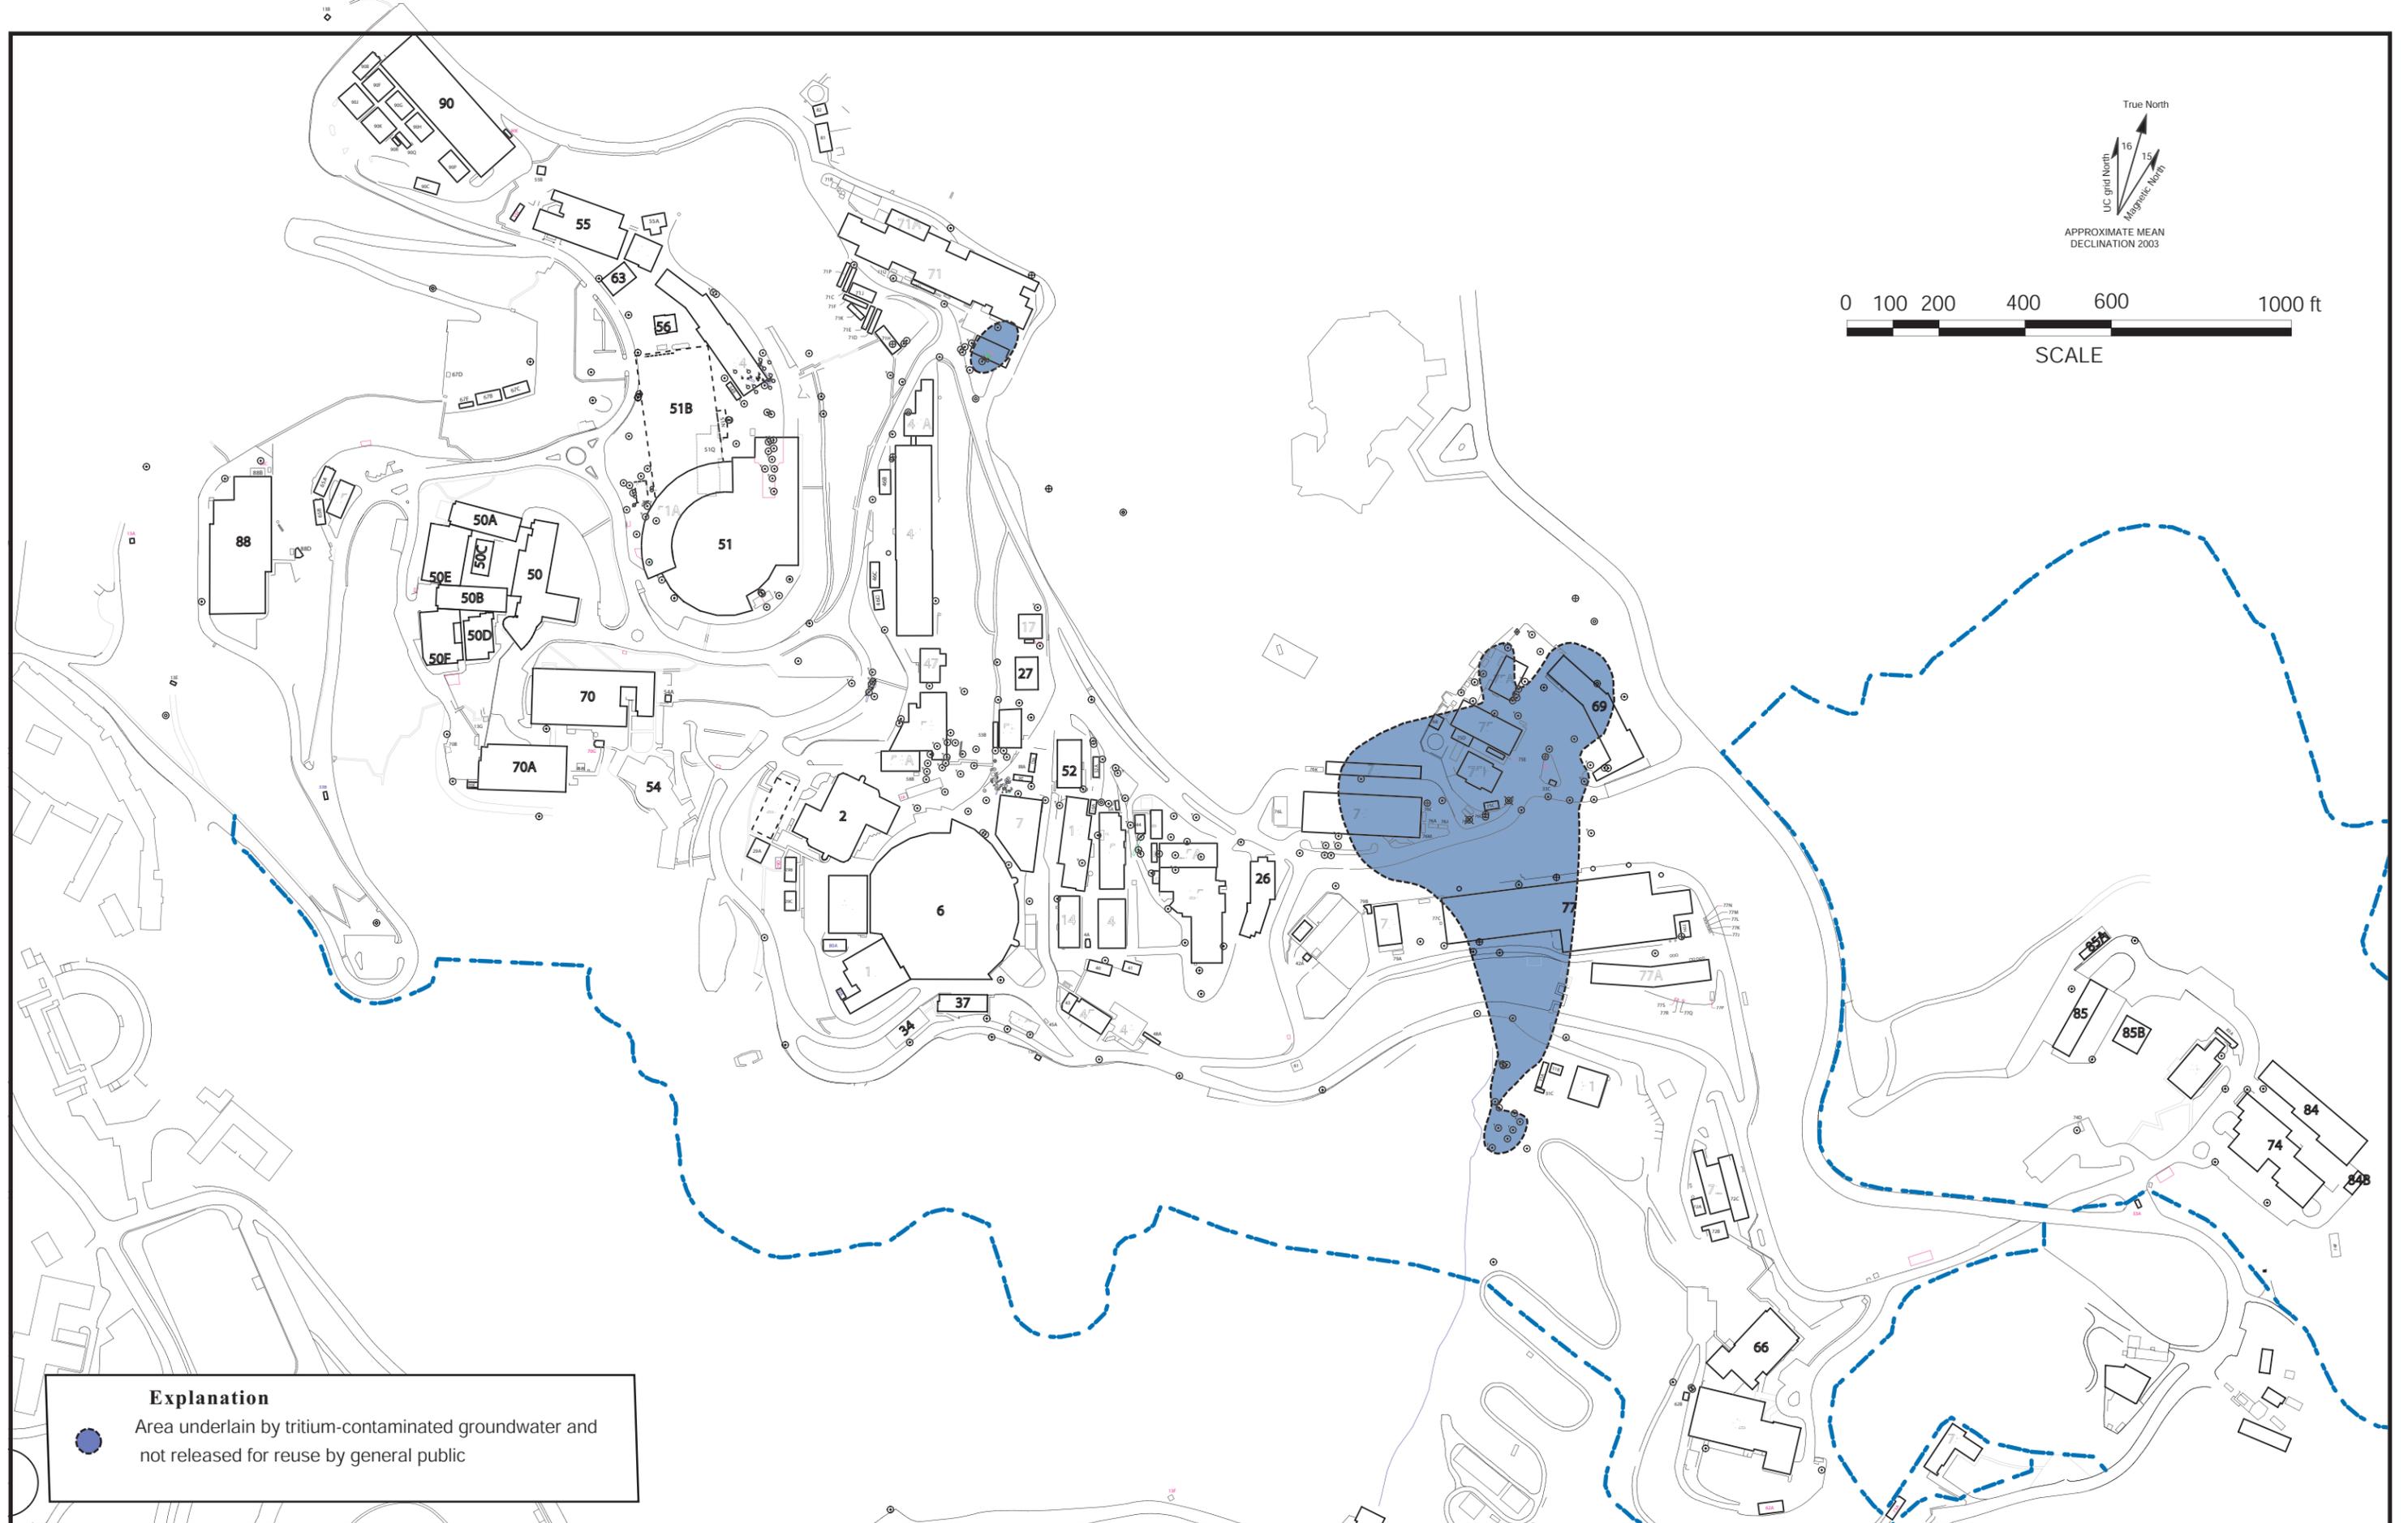
Figure 4.4. Locations of Areas of Underlain by Tritium-Contaminated Groundwater Not Released for Reuse by General Public.
